Minnesota Action Plans

Minnesota Department of
Transportation

Andrea Hendrickson

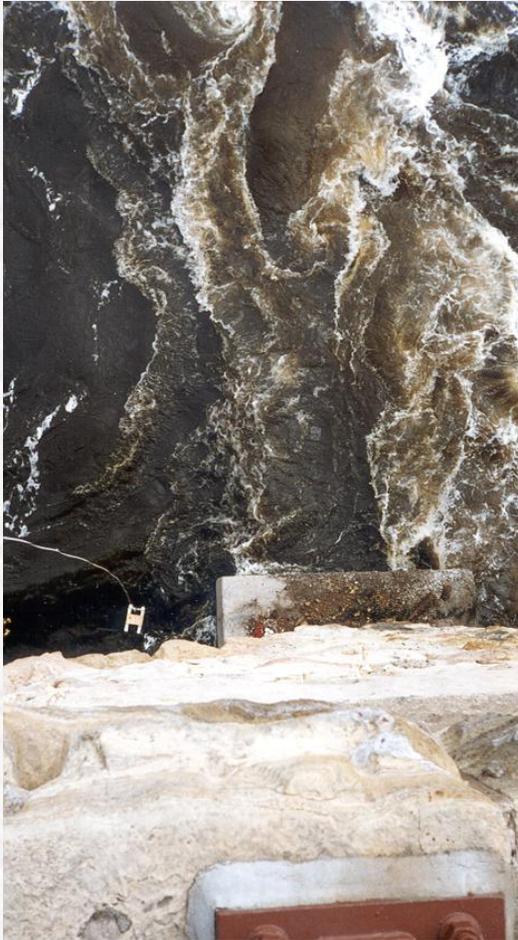
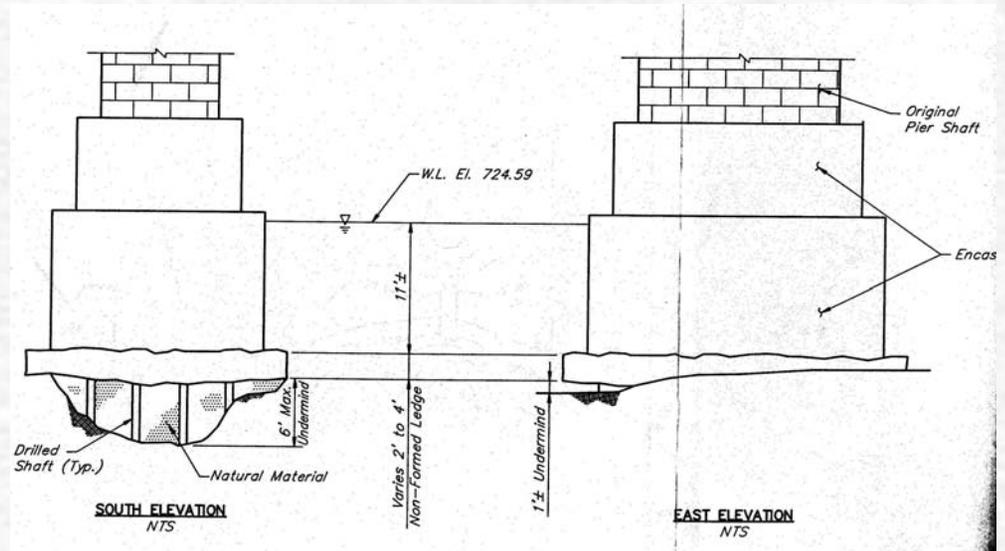
Piers Undermined Protection Required

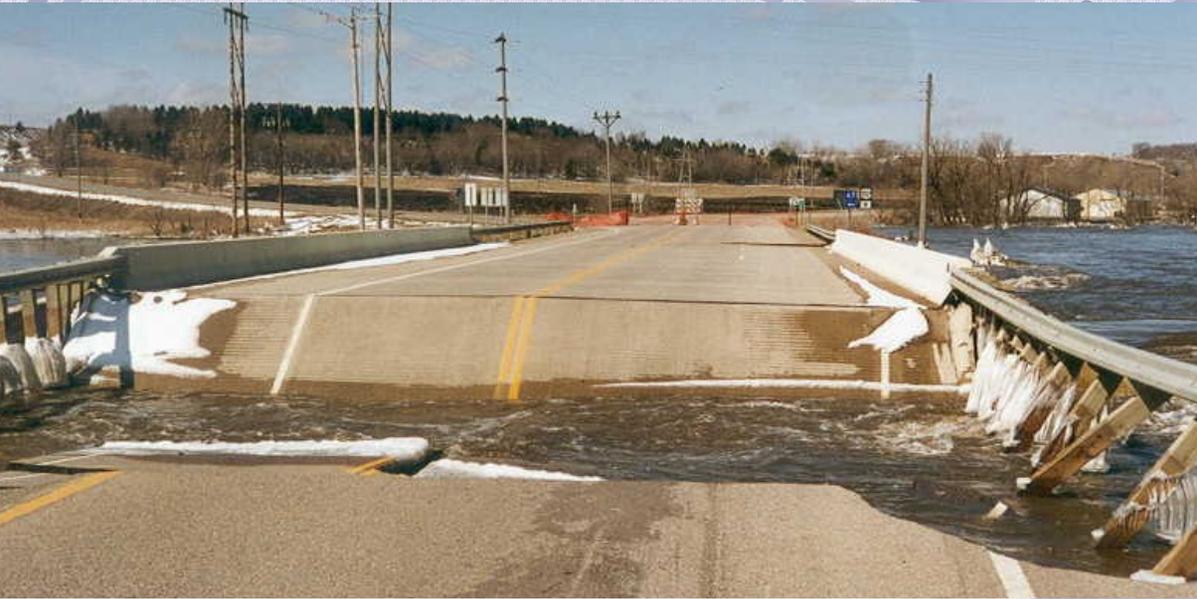
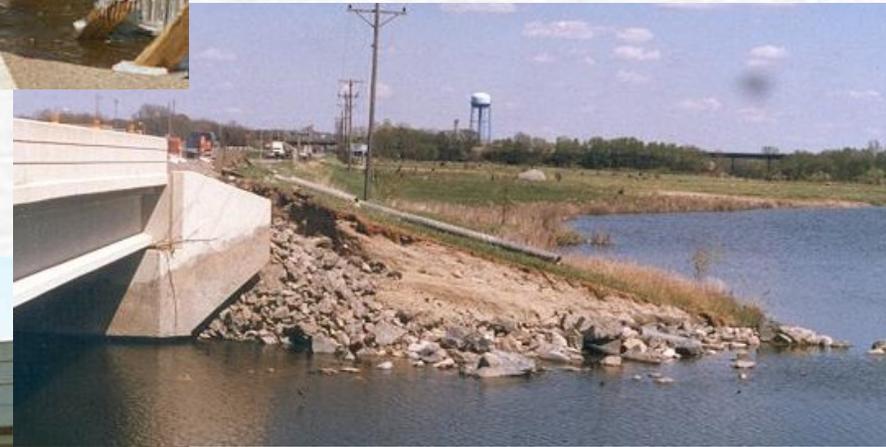
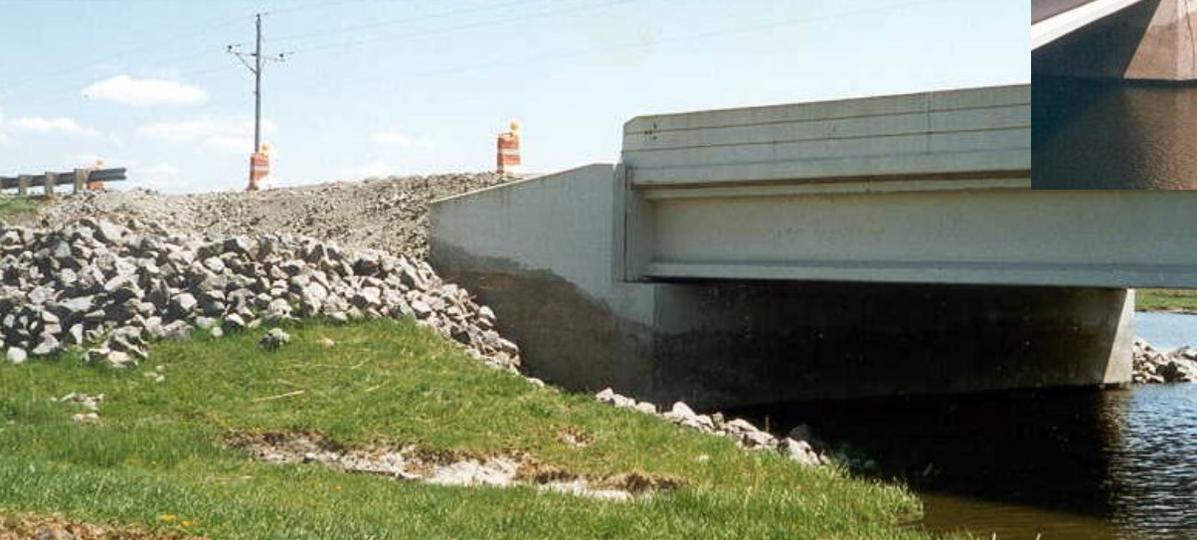
Bridge 87015

Overflow Abutment Fill and Approach Panel Lost

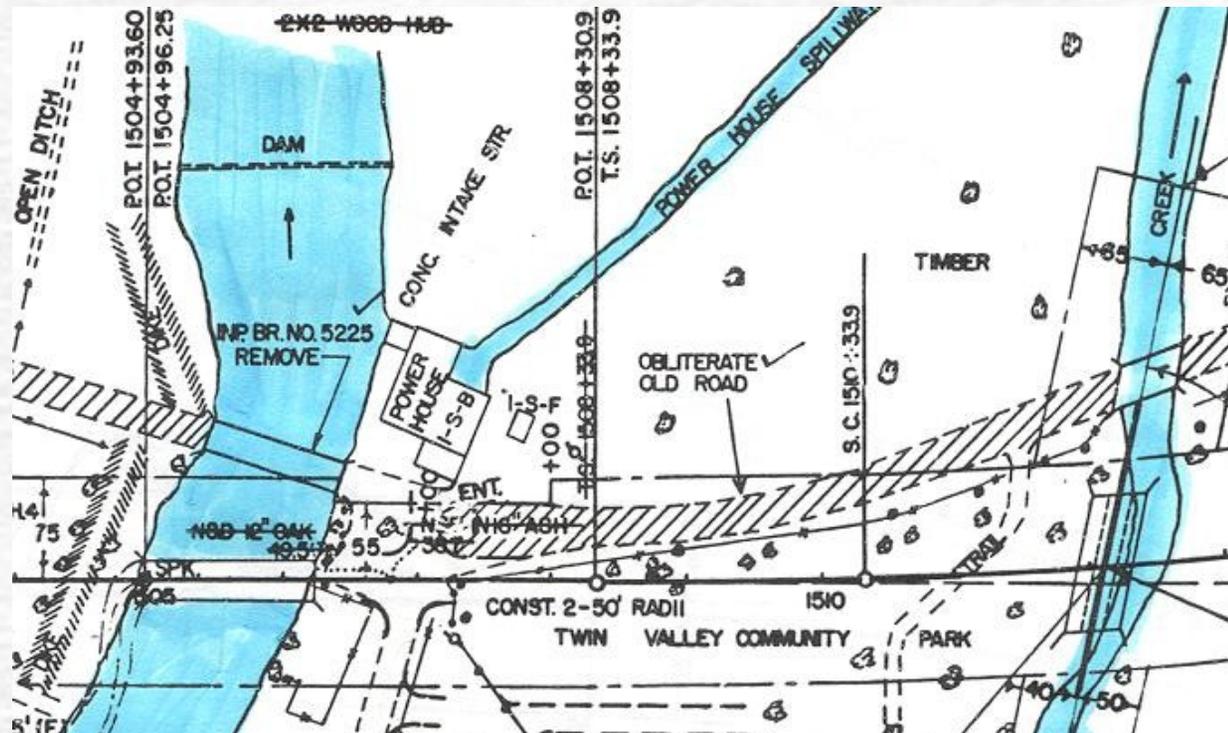
Bridge 9019

- Built 1956
- 2 Span Bridge
- Riprap added before, during and after flood event.
- Long term plan ???

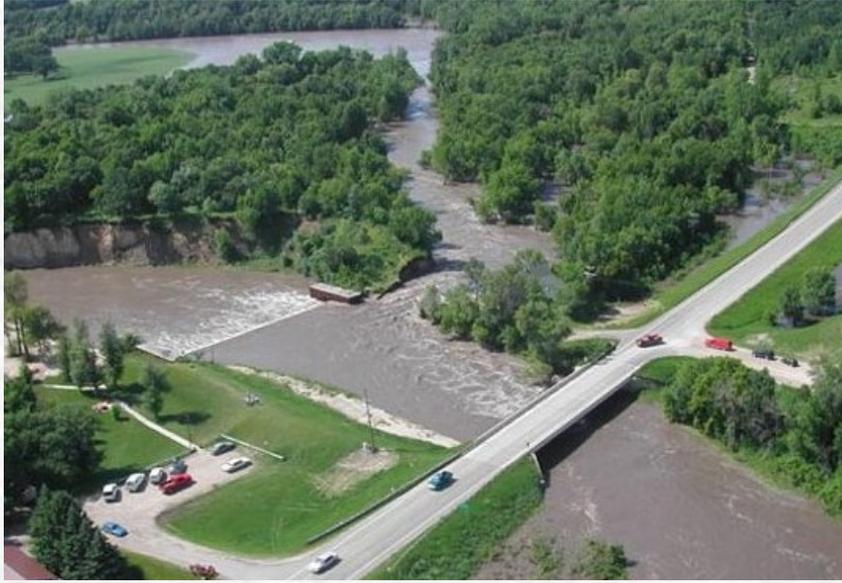
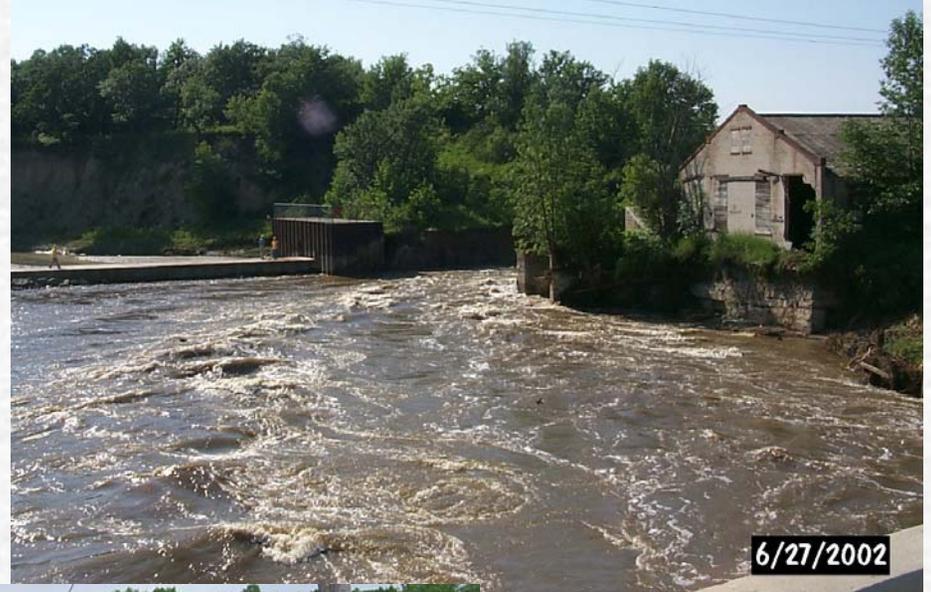
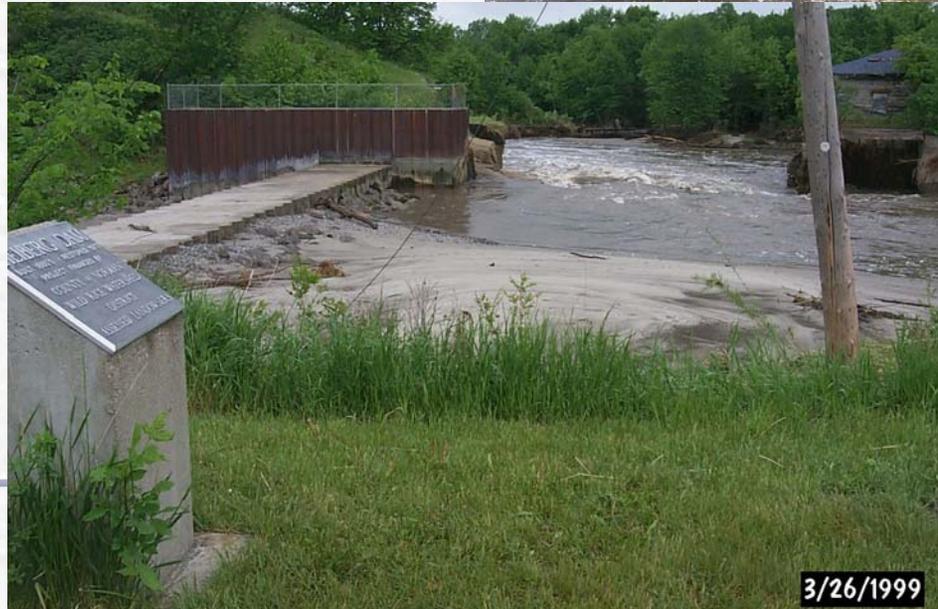
Bridge 9019 Channel Rerouted

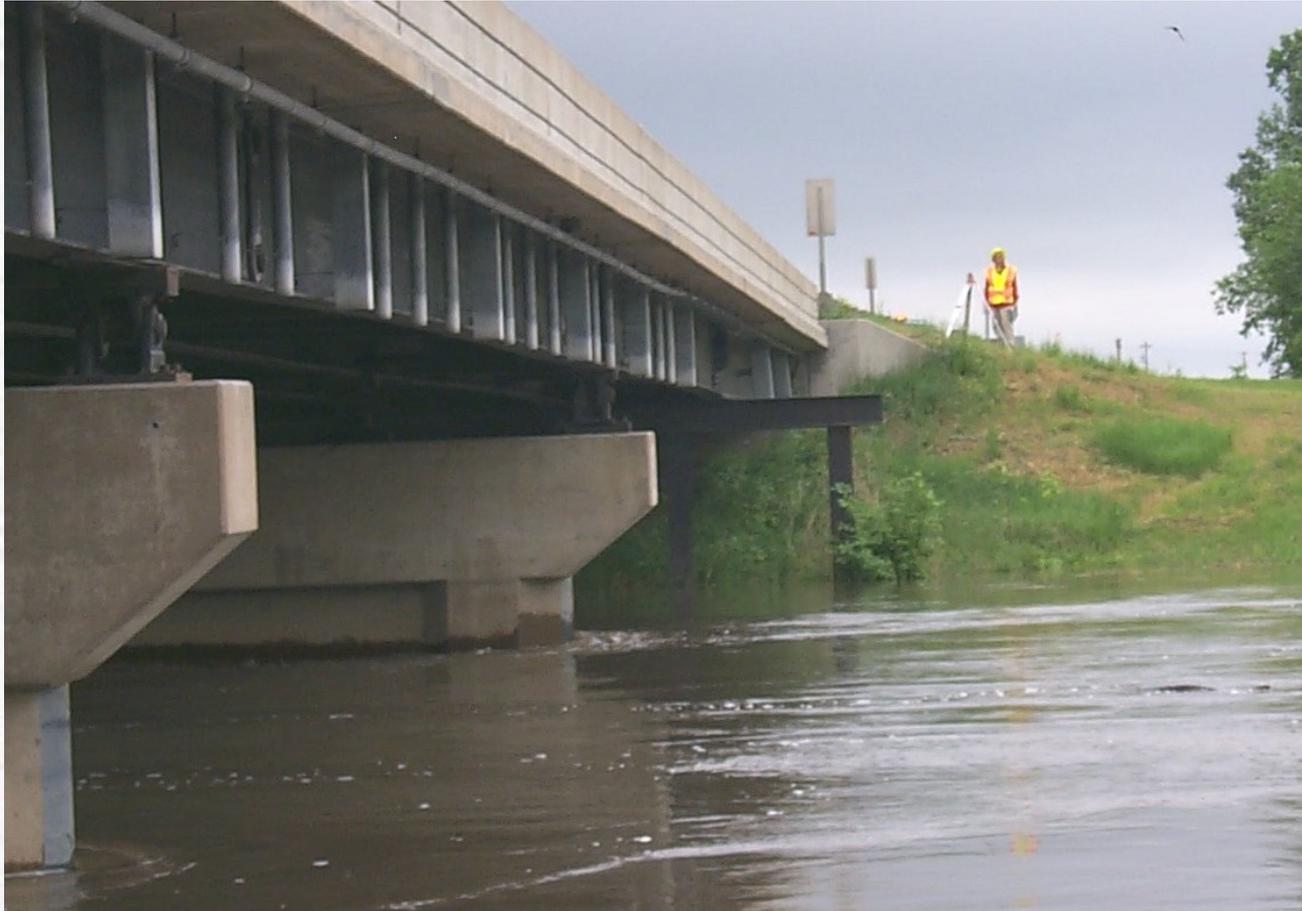
Bridge 6477

Flood 6/2002 over 500-year event
