The Road Inventory of Amistad National Recreation Area AMIS - 1700

Road Inventory Program

Prepared By:
Federal Highway Administration
Eastern Federal Lands Highway Division
Cycle 3

Amistad National Recreation Area in Texas

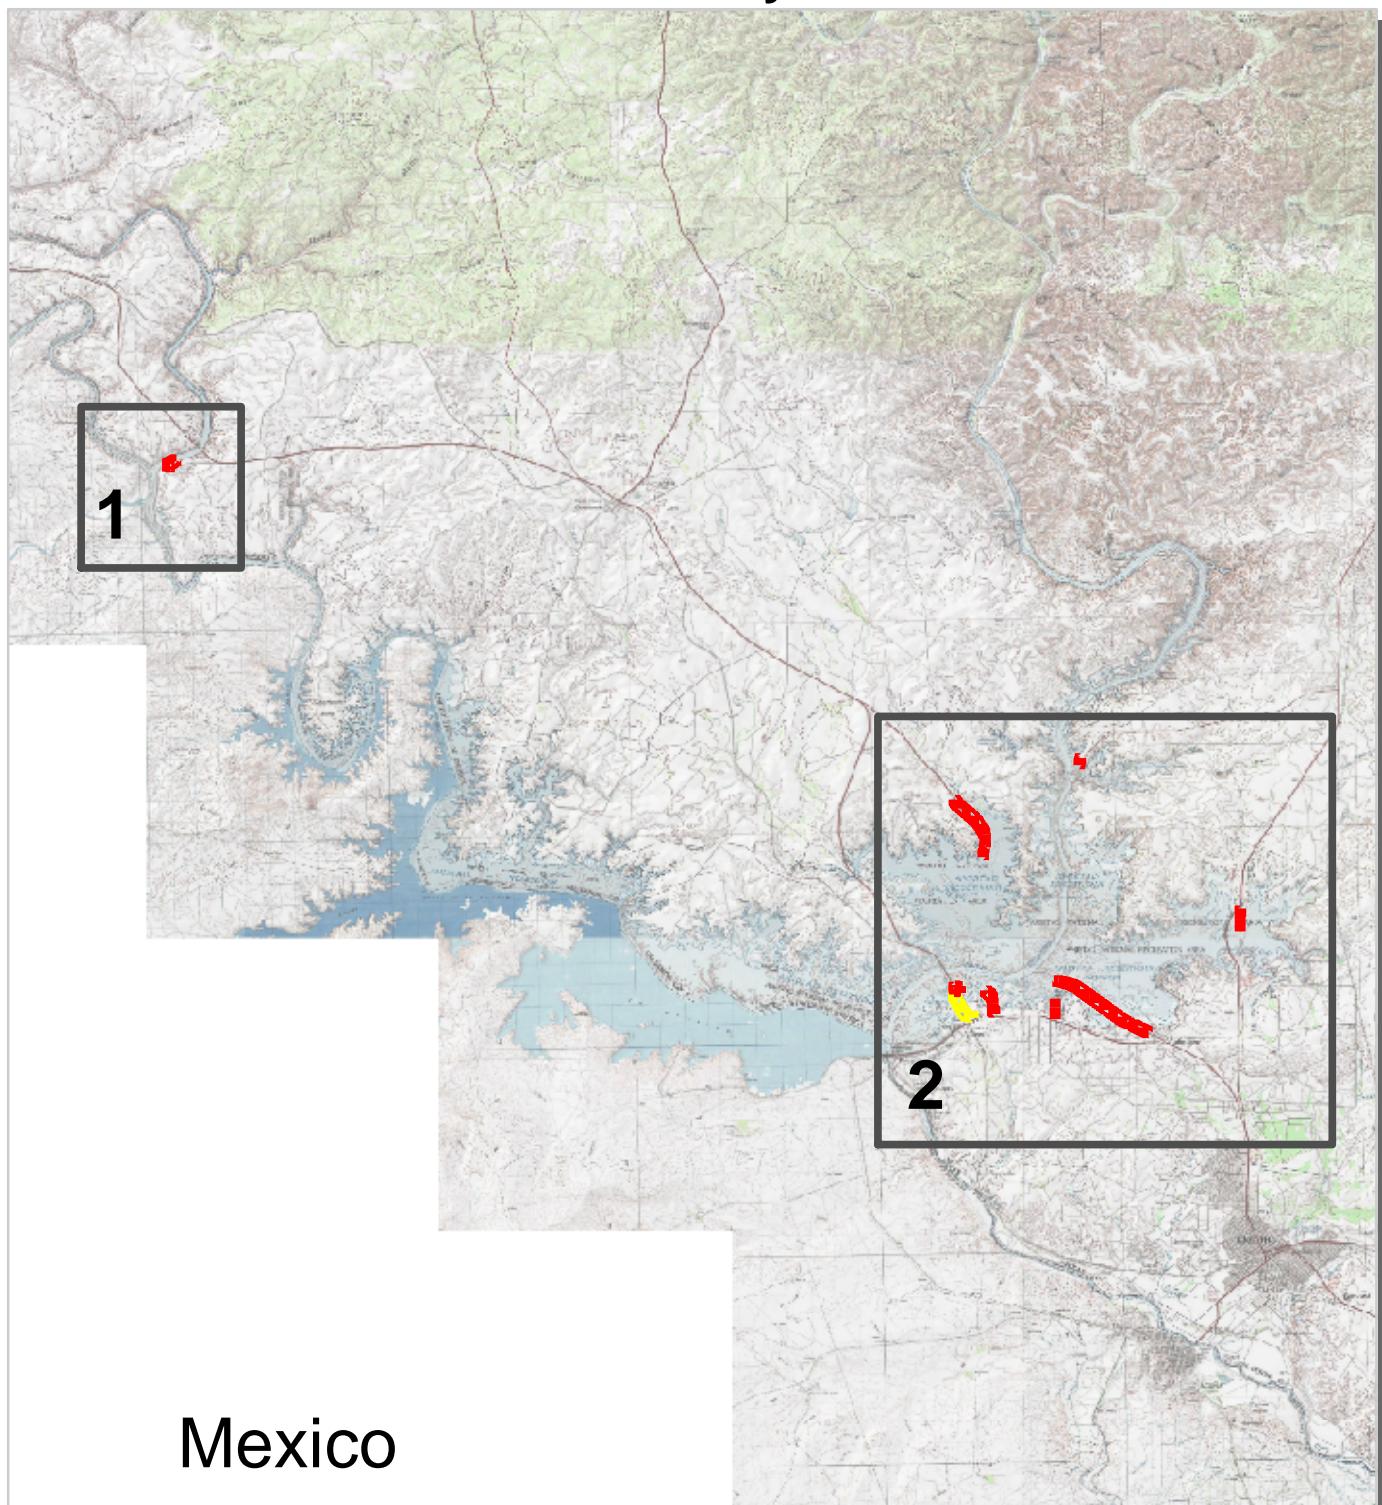
Amistad National Recreation Area Route Condition Key Map PCR - Mile by Mile

PCR	Poor		Fair		Good		Excellent	
	(<=60)		(61 - 84)		(85 - 94)		(95 - 100)

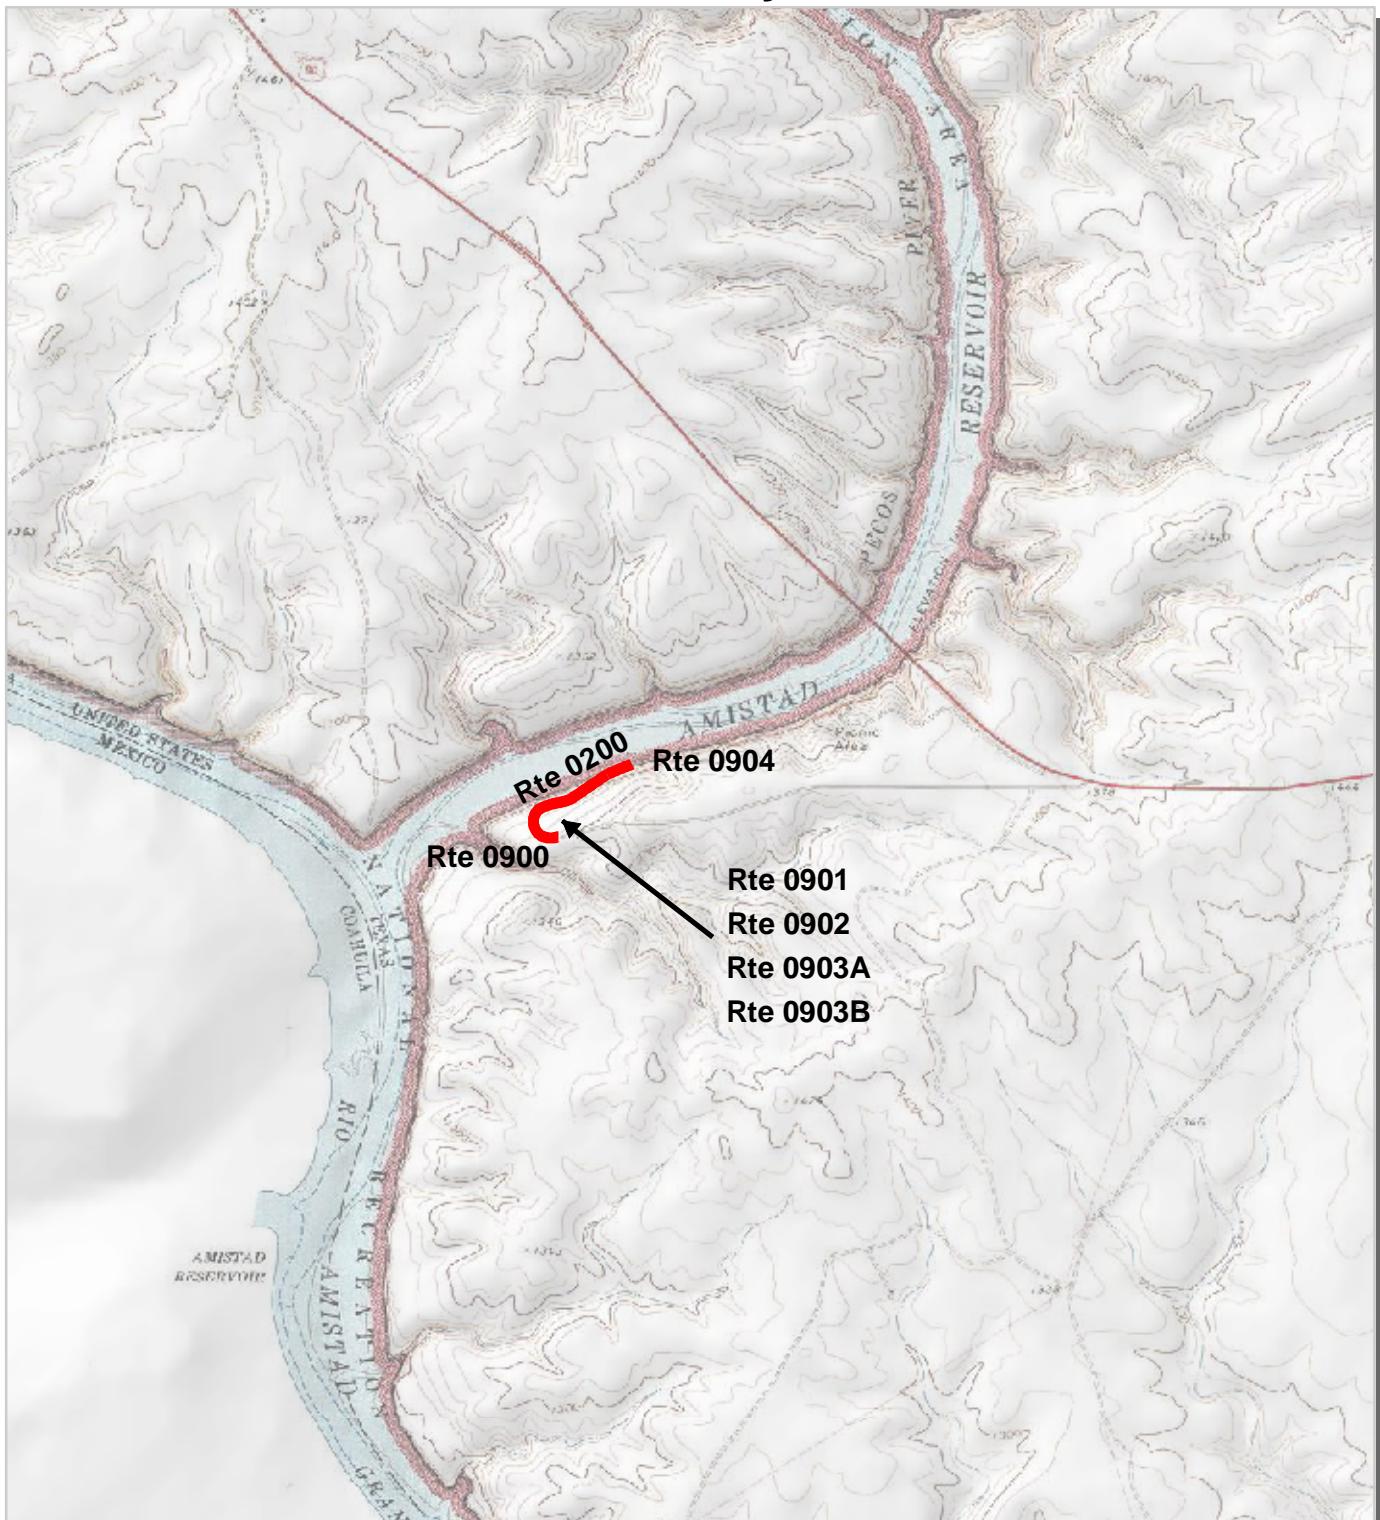
Route Condition Area Map 1

PCR	Poor		Fair		Good		Excellent	
	(<=60)		(61 - 84)		(85 - 94)		(95 - 100)

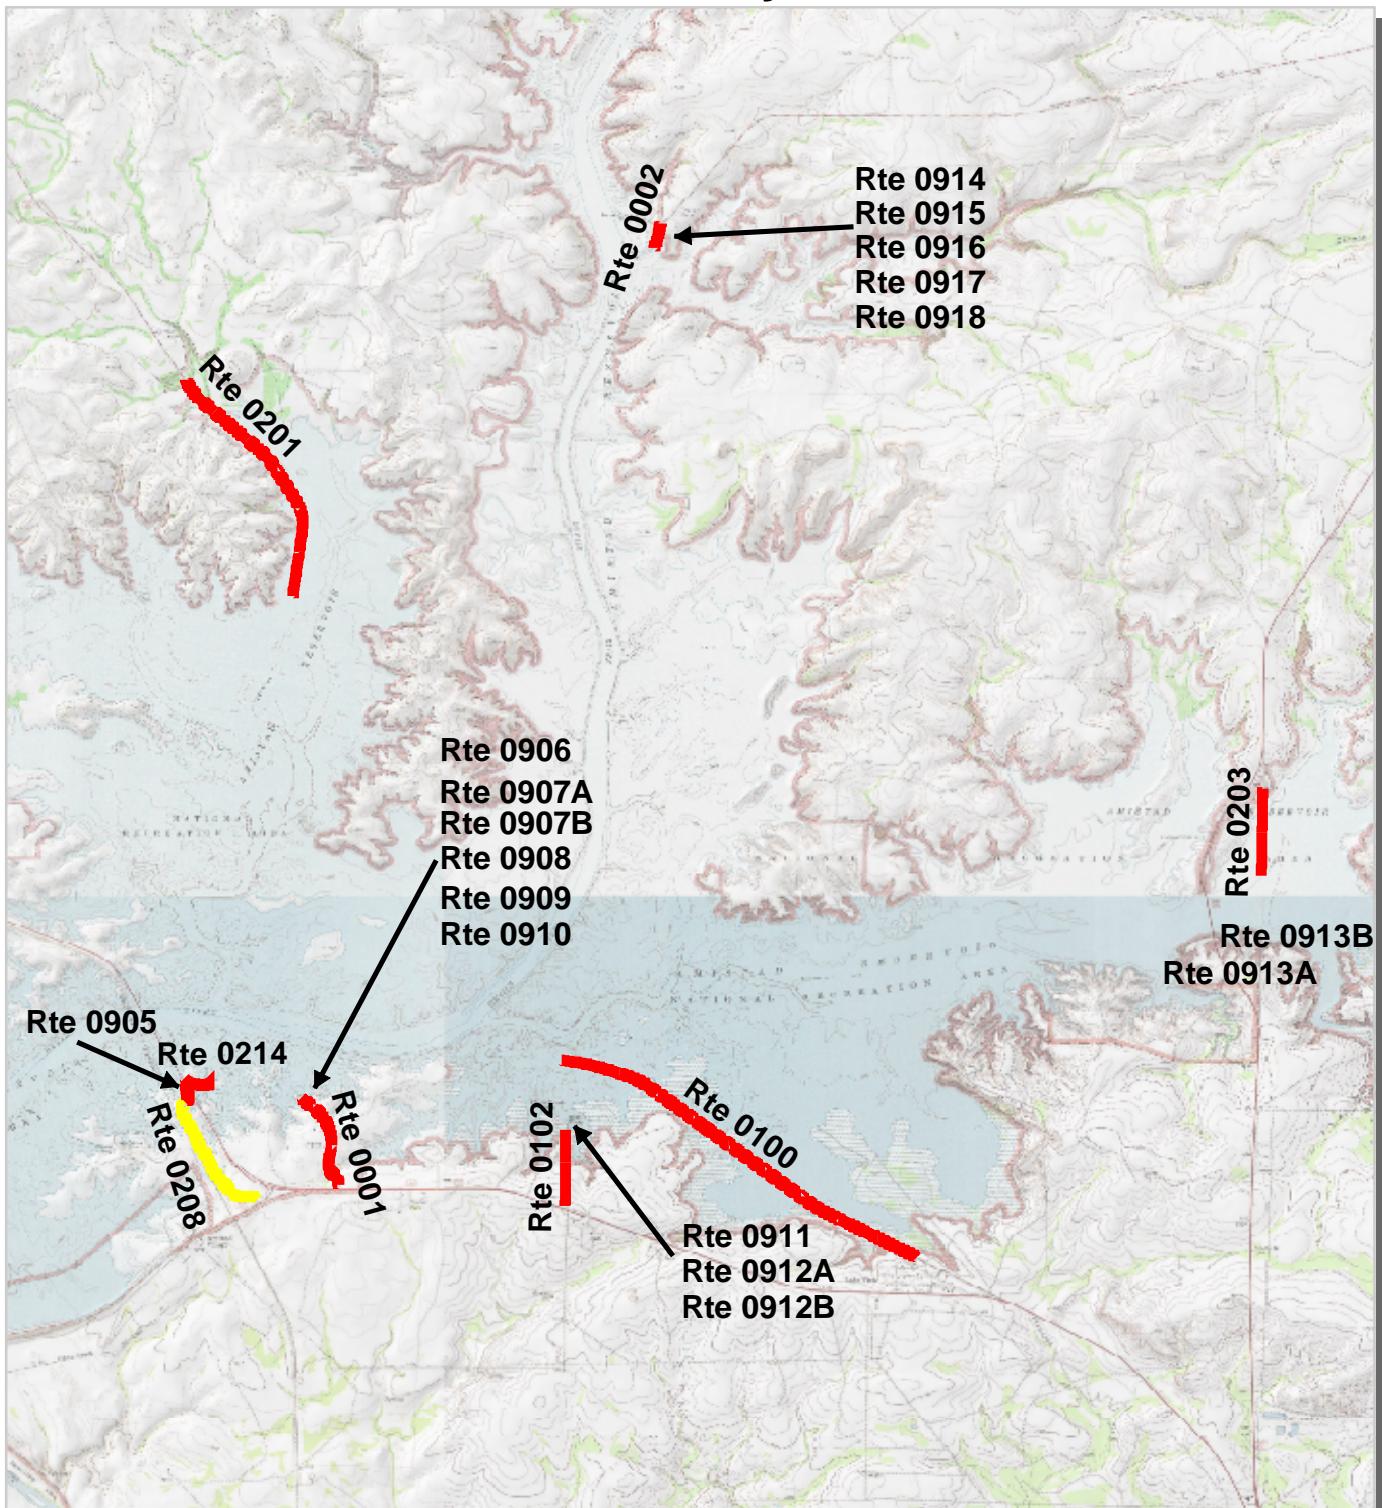
Route Condition Area Map 2

* If the PCR rating is not available for a section, the SCR rating will be displayed. See appendix for definitions and formulas.

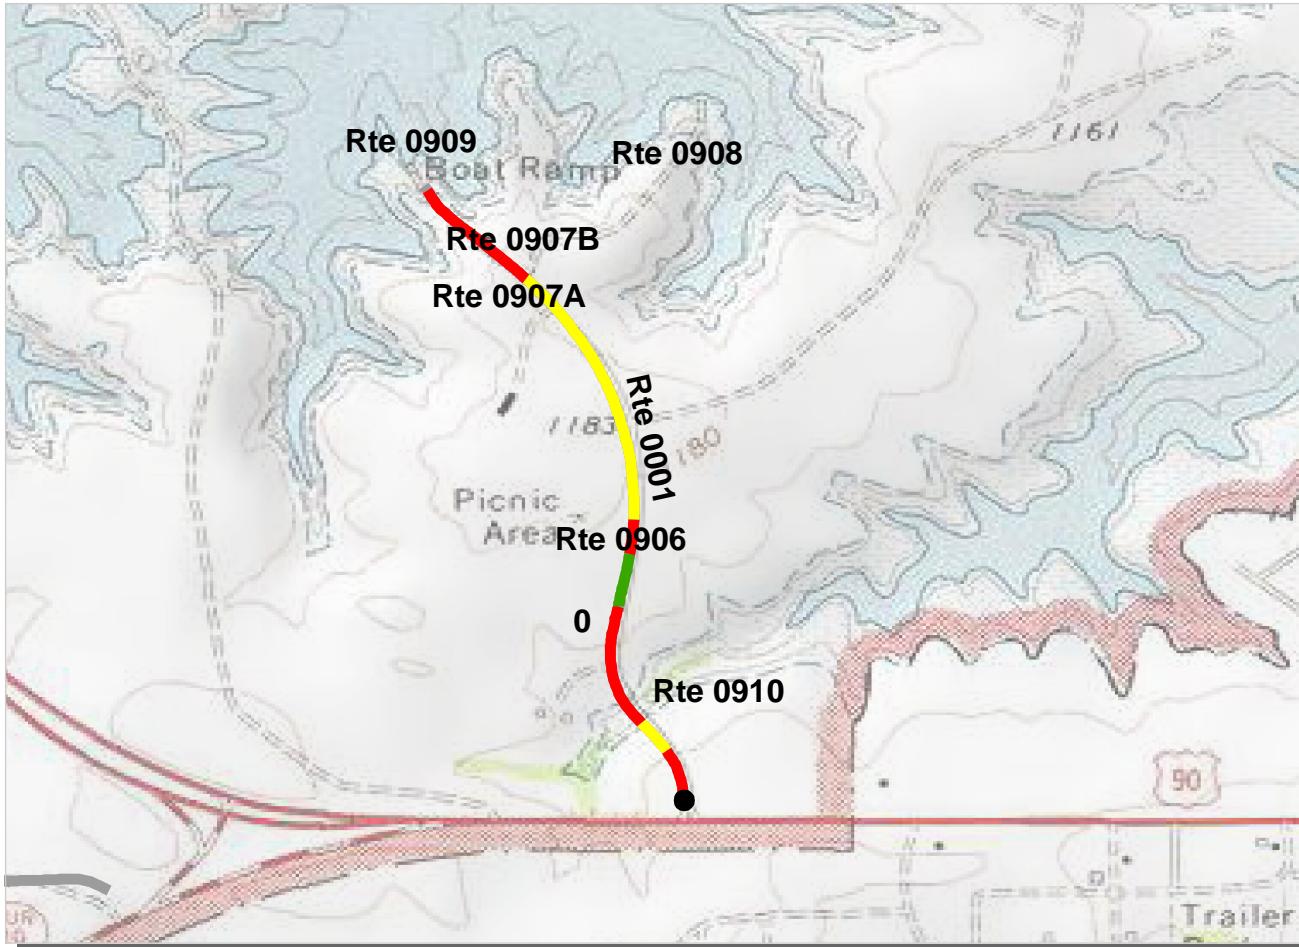
Section Number	0				
Section Length (mi)	0.79				
AADT	**				
SADT	**				
ADT Date	**				
Cross Section Information					
Number of Lanes	2				
Paved Width (ft)	21				
Lane Width (ft)	11				
Shoulder Width (ft)	0				
Roadway Condition Information					
PCR (Pavement Condition Rating)	59				
RCI (Roughness Condition Index)	76				
SCR (Surface Condition Rating)	51				
Alligator Cracking Index	100				
Rutting Index	53				
Patching Index	100				
Transverse Cracking Index	99				
Longitudinal Cracking Index	99				
Shoulder Condition Rating	N/A				
Drainage Condition Rating	N/C

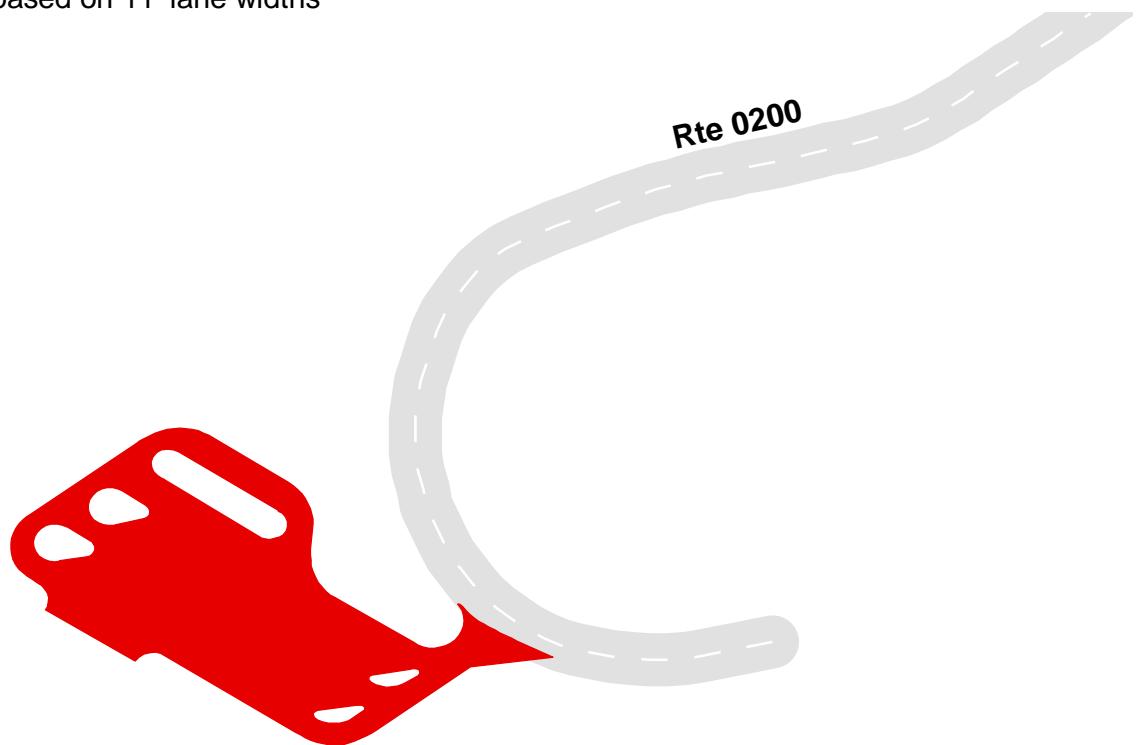
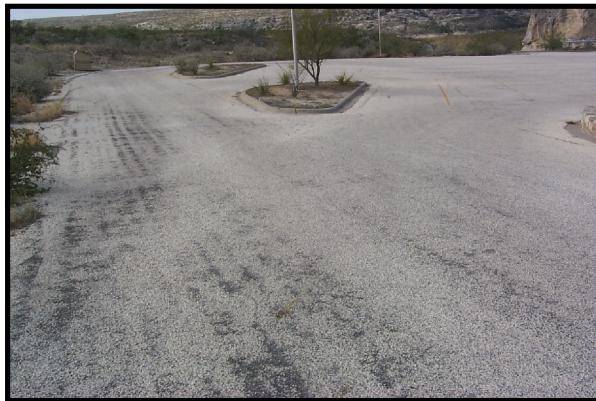
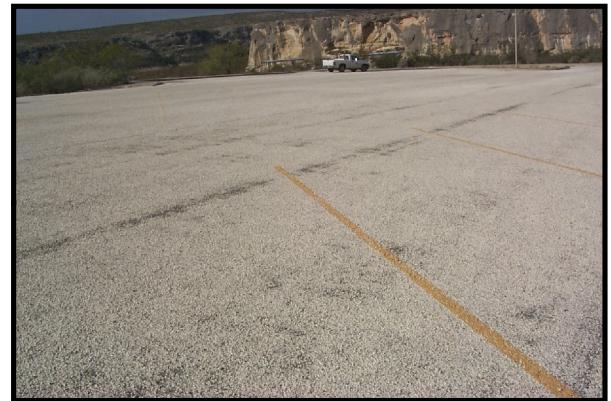
Route	Public / NonPublic	Date Visited	Area (sq ft)	Lane Miles *	Surface Type	Condition / PCR
0900	Public	12/16/2001	59849	1.03	OC	GOOD / 90

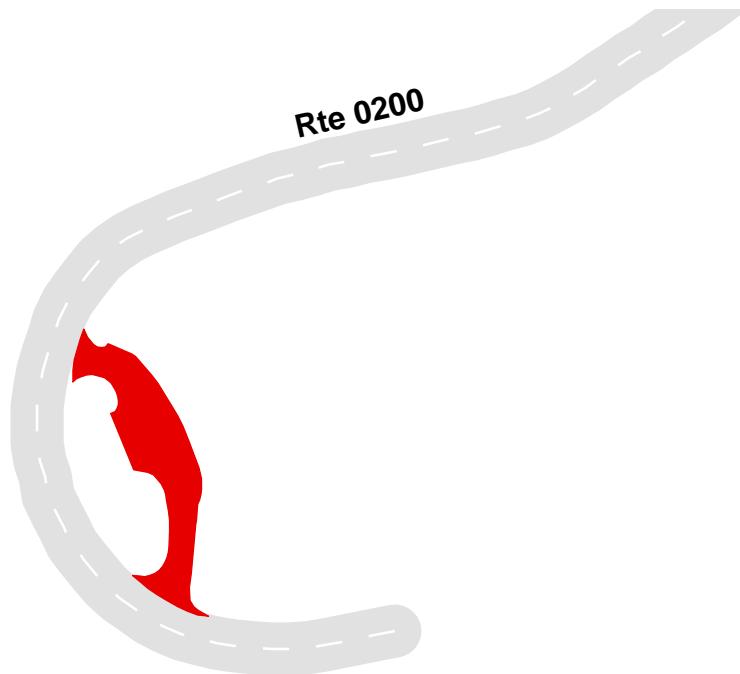
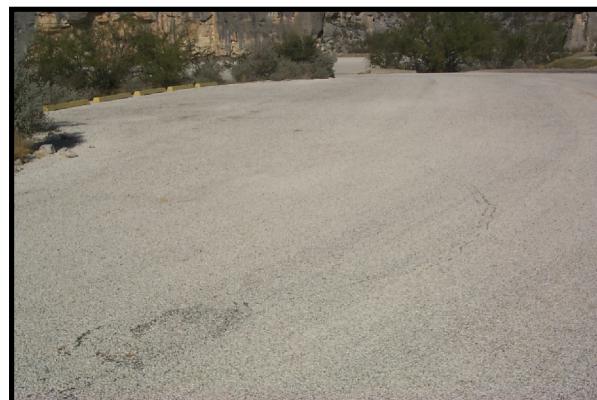
Route	Public / NonPublic	Date Visited	Area (sq ft)	Lane Miles *	Surface Type	Condition / PCR
0901	Public	12/16/2001	11078	0.19	OC	GOOD / 90

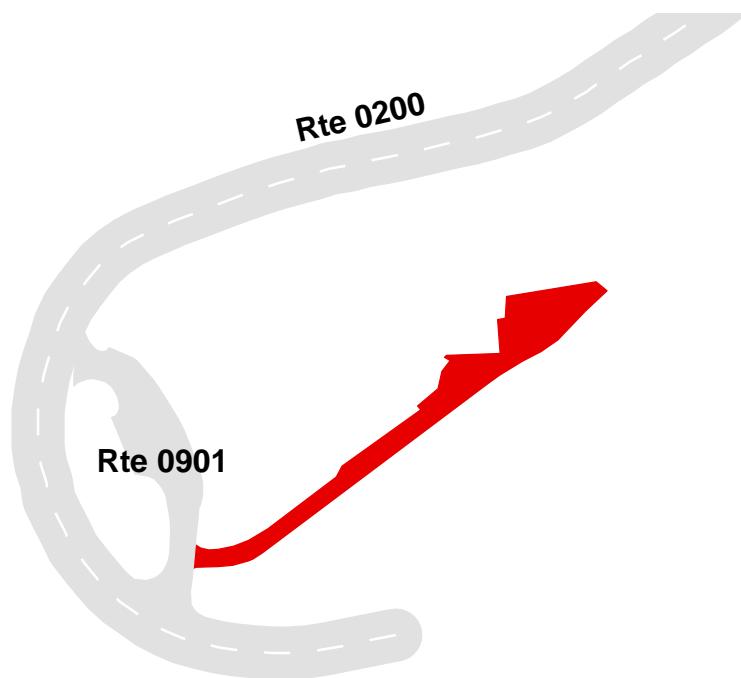
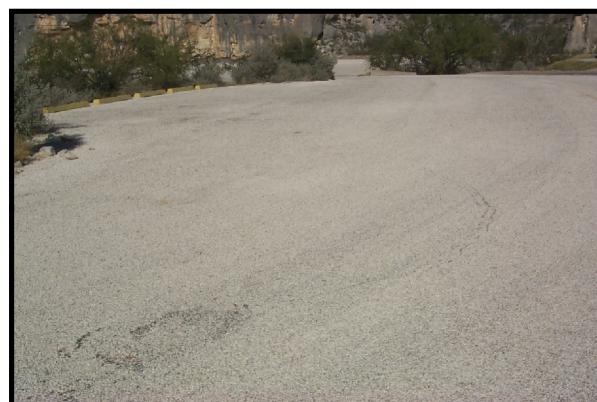
Route 0902

Route	Public / NonPublic	Date Visited	Area (sq ft)	Lane Miles *	Surface Type	Condition / PCR
0902	NonPublic	12/16/2001	12457	0.21	OC	GOOD / 90

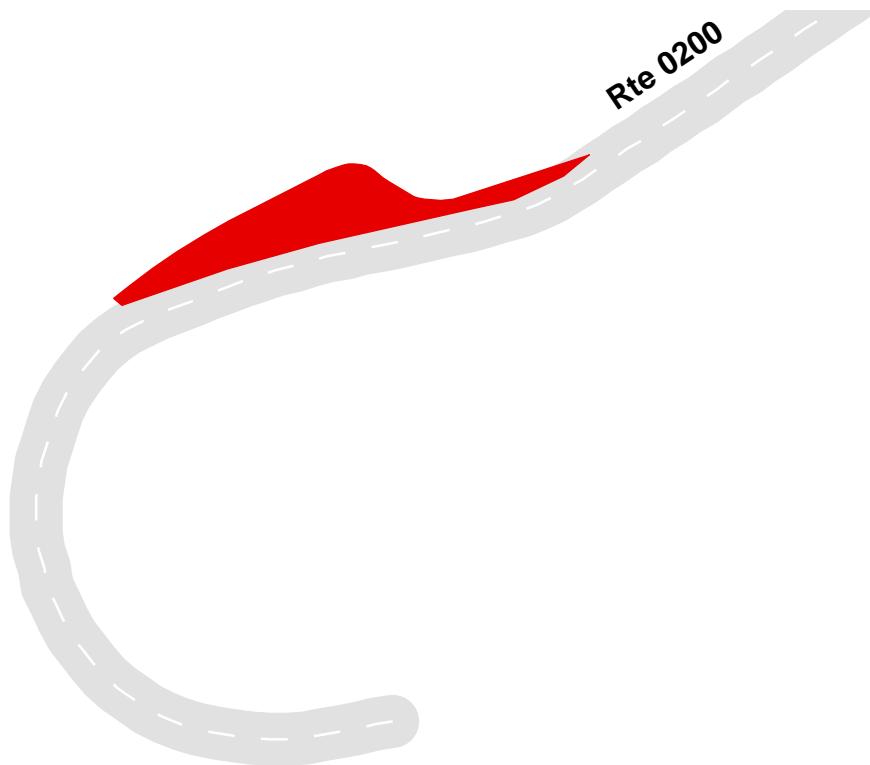
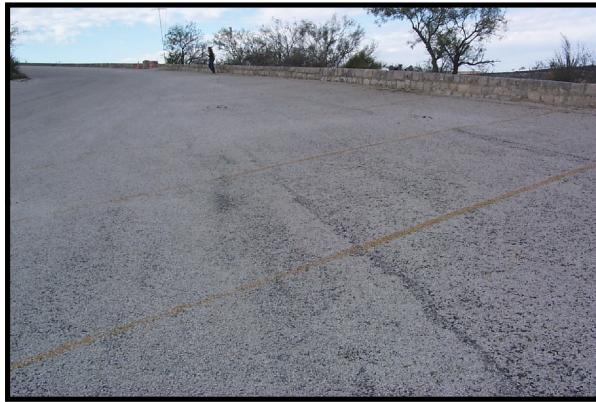
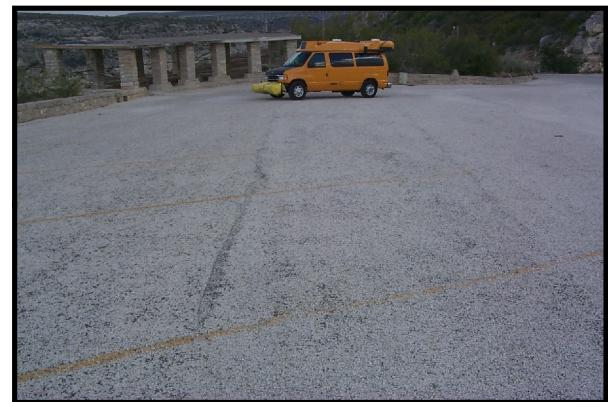
Route 0903A

Route	Public / NonPublic	Date Visited	Area (sq ft)	Lane Miles *	Surface Type	Condition / PCR
0903A	Public	12/16/2001	15561	0.27	OC	GOOD / 90

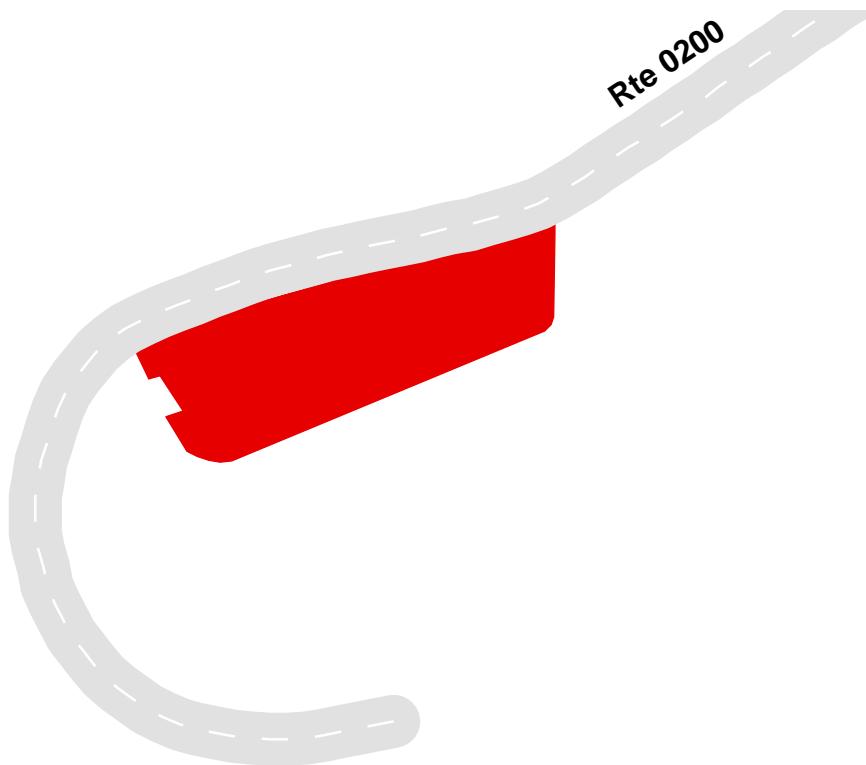
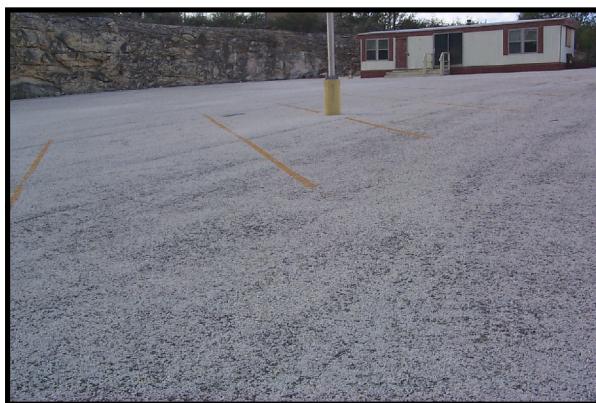
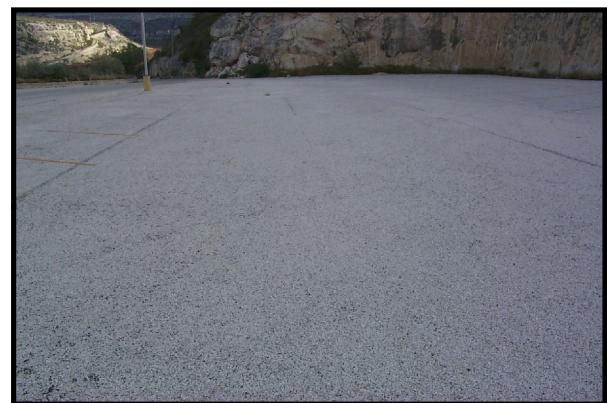
Route 0903B

Route	Public / NonPublic	Date Visited	Area (sq ft)	Lane Miles *	Surface Type	Condition / PCR
0903B	Public	12/16/2001	44961	0.77	OC	FAIR / 73

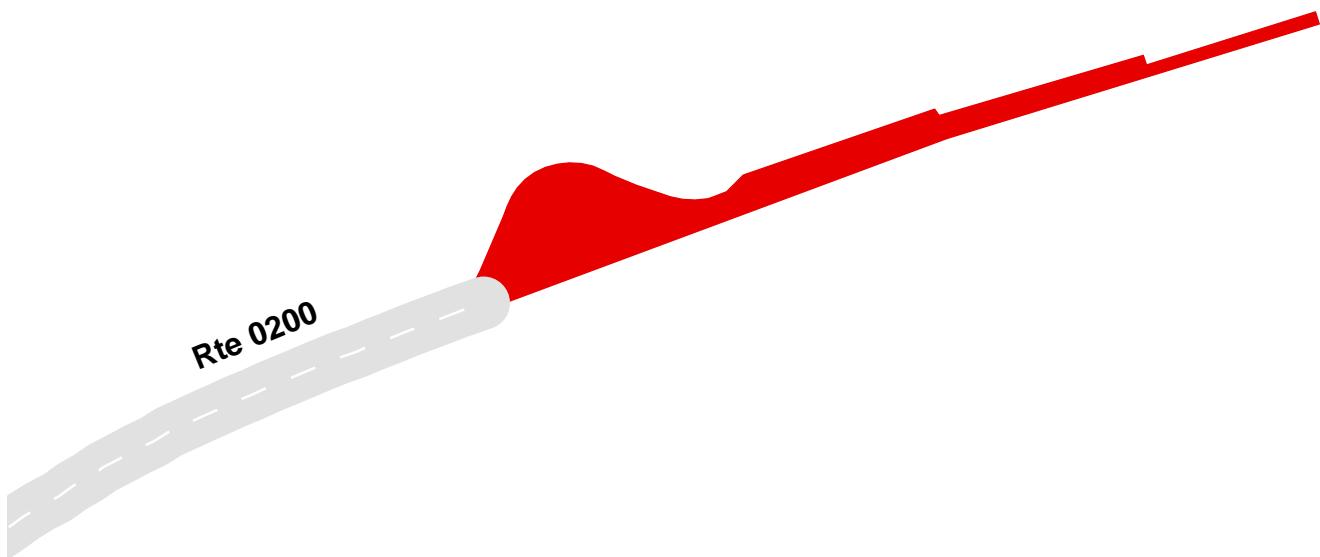
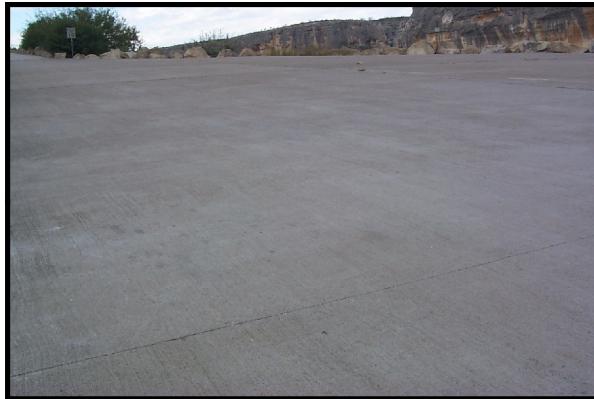
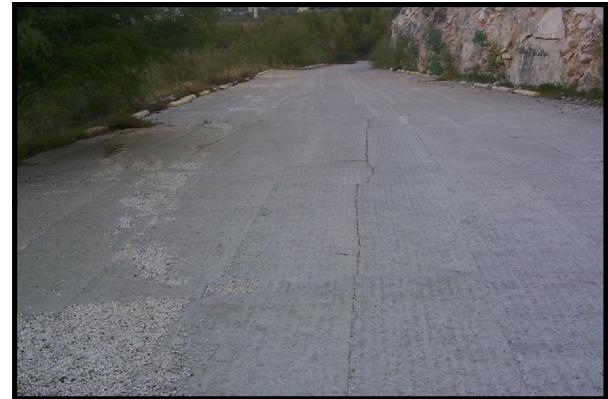
Route 0904

Route	Public / NonPublic	Date Visited	Area (sq ft)	Lane Miles *	Surface Type	Condition / PCR
0904	Public	12/16/2001	29153	0.50	CO	FAIR / 73

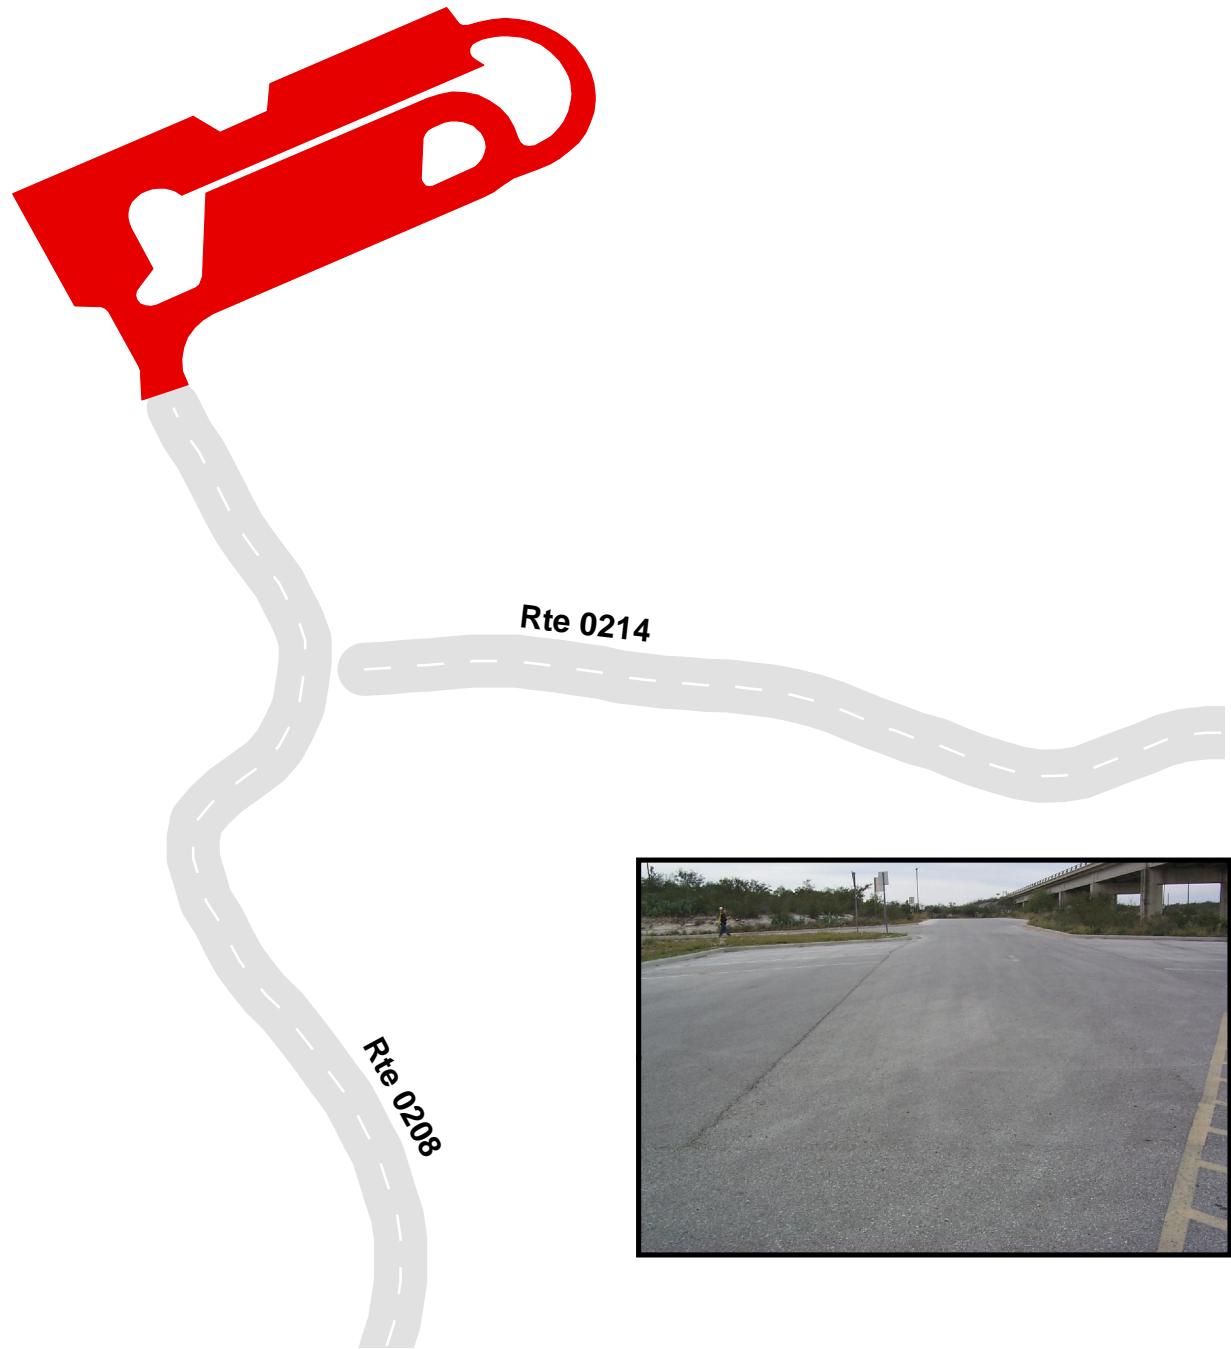
Route 0906

Route	Public / NonPublic	Date Visited	Area (sq ft)	Lane Miles *	Surface Type	Condition / PCR
0906	Public	12/15/2001	10499	0.18	OC	FAIR / 73

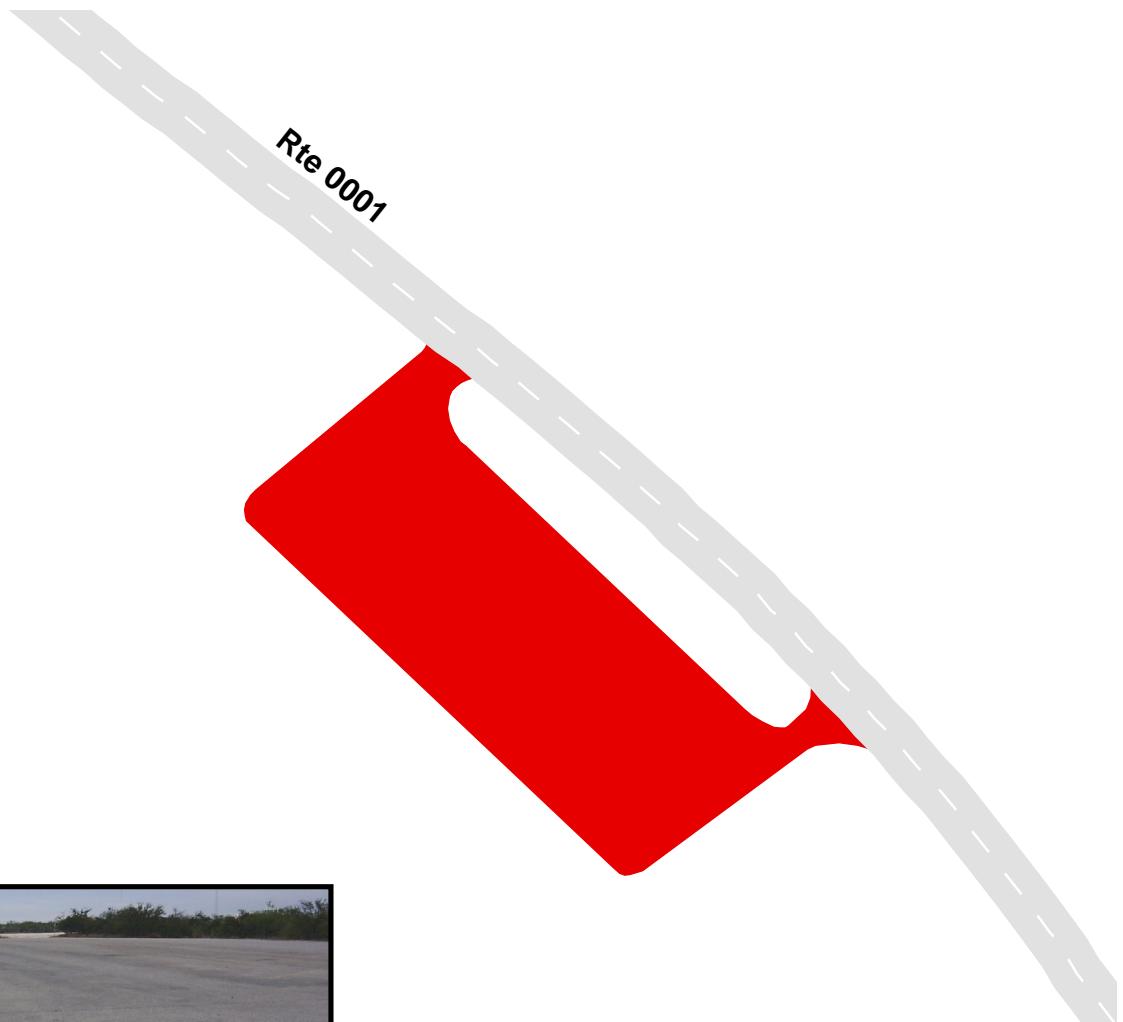
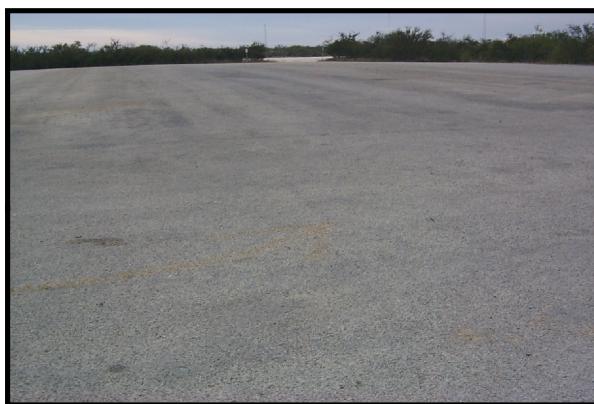
Route	Public / NonPublic	Date Visited	Area (sq ft)	Lane Miles *	Surface Type	Condition / PCR
0907A	Public	12/15/2001	55082	0.95	OC	GOOD / 90

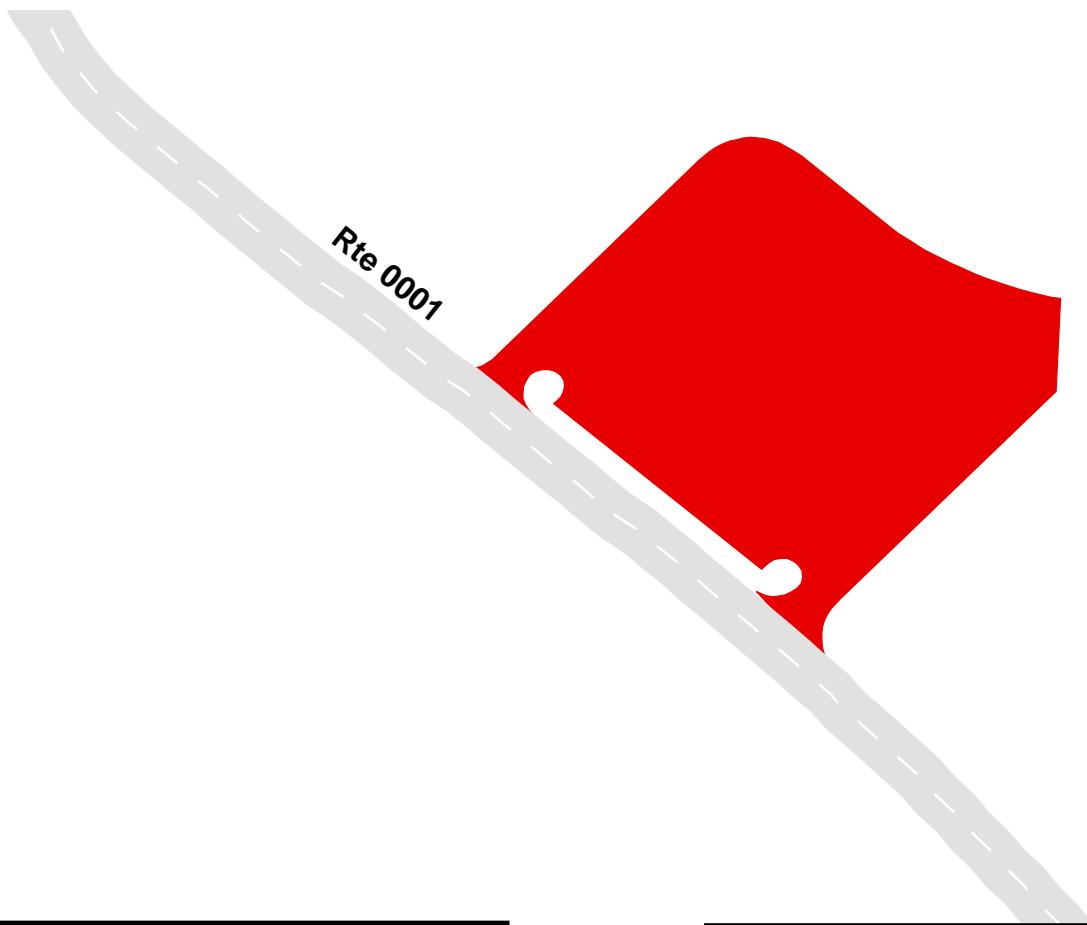
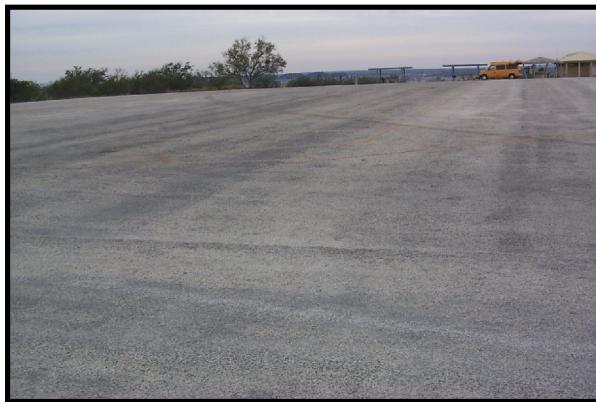
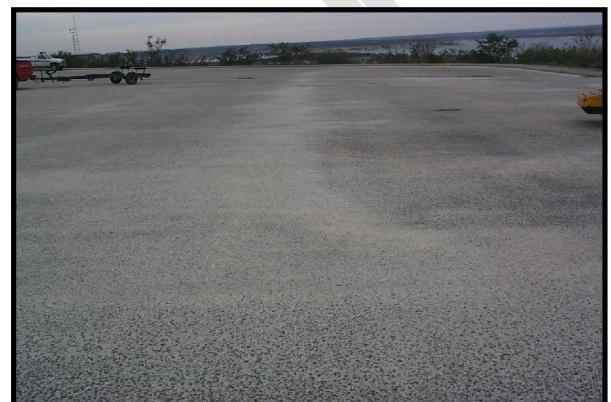
Route 0907B

Route	Public / NonPublic	Date Visited	Area (sq ft)	Lane Miles *	Surface Type	Condition / PCR
0907B	Public	12/15/2001	69332	1.19	OC	GOOD / 90

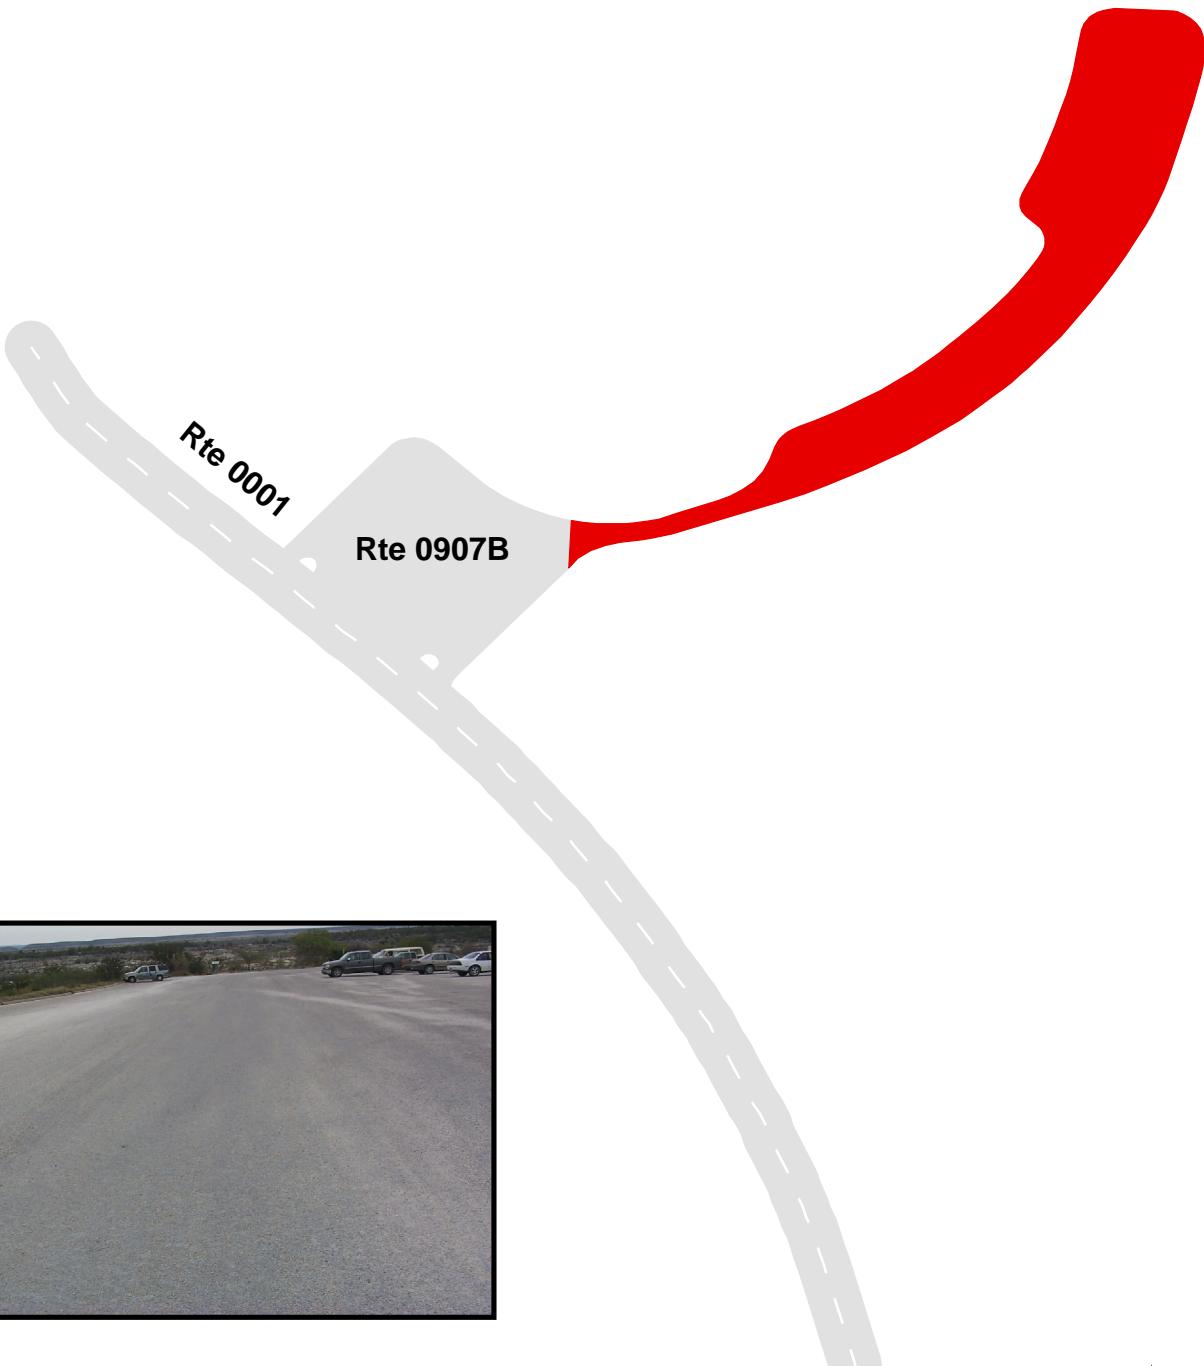
Route 0908

Route	Public / NonPublic	Date Visited	Area (sq ft)	Lane Miles *	Surface Type	Condition / PCR
0908	Public	12/15/2001	106827	1.84	OC	GOOD / 90

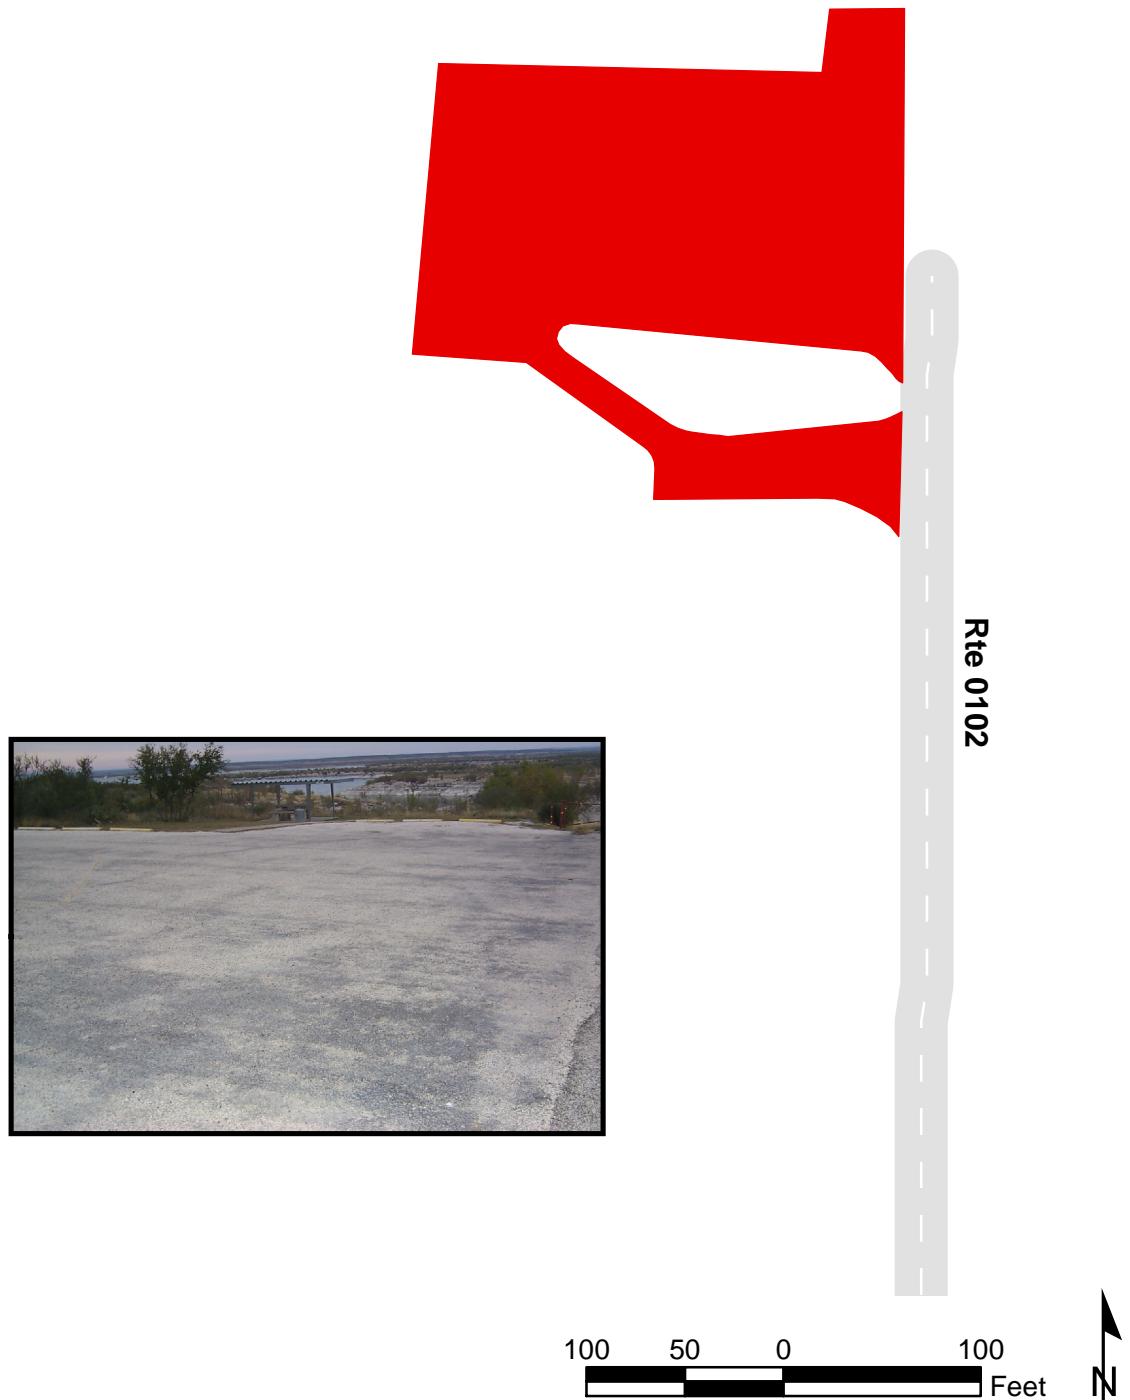
Route 0911

Route	Public / NonPublic	Date Visited	Area (sq ft)	Lane Miles *	Surface Type	Condition / PCR
0911	Public	12/15/2001	35841	0.62	OC	GOOD / 90
