The Road Inventory of Amistad National Recreation Area AMIS - 1700

Road Inventory Program

Prepared By:
Federal Highway Administration
Eastern Federal Lands Highway Division
Cycle 3

Amistad National Recreation Area in Texas

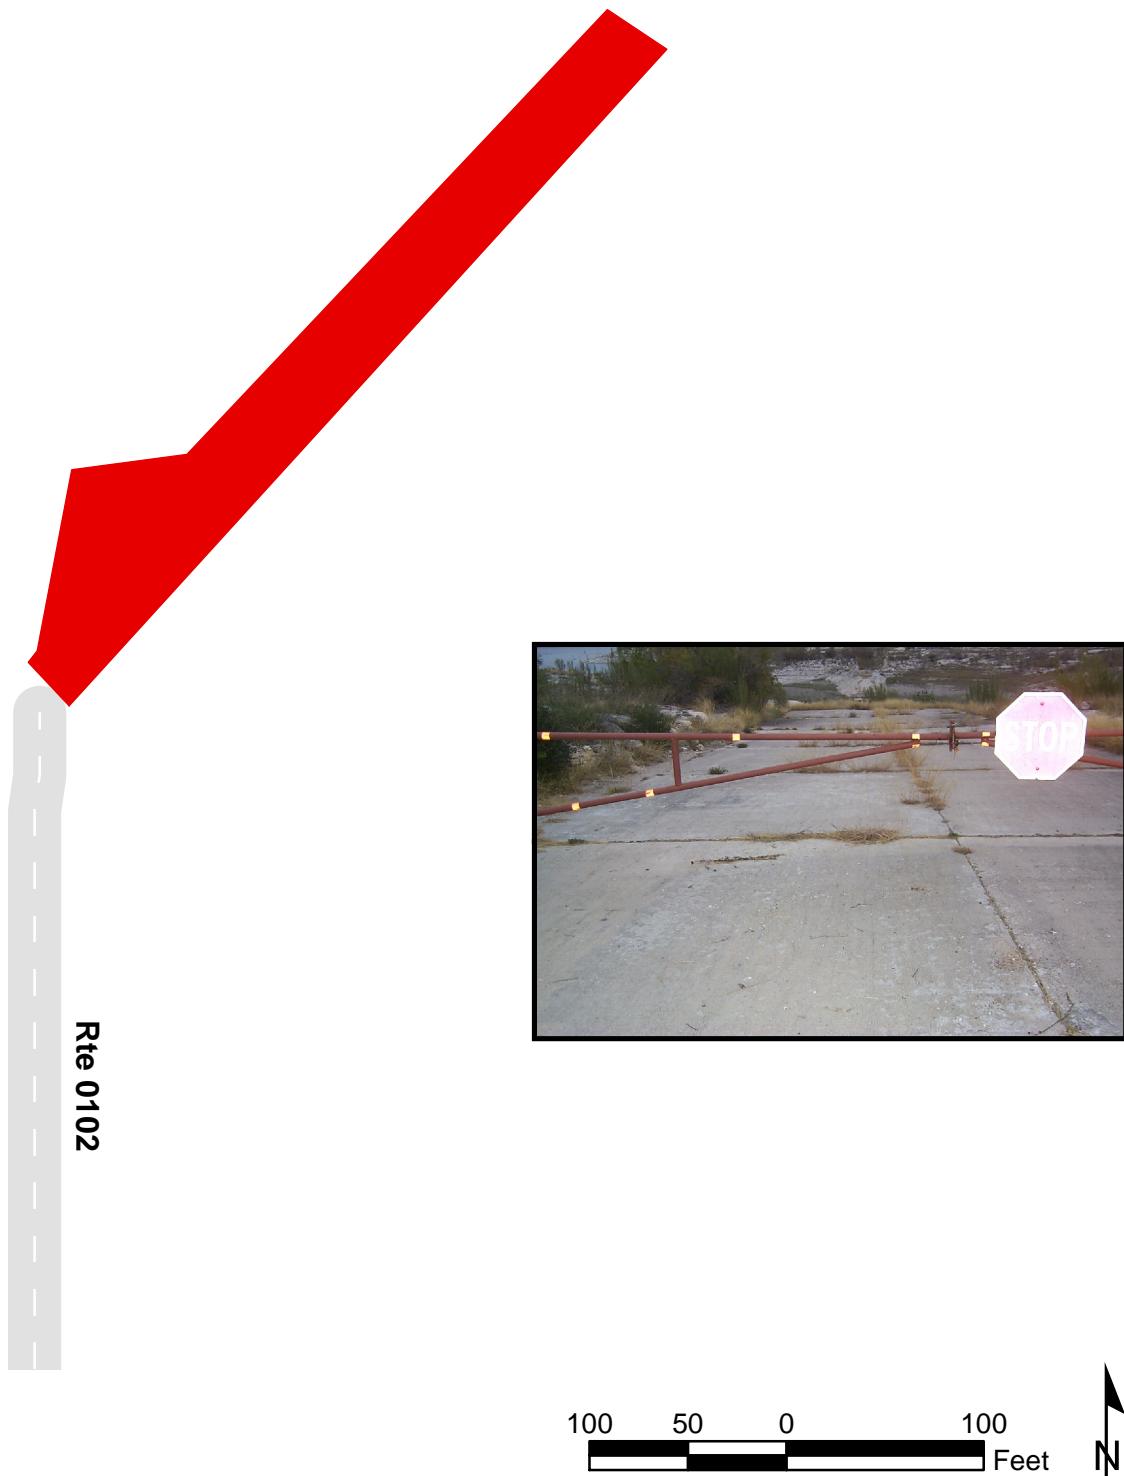
Route	Public / NonPublic	Date Visited	Area (sq ft)	Lane Miles *	Surface Type	Condition / PCR
0912B	Public	12/15/2001	16999	0.29	CO	POOR / 45

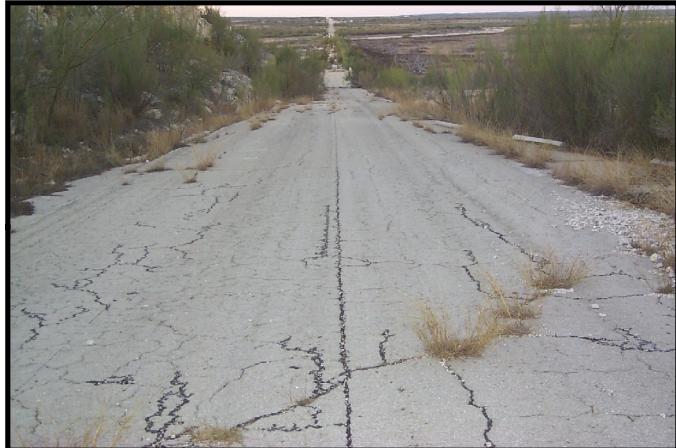
Route 0913B

Route	Public / NonPublic	Date Visited	Area (sq ft)	Lane Miles *	Surface Type	Condition / PCR
0913B	NonPublic	12/16/2001	16996	0.29	CO	POOR / 45

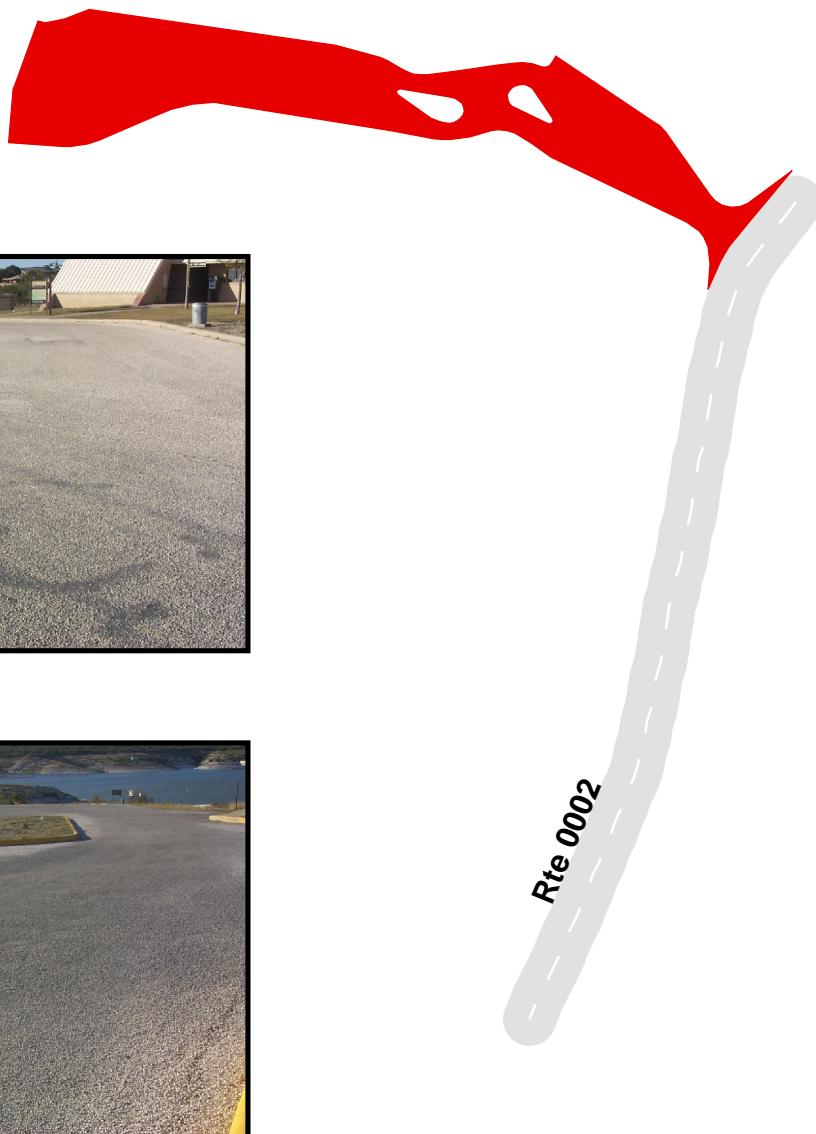
Route	Public / NonPublic	Date Visited	Area (sq ft)	Lane Miles *	Surface Type	Condition / PCR
0915	Public	12/16/2001	77949	1.34	OC	GOOD / 90

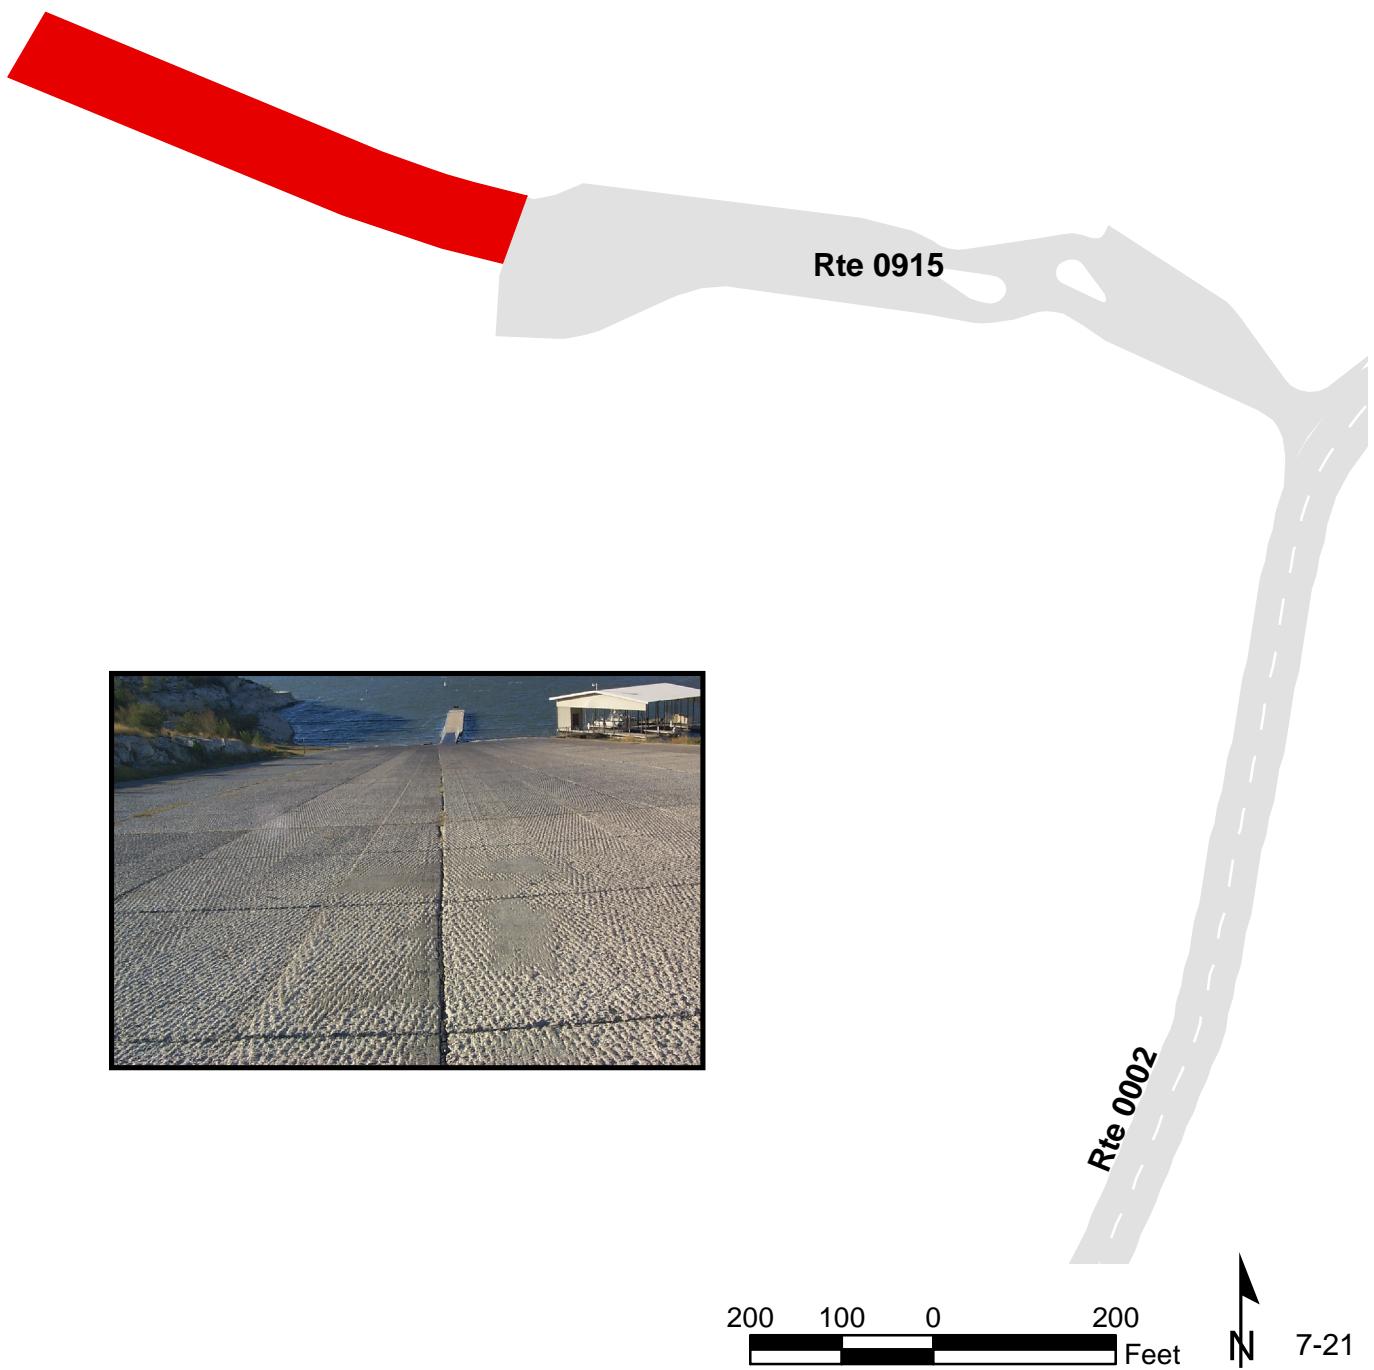
Route 0916

Route	Public / NonPublic	Date Visited	Area (sq ft)	Lane Miles *	Surface Type	Condition / PCR
0916	Public	12/16/2001	39939	0.69	CO	GOOD / 90

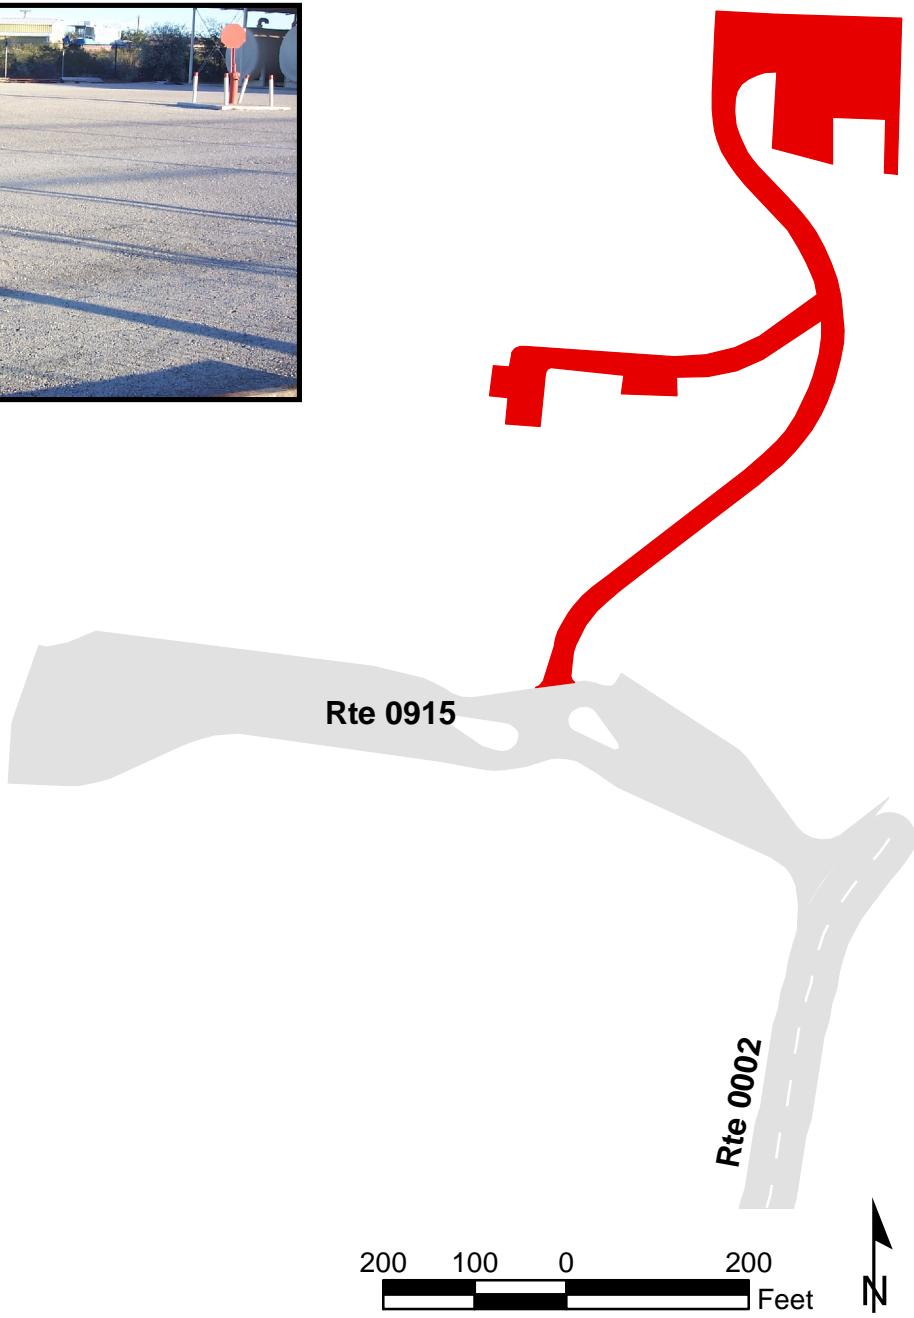
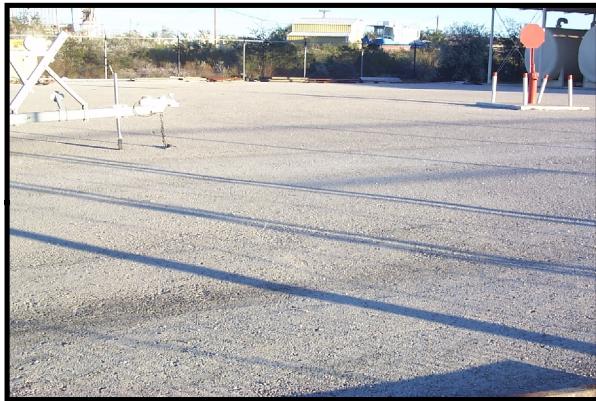
Route 0918

Route	Public / NonPublic	Date Visited	Area (sq ft)	Lane Miles *	Surface Type	Condition / PCR
0918	Public	12/16/2001	21588	0.37	CO	FAIR / 73
