# The Road Inventory of Big Thicket National Preserve BITH – 7140

## Road Inventory Program

Prepared By:  
Federal Highway Administration  
Eastern Federal Lands Highway Division  
Cycle 3

# Big Thicket National Preserve in Texas

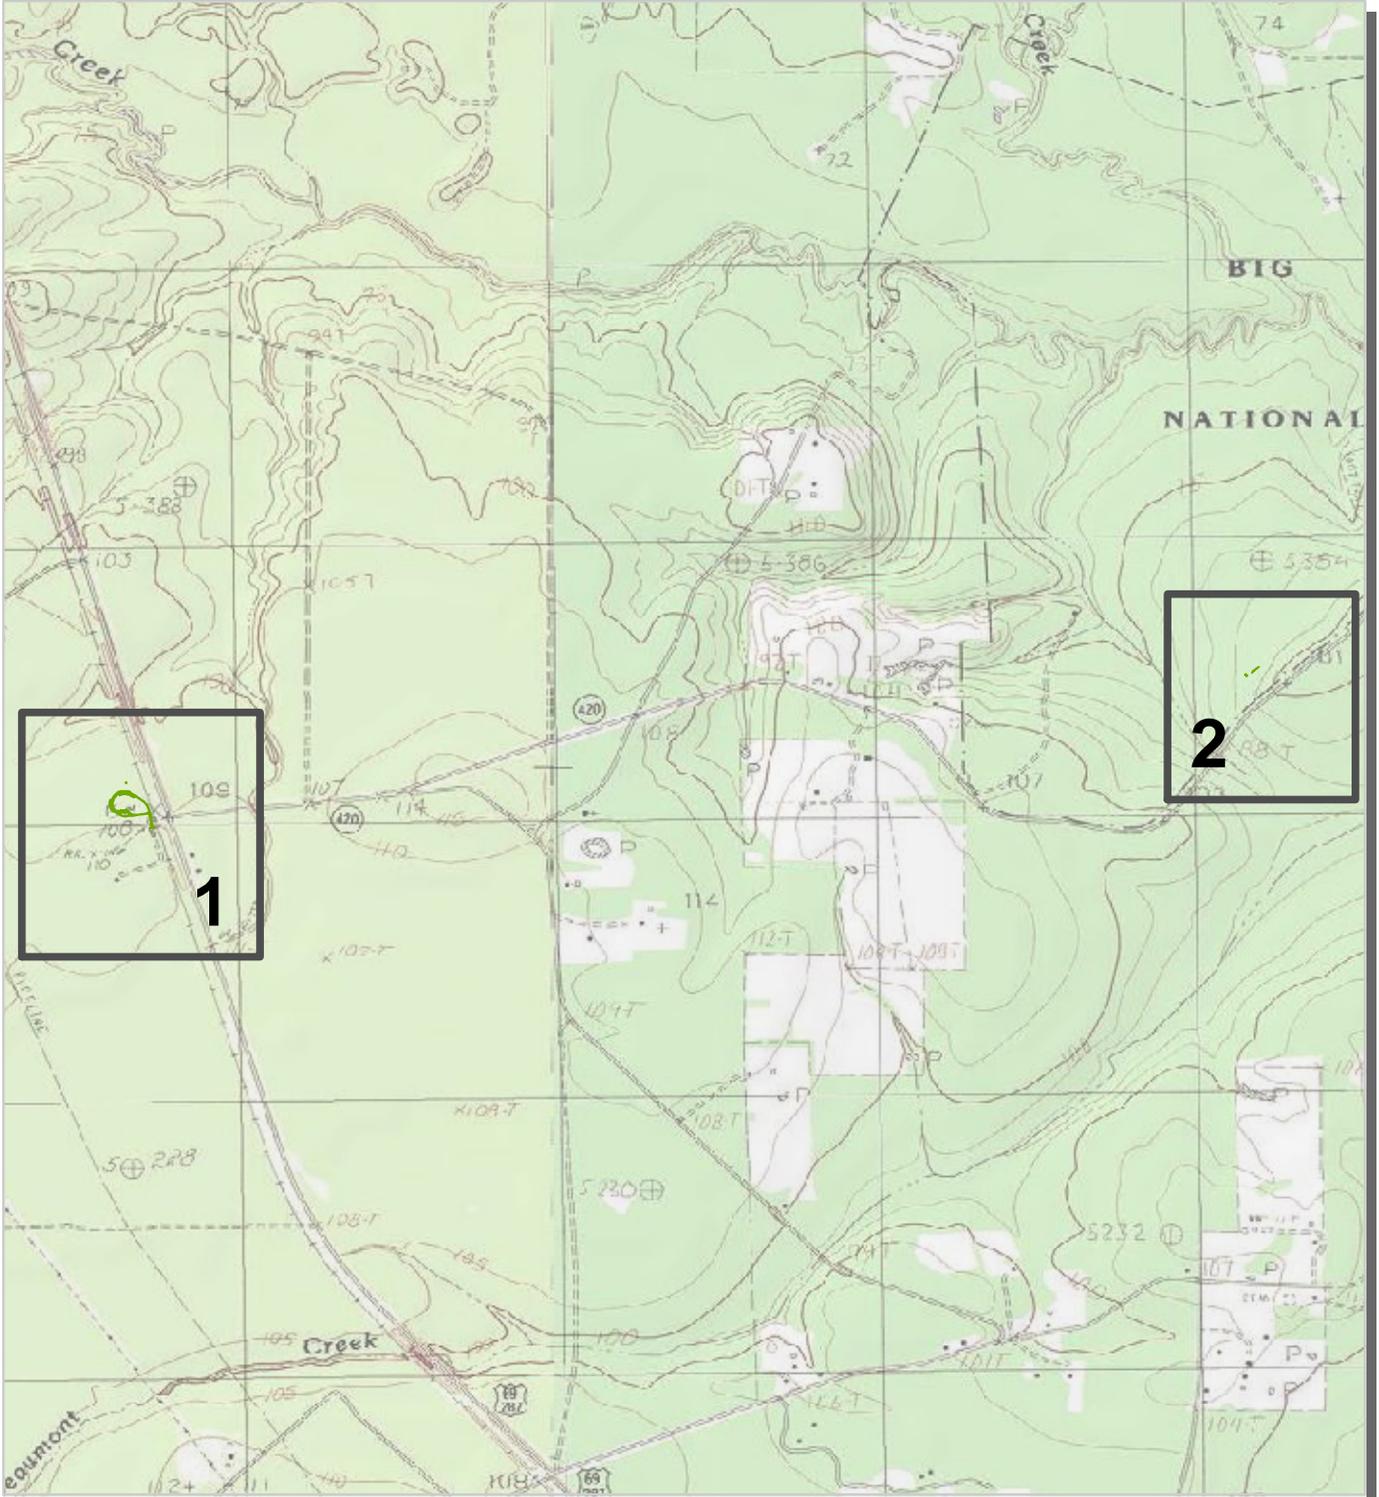
# Big Thicket National Preserve Route Condition Key Map PCR - Mile by Mile

PCR	Poor

Fair

Good

Excellent

(<=60)		(61 - 84)		(85 - 94)		(95 - 100)

\* If the PCR rating is not available for a section, the SCR rating will be displayed. See appendix for definitions and formulas.

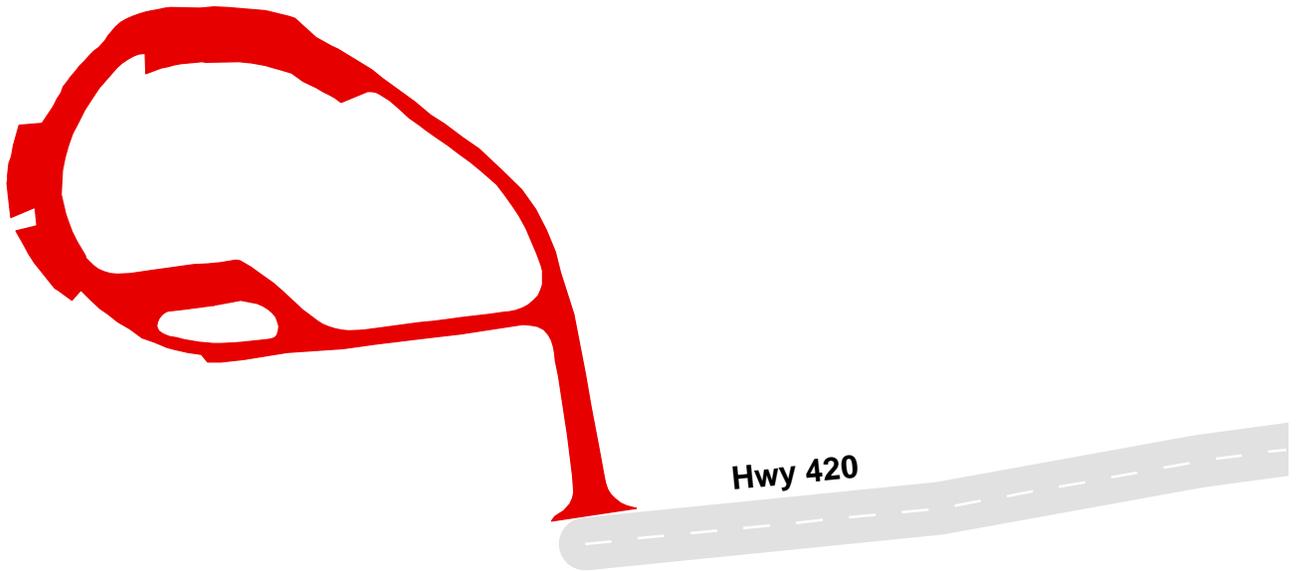
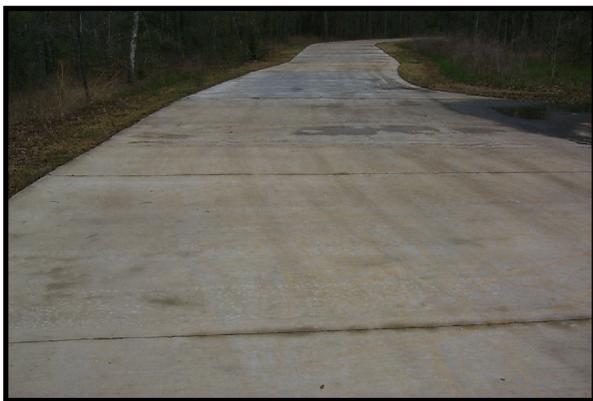
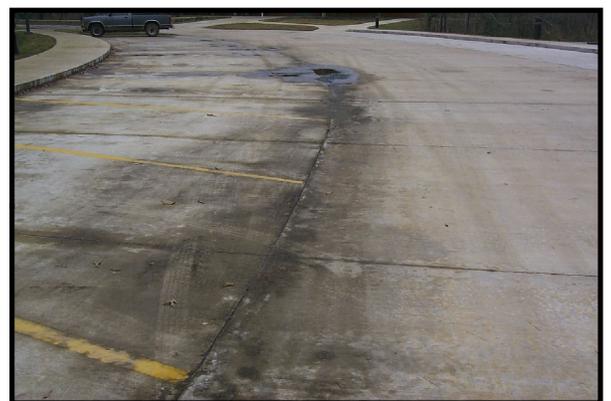
## Route 0900

VISITOR CENTER  
FROM STATE HIGHWAY 420

Route	Public / NonPublic	Date Visited	Area (sq ft)	Lane Miles *	Surface Type	Condition / PCR
0900	Public	2/28/2003	34502	0.59	CO	GOOD / 90

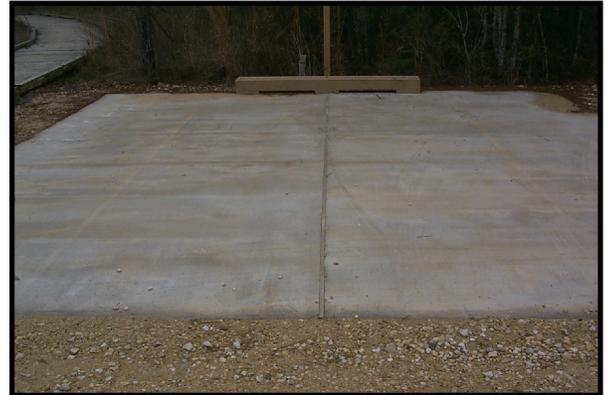
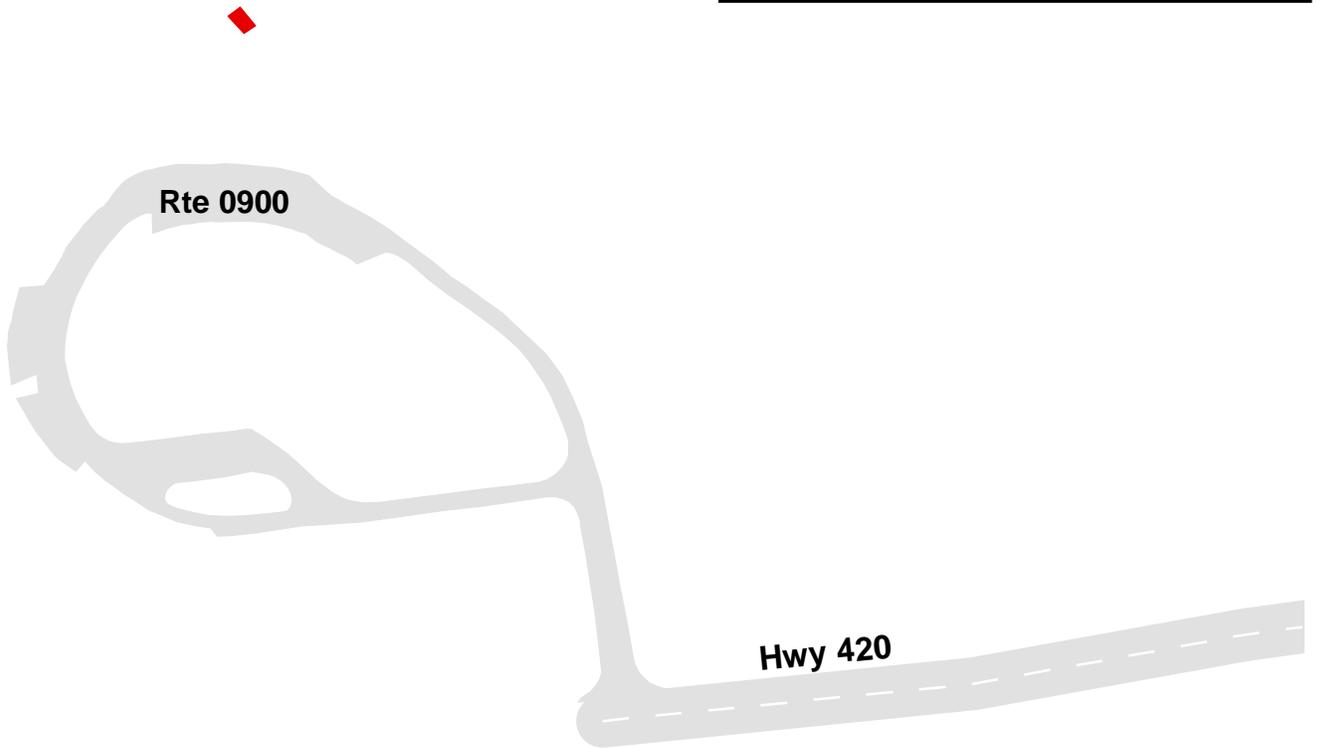
**Big Thicket National Preserve**  
**Route 0901**  
 MAINTENANCE HANDICAP PARKING  
 FROM ROUTE 0902

Route	Public / NonPublic	Date Visited	Area (sq ft)	Lane Miles *	Surface Type	Condition / PCR
0901	NonPublic	2/28/2003	204	0.00	CO	GOOD / 90

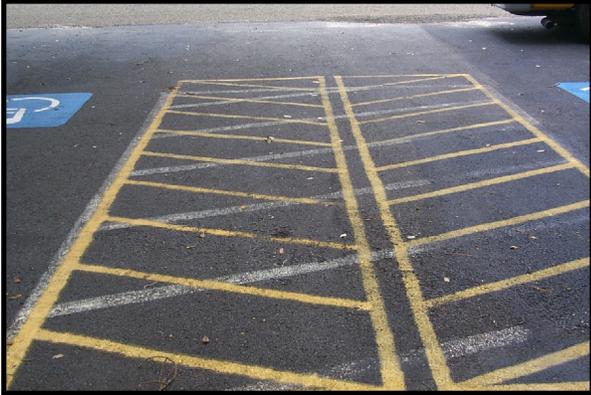
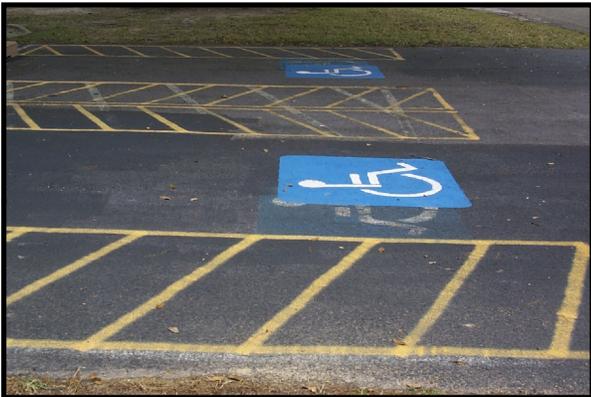
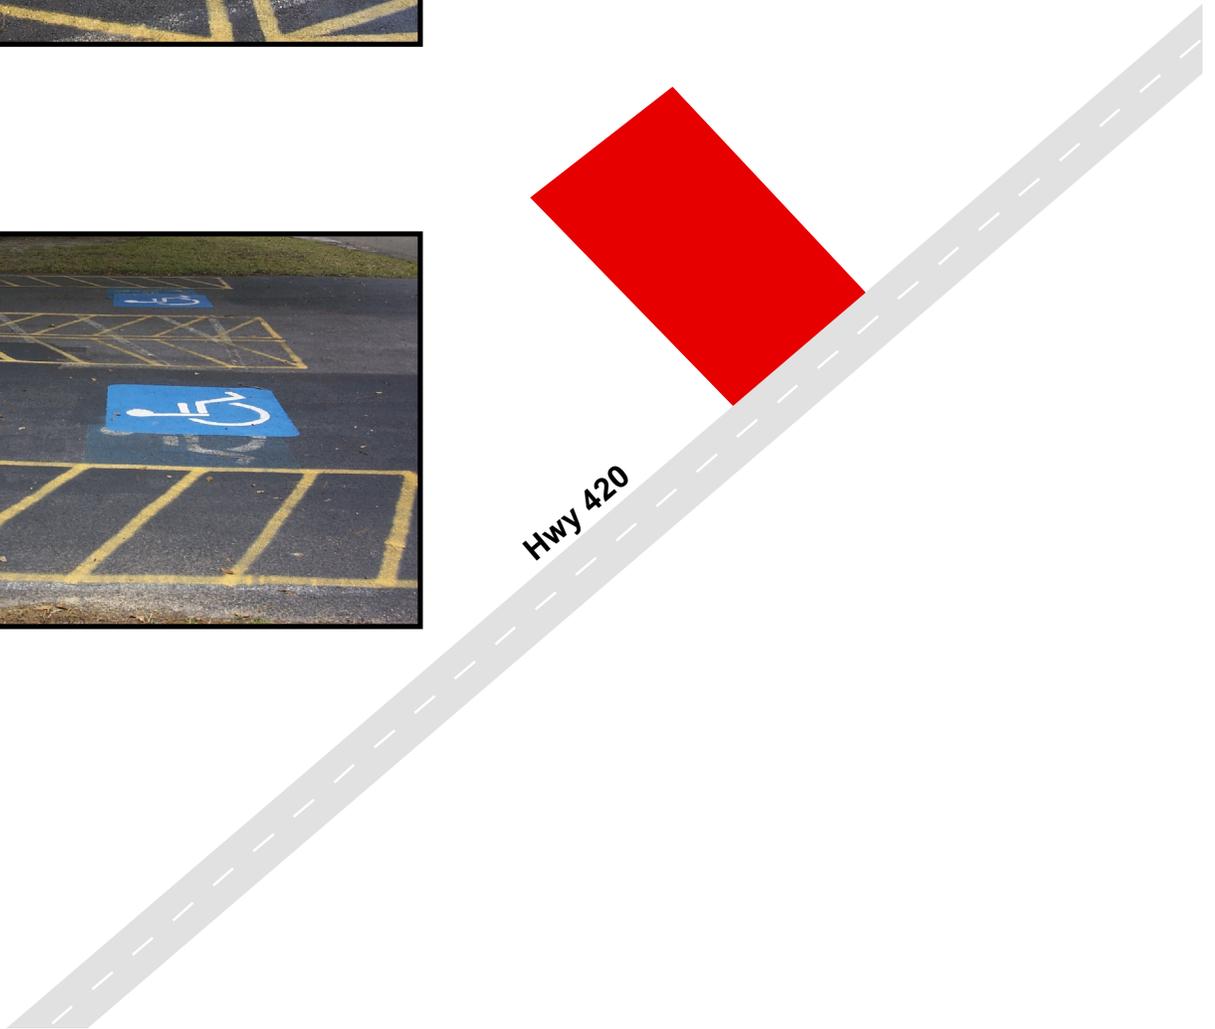
## Route 0903

STALEY CABIN PARKING  
FROM STATE HIGHWAY 420

Route	Public / NonPublic	Date Visited	Area (sq ft)	Lane Miles *	Surface Type	Condition / PCR
0903	Public	2/28/2003	486	0.01	AS	GOOD / 90

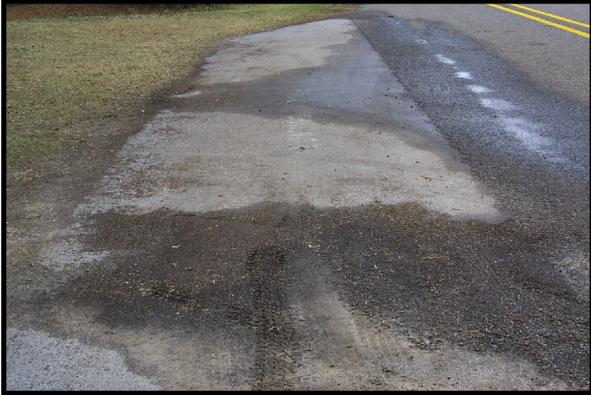
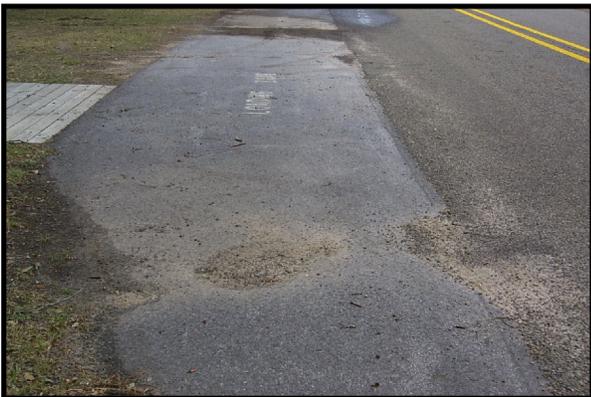
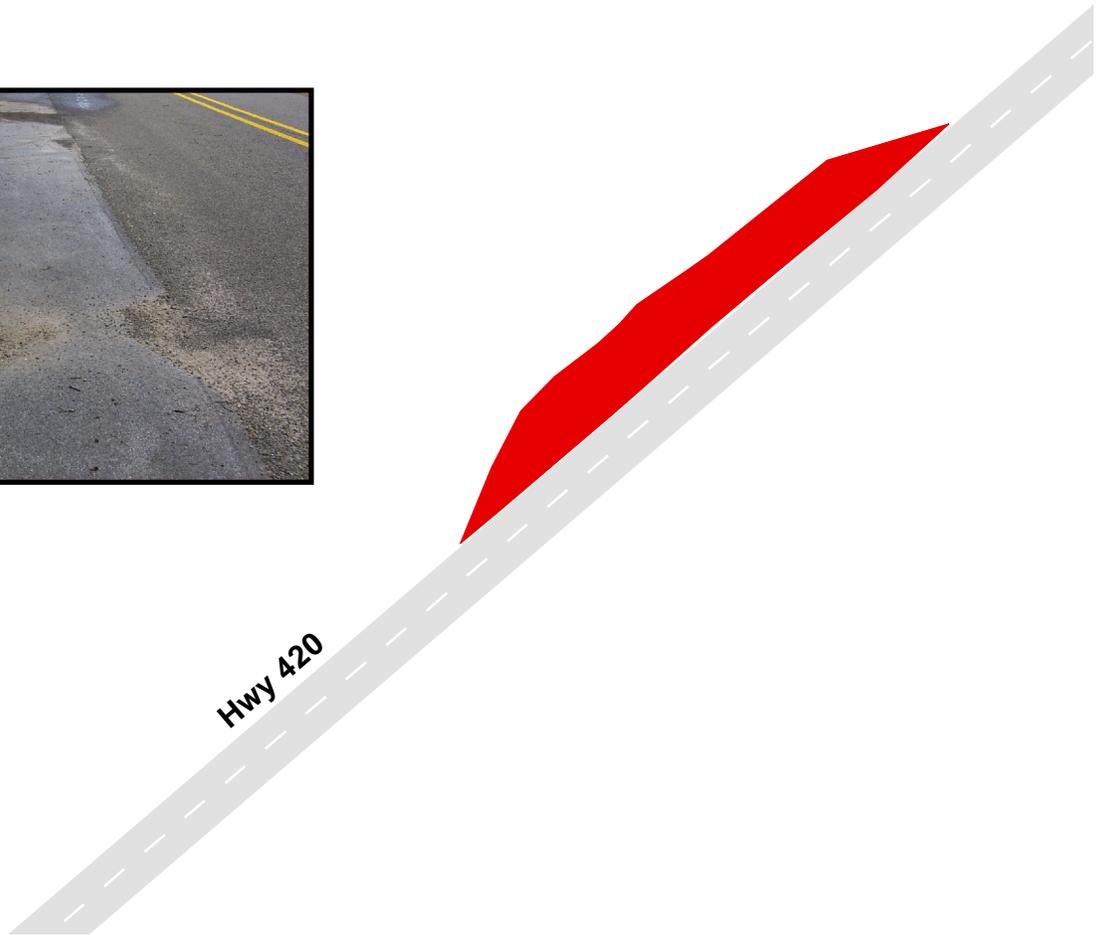
## Route 0904

KIRBY NATURE TRAIL PARKING  
FROM STATE HIGHWAY 420

Route	Public / NonPublic	Date Visited	Area (sq ft)	Lane Miles *	Surface Type	Condition / PCR
0904	Public	2/28/2003	940	0.02	AS	GOOD / 90
