**WYOMING  
BEARTOOTH HIGHWAY  
MATERIALS SOURCE INVESTIGATION**

**SEPTEMBER 1999  
REPORT 99-14**

**Technical Services Branch  
Central Federal Lands Highway Division  
Federal Highway Administration  
Denver, Colorado**

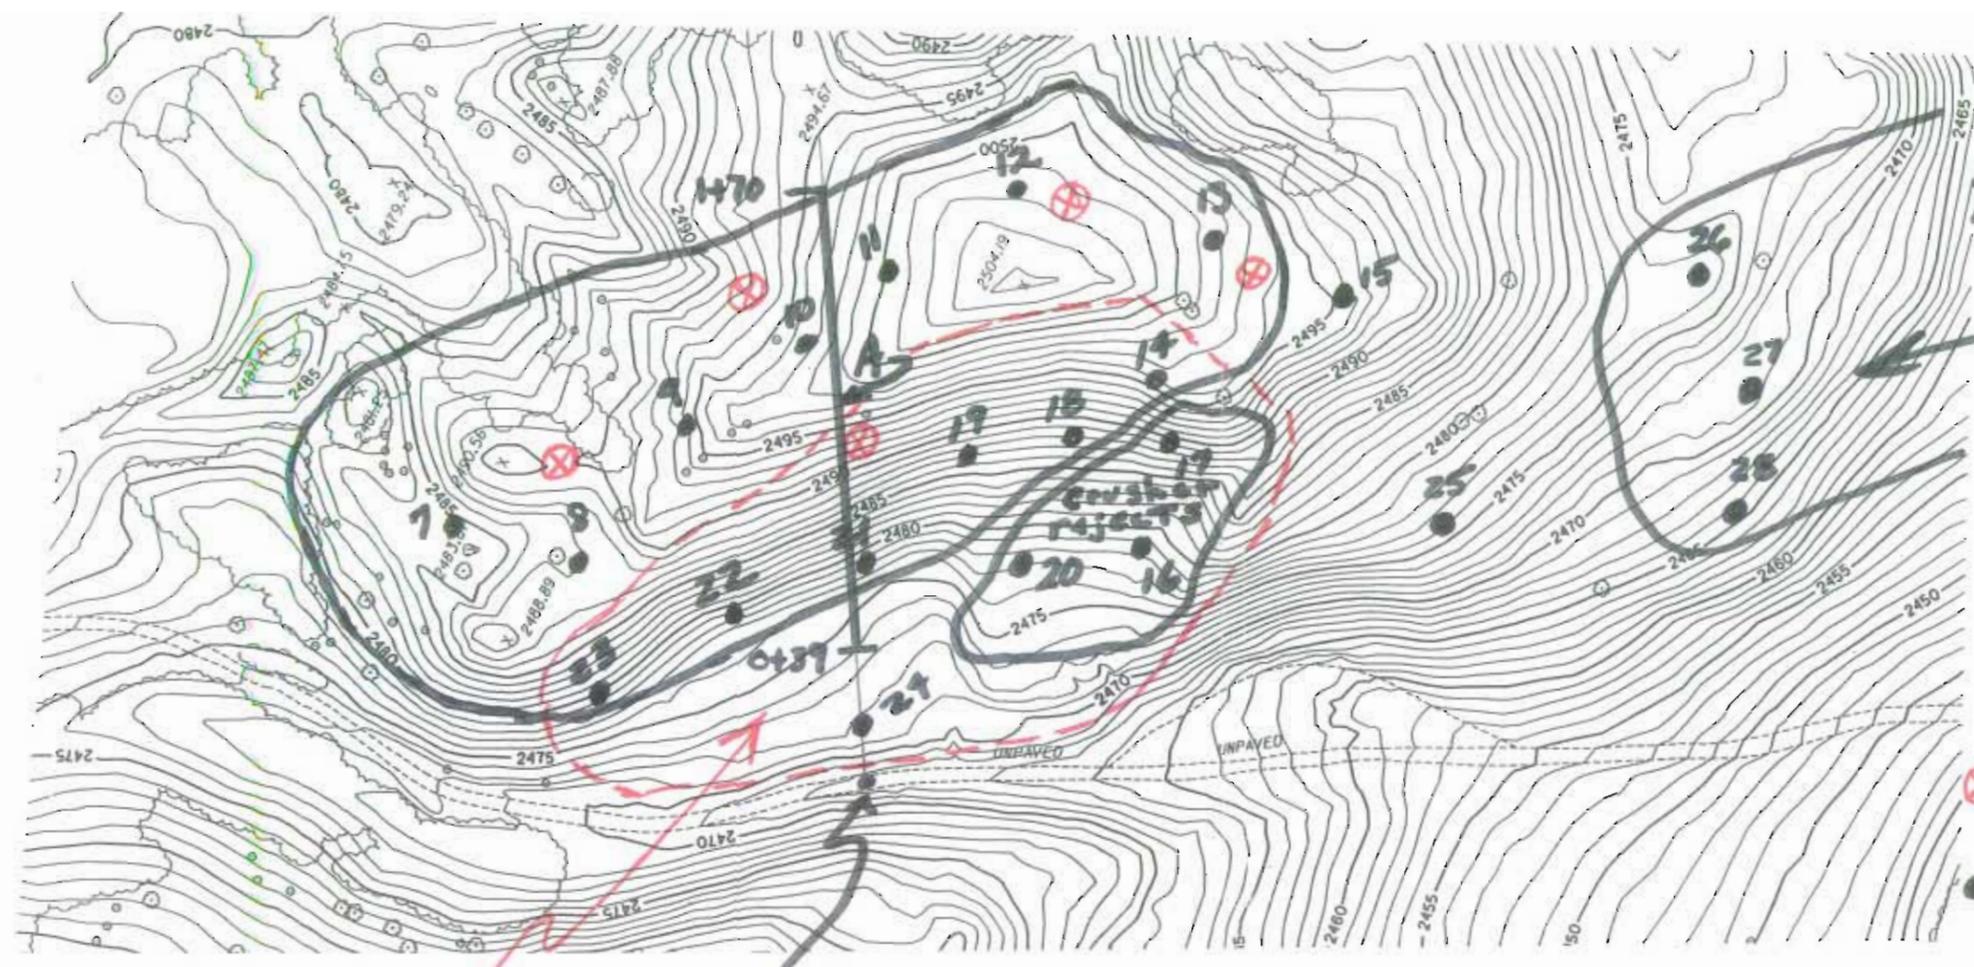
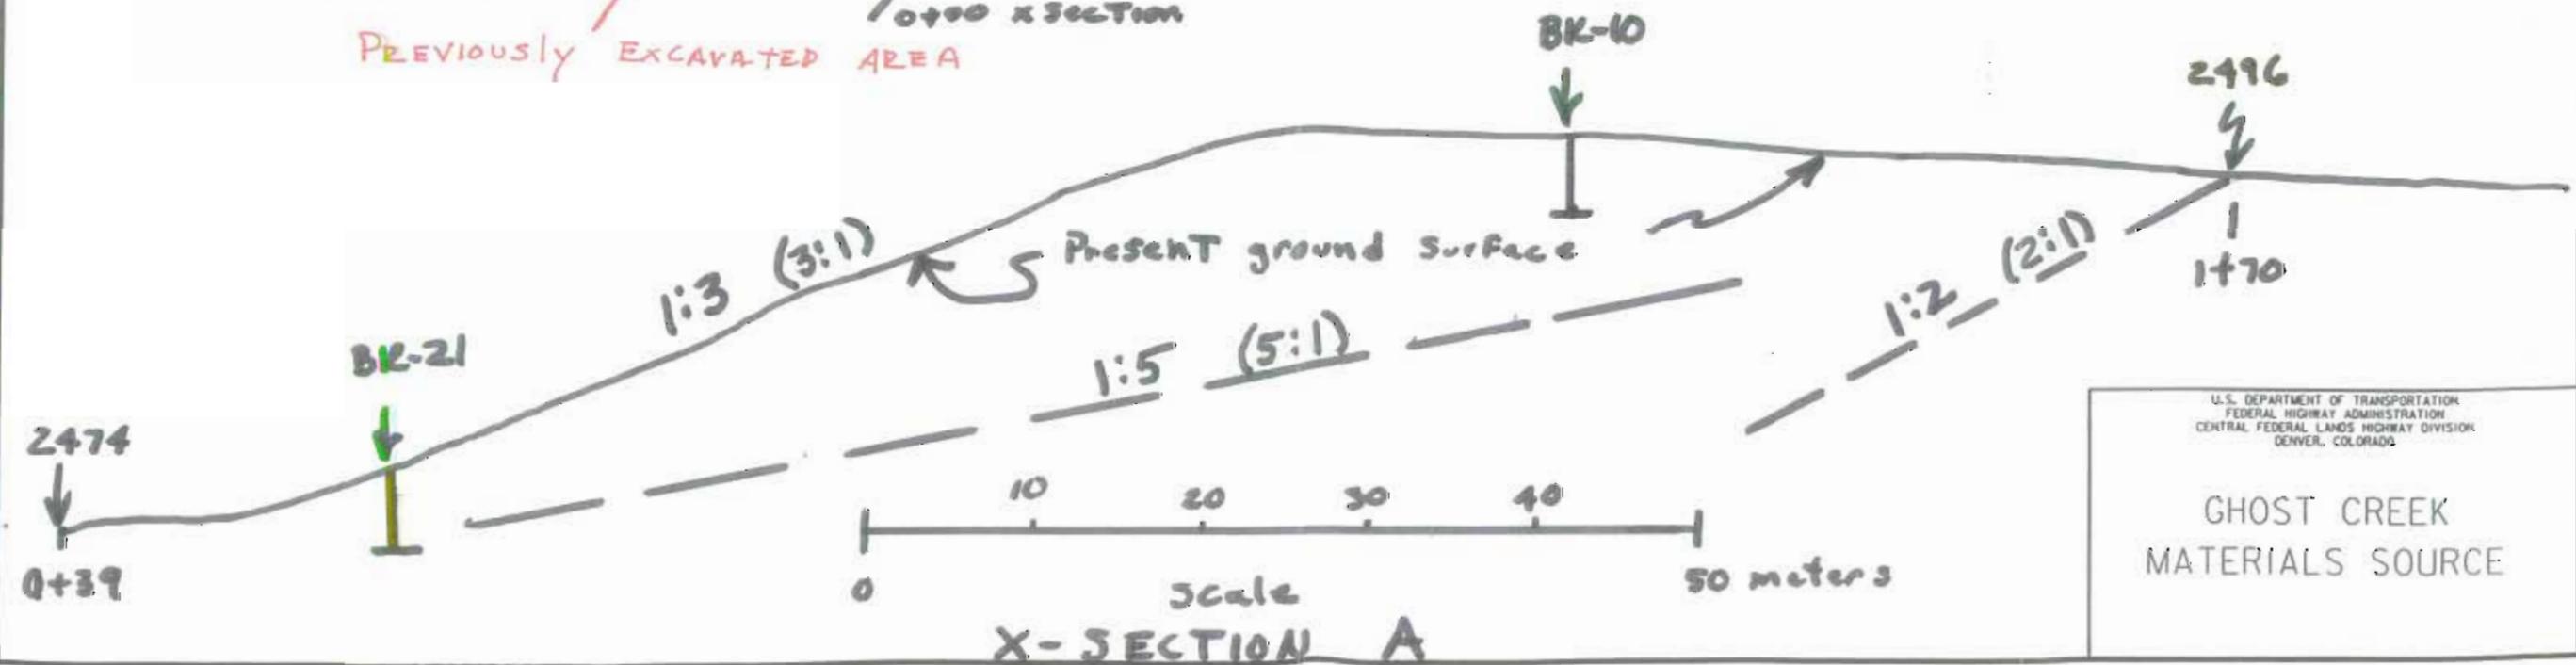
GHOST CREEK  
MATERIALS SOURCE

MATERIAL AVAILABLE IN THIS AREA

PREVIOUSLY EXCAVATED AREA. (OFF MAPPING)

PREVIOUSLY EXCAVATED AREA

0+39 X SECTION

There is a large quantity of material available in the area above the previously excavated North Area at a 6-meter (20-foot) depth estimated at 150,000 cubic meters (200,000 cubic yards). The sand and gravel is estimated to be much deeper and we recommend that borings (coring) be drilled as per the map in Appendix D. Depending on the depth of sand and gravel, the back slope can be steepened to a 1:2 (2:1), thus increasing the volume available, or a flatter slope can be excavated, but this will decrease the volume available. See cross section on map of Ghost Creek in Appendix D.

Once mapping and borings are completed, a excavation and reclamation plan can be designed for Forest Service approval.

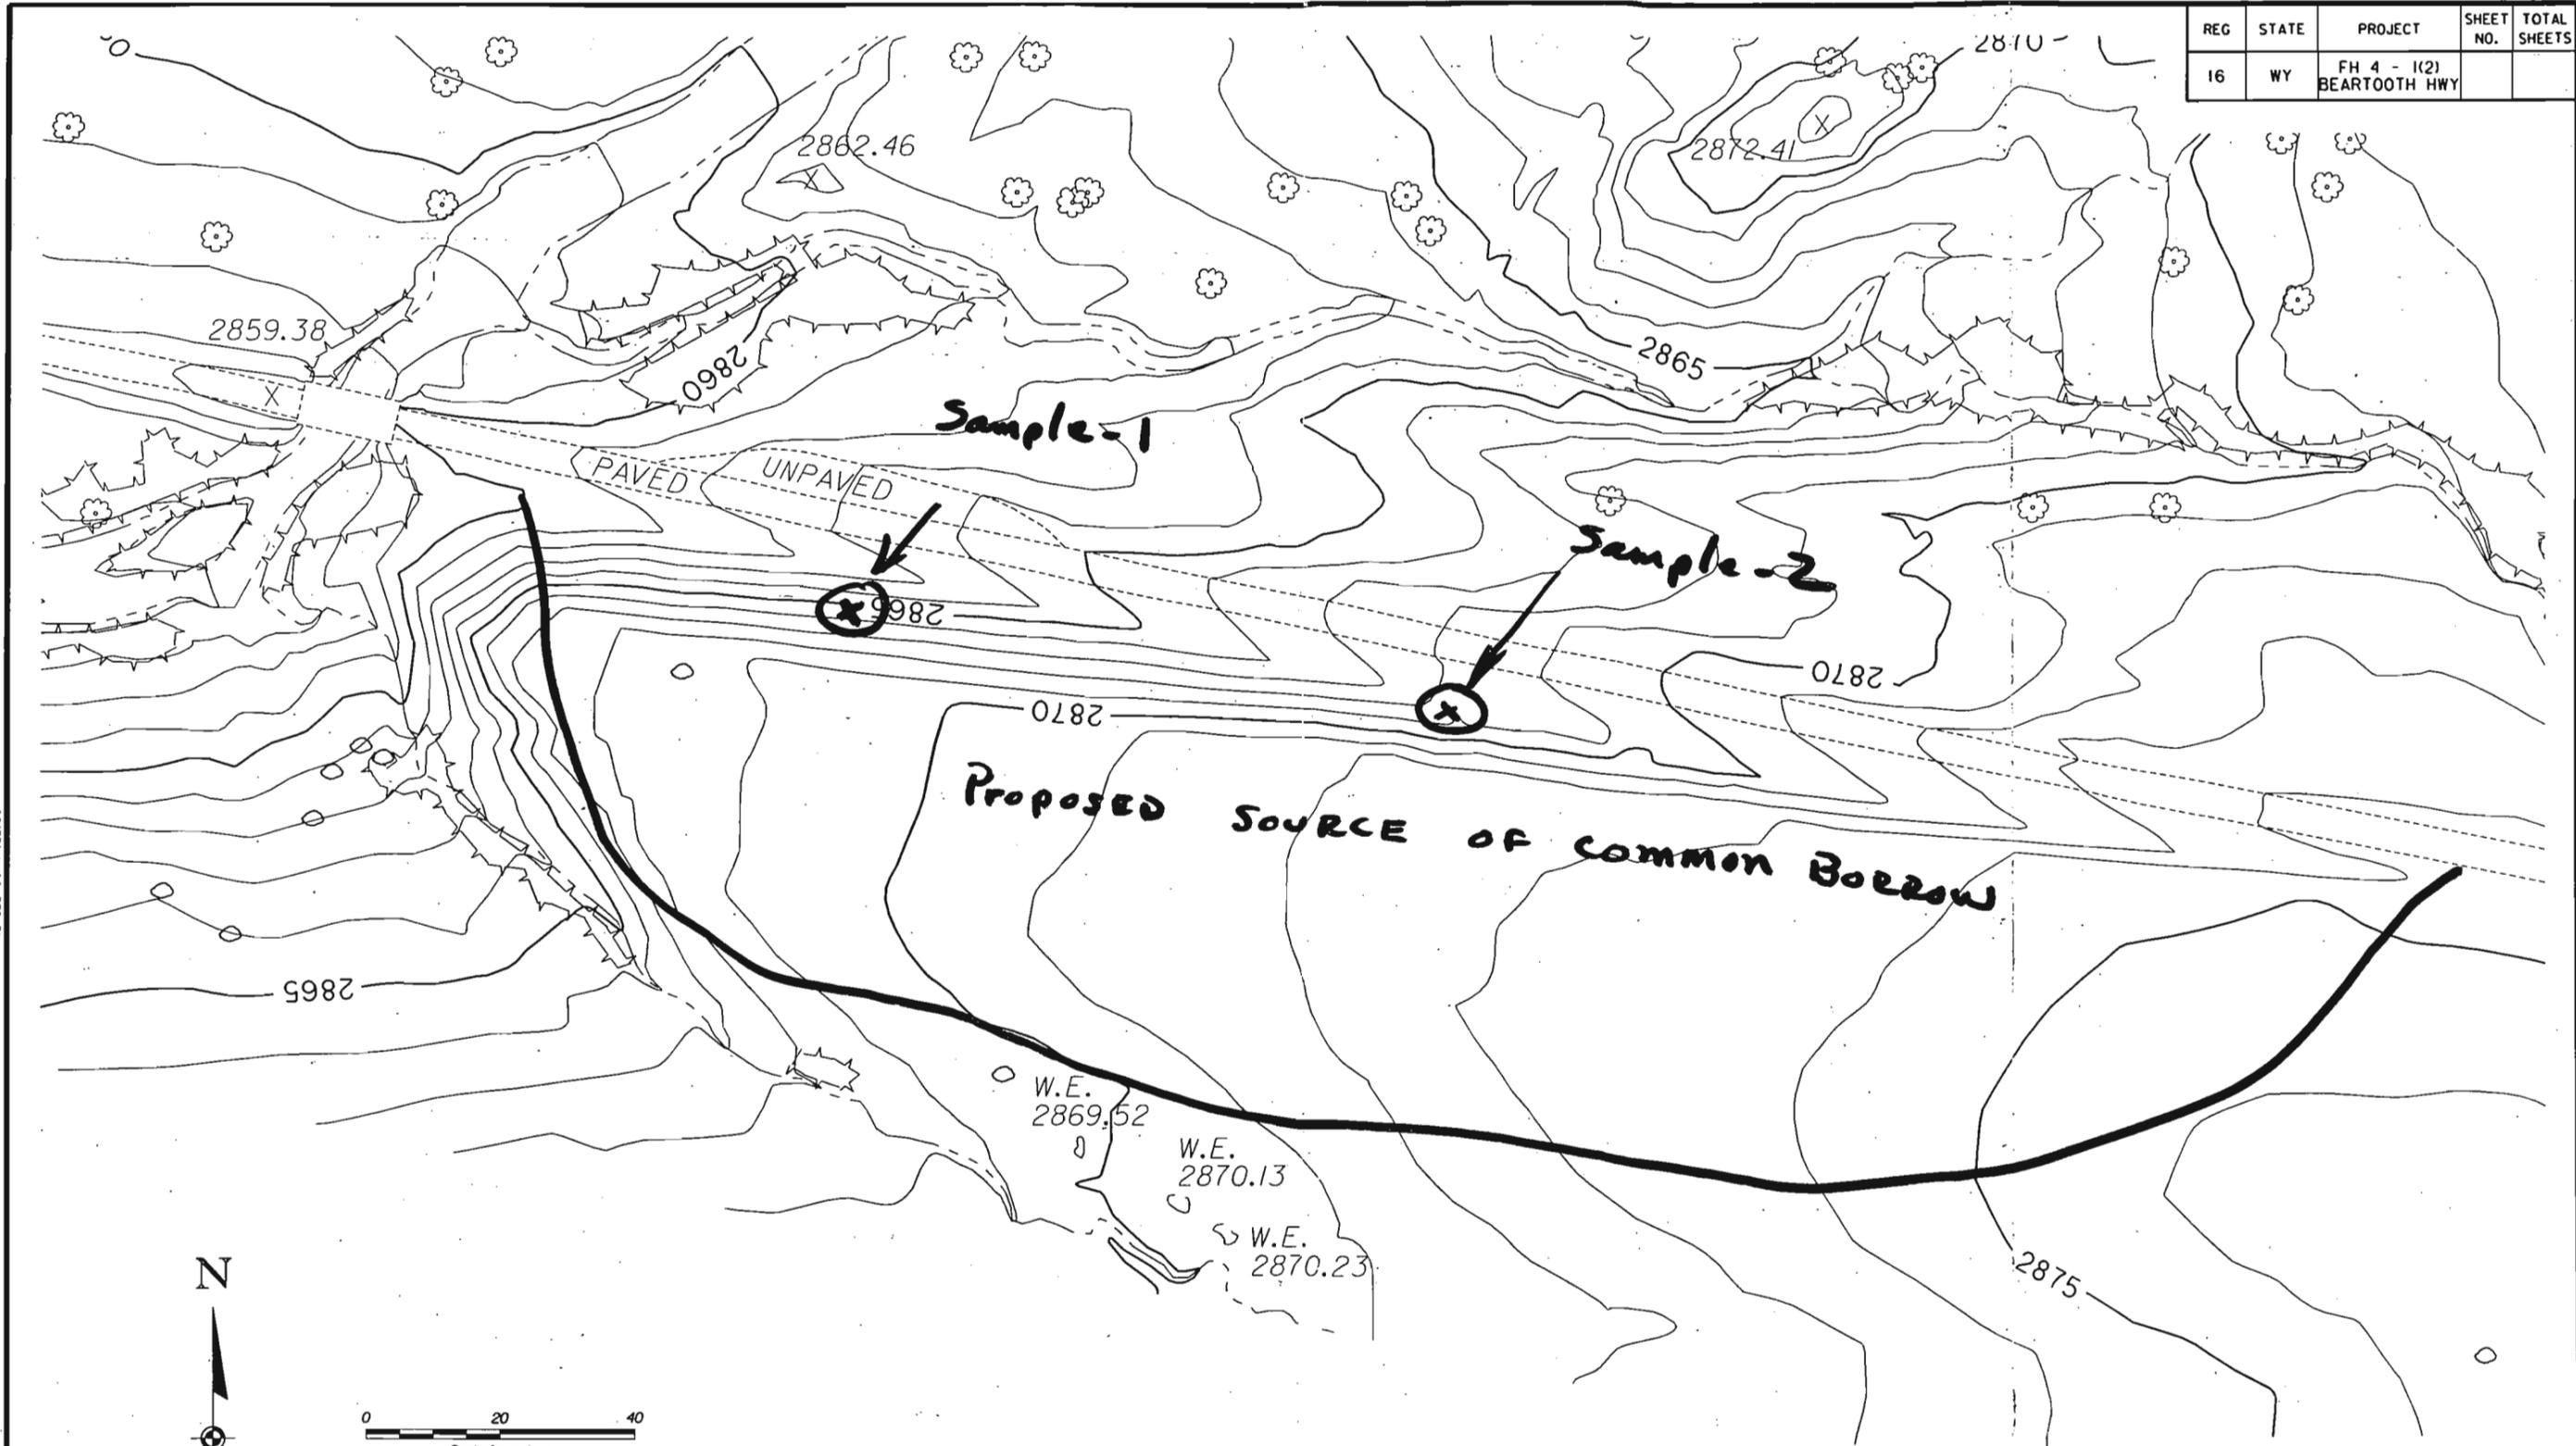
**STATION 46+800  
 MATERIALS SOURCE**

This area is adjacent to the roadway at preliminary metric Station 46+800. The proposed borrow area consists of a glacial till of sand, gravel, cobbles, and boulders. Two (2) samples of the material in the existing cut slope was sampled and tested. The material classified as an A-1-b. We would like to point out that the material sampled was only the minus 150 mm (6-inch) material. There will be cobbles and large boulders within this glacial till borrow area.

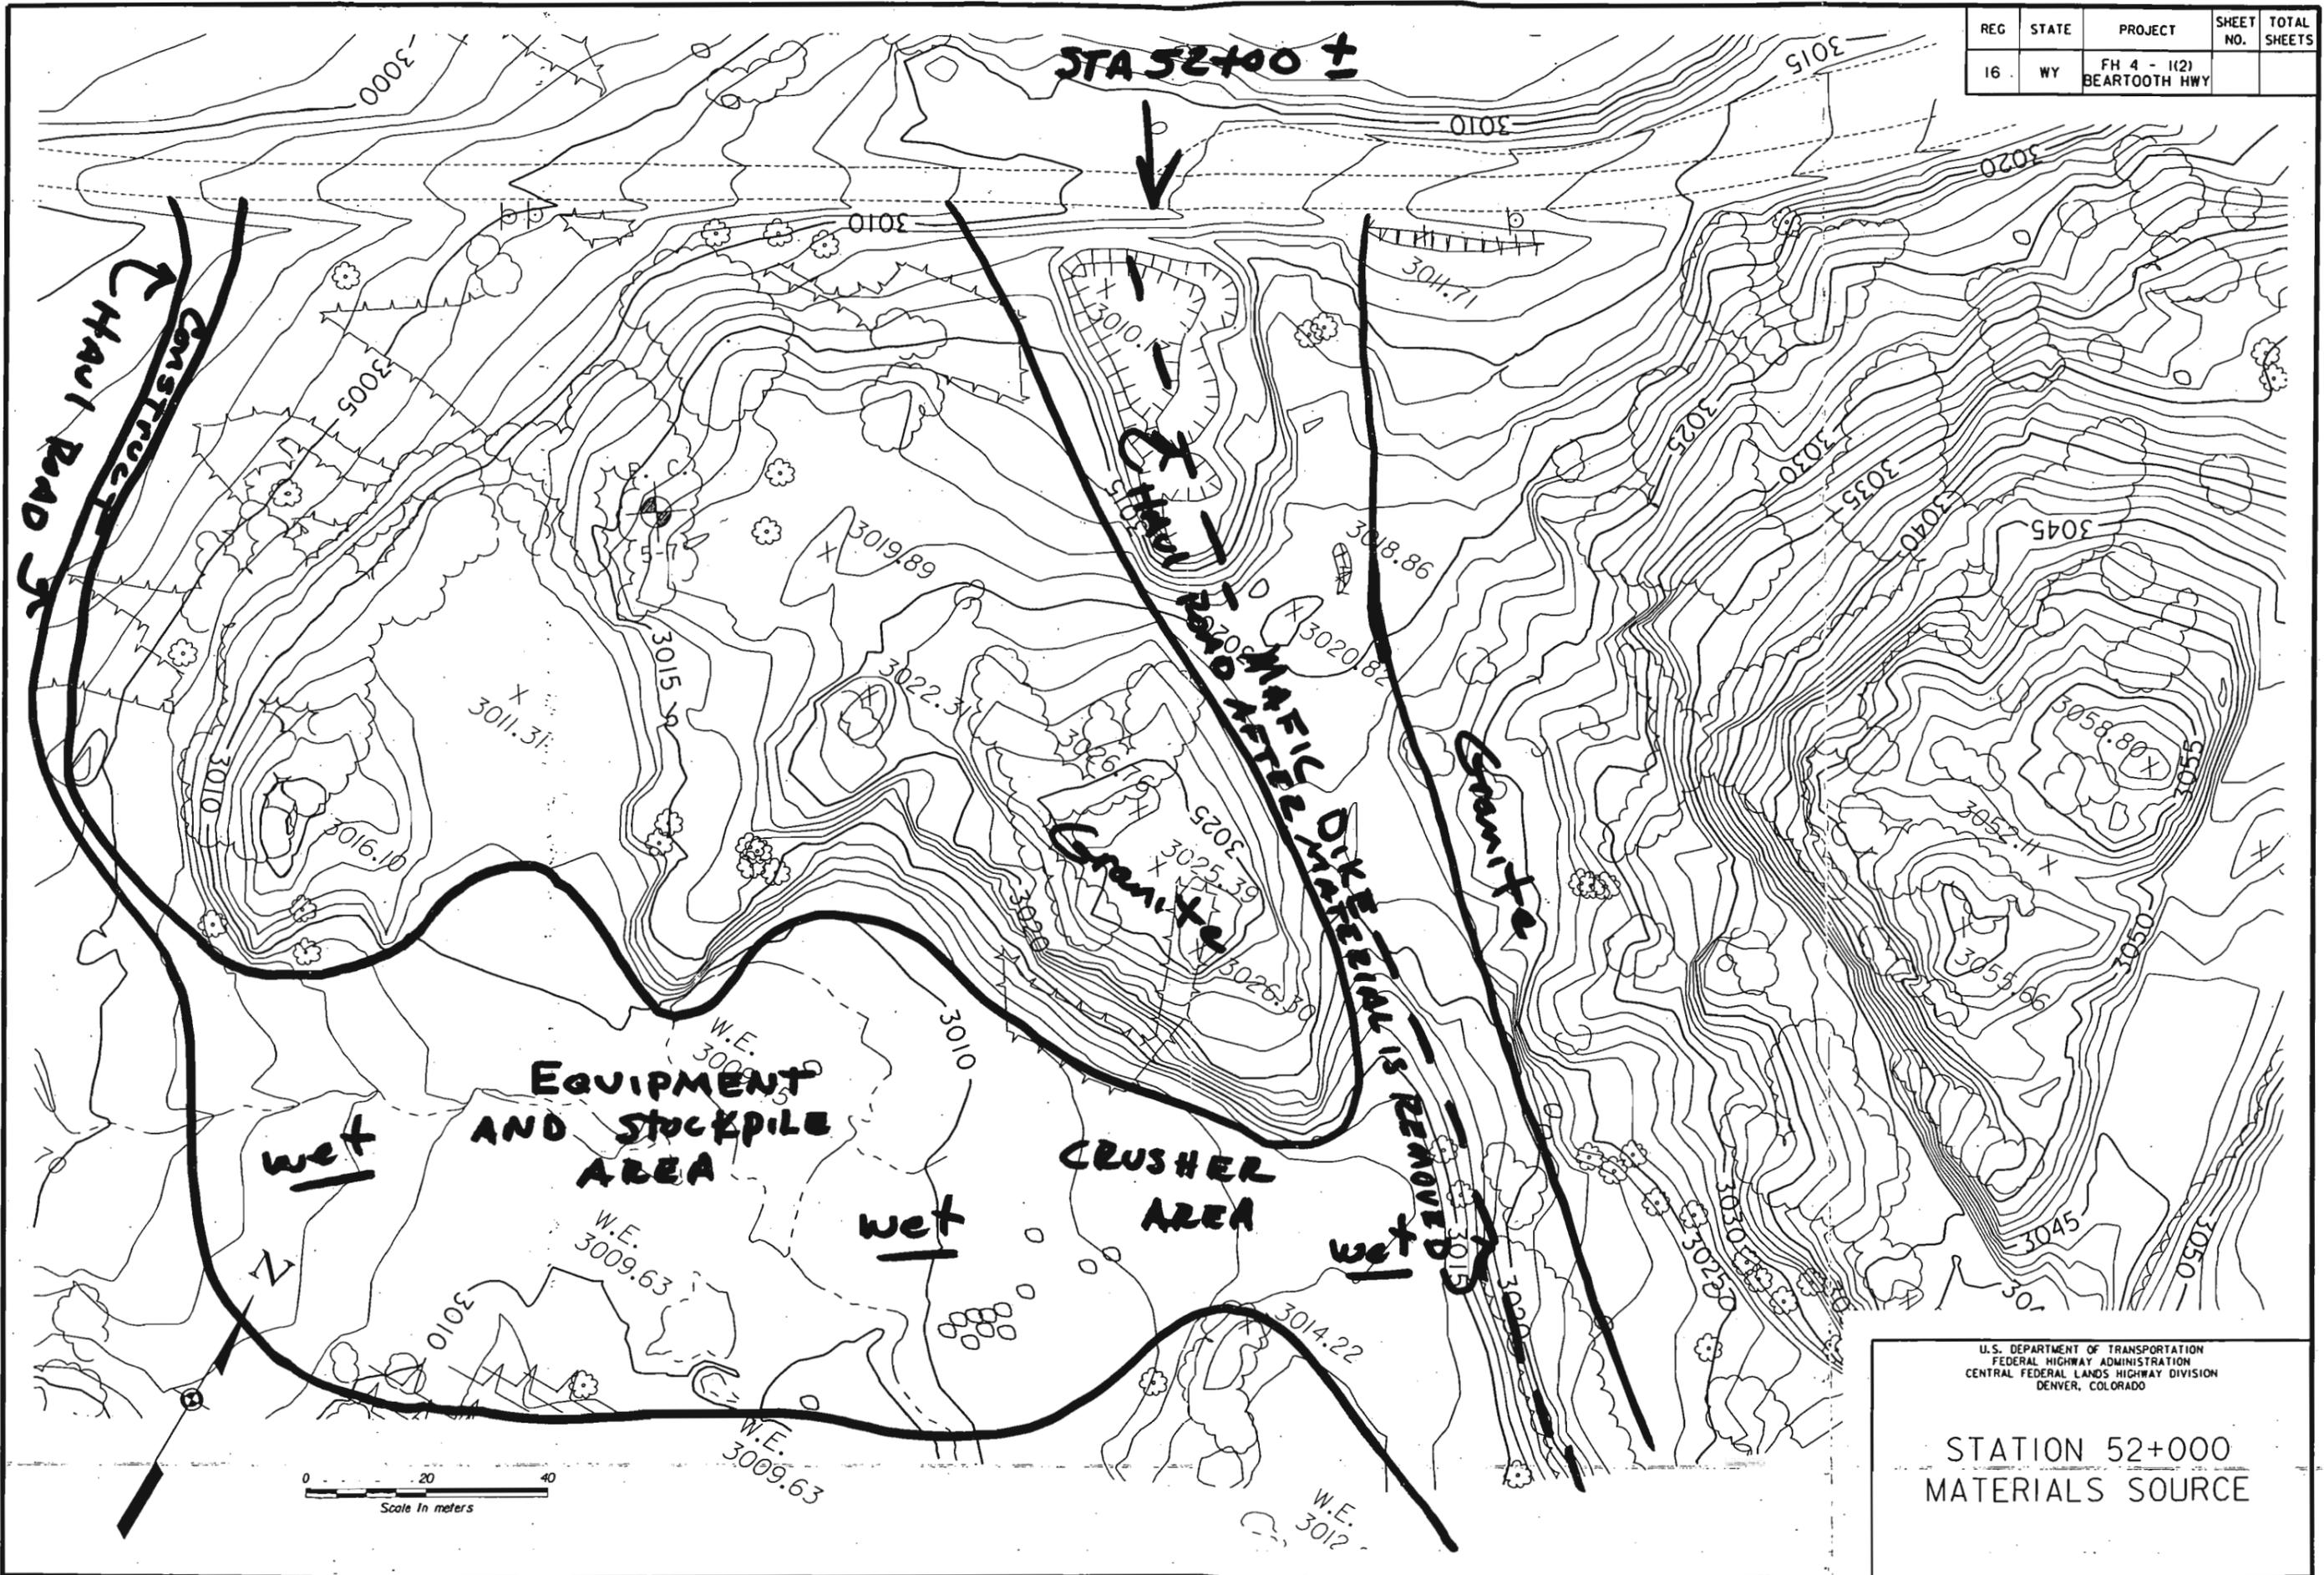
STATION 52+000  
 MATERIALS SOURCE

This area consists of a dark colored mafic dike surrounded by granite. (Mafic - an igneous rock composed chiefly of dark colored ferromagnesian minerals.) A small quarry excavation is next to the road and the material was used for road construction in the 1950's. The mafic material is very hard with an LA abrasion loss of 11 percent compared to the surrounding granite which has an LA abrasion loss of 35 percent. See test results in Appendix G of Materials Report 98-16. The material in this quarry site will be adequate for production of base and bituminous aggregate. The material will require blasting and crushing. The quantity of mafic material and granite available is only limited by the restrictions of the area that can be used per Forest Service approval.

A preliminary excavation plan is provided in Appendix F. A haul road could be constructed into the crusher and stockpile area from two directions. The area is wet, most if not all year, due to snow melt. Drainage ditches would need to be constructed, and the crusher and stockpile area would need to have the topsoil 0.60 meters ( $\pm$  2 feet) removed and the area plated with 0.90 meters ( $\pm$  3 feet) of rock. It is not necessary to use only the mafic material. The adjacent granite will meet our needs just as well.

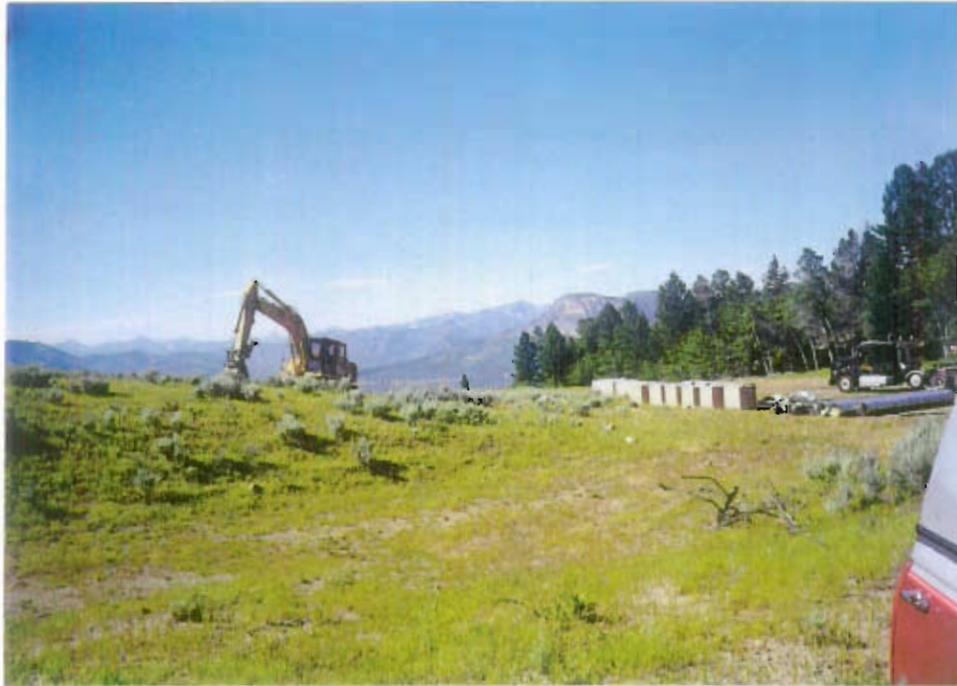
**PHOTO #1  
BK-1**

Excavations were started in the South Area with BK-1 in the floor of the old excavation, BK-3 was also in the floor of the old excavation. Both showed waste material from previous work, crusher rejects, limbs, boulders, etc. BK-2 and BK-4 were in the face of the old excavation. Both showed sand and gravel on the fine side (mostly sand and small gravel). Excavation BK-5 showed sand and gravel on the sandy side, and BK-6 was mostly sand with large boulders.

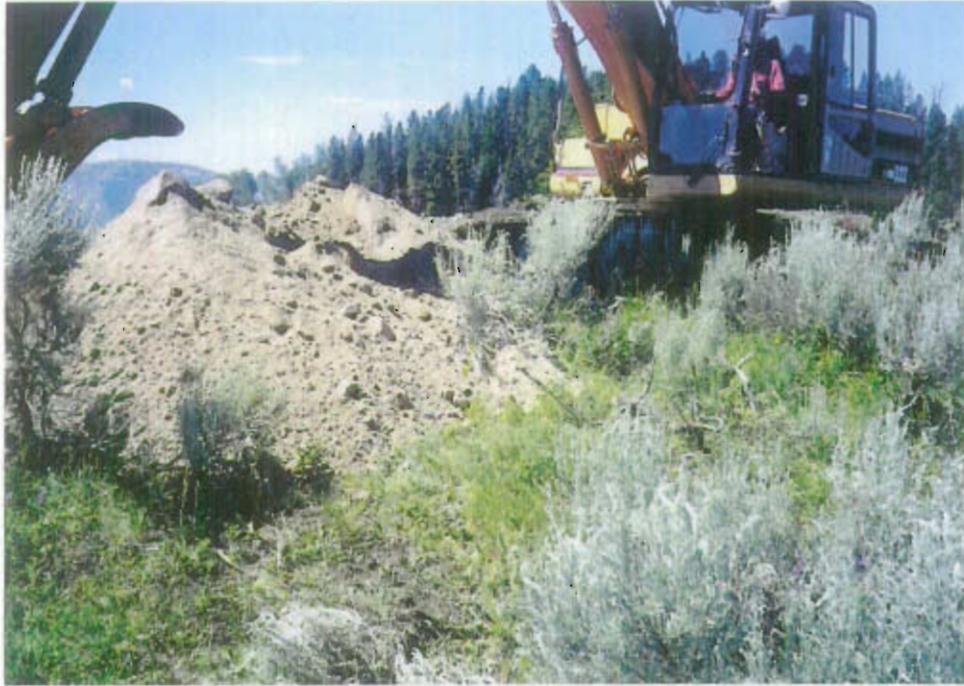
1.52 to 4.88	Light brown sand, gravel, cobbles, and boulders. Sampled 152 mm (6 inches) minus. Estimated cobbles and boulders over 152 mm (6 inches) is 15 to 25 percent.
BK-9	0 to 0.61	Dark brown gravelly topsoil.

PHOTO #7  
BK-8, CLOSE UP.

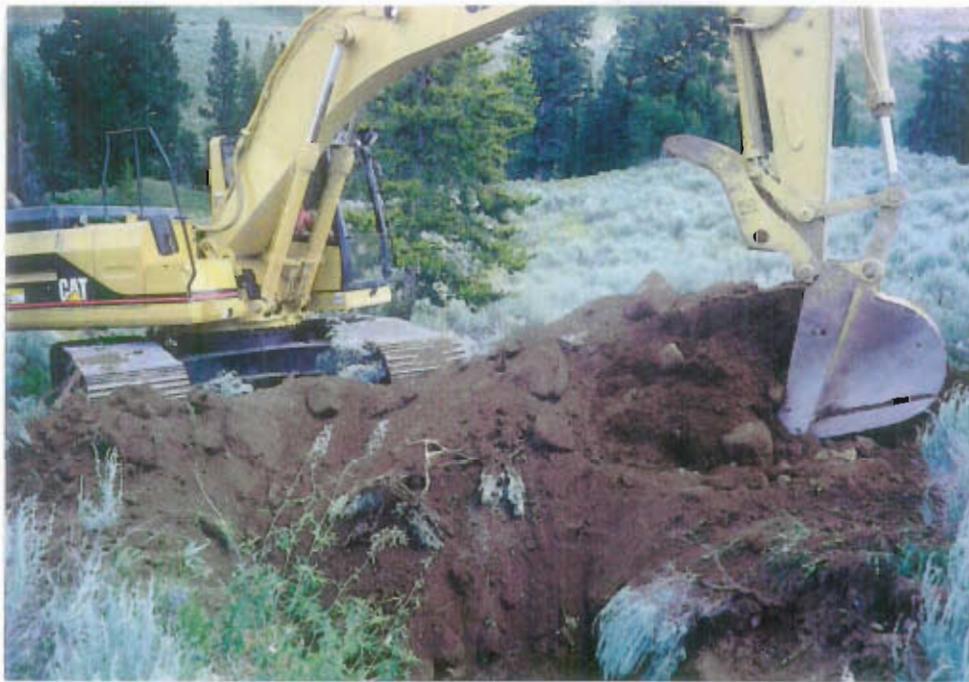
0.76 to 4.57	Light brown sand, gravel, cobbles, and boulders. Sampled 152 mm (6 inches) minus. Estimated cobbles and boulders above 152 mm (6 inches) is 20 to 30 percent.
BK-11	0 to 0.46	Dark brown topsoil.

PHOTO #8  
BK-10, CLOSE UP.

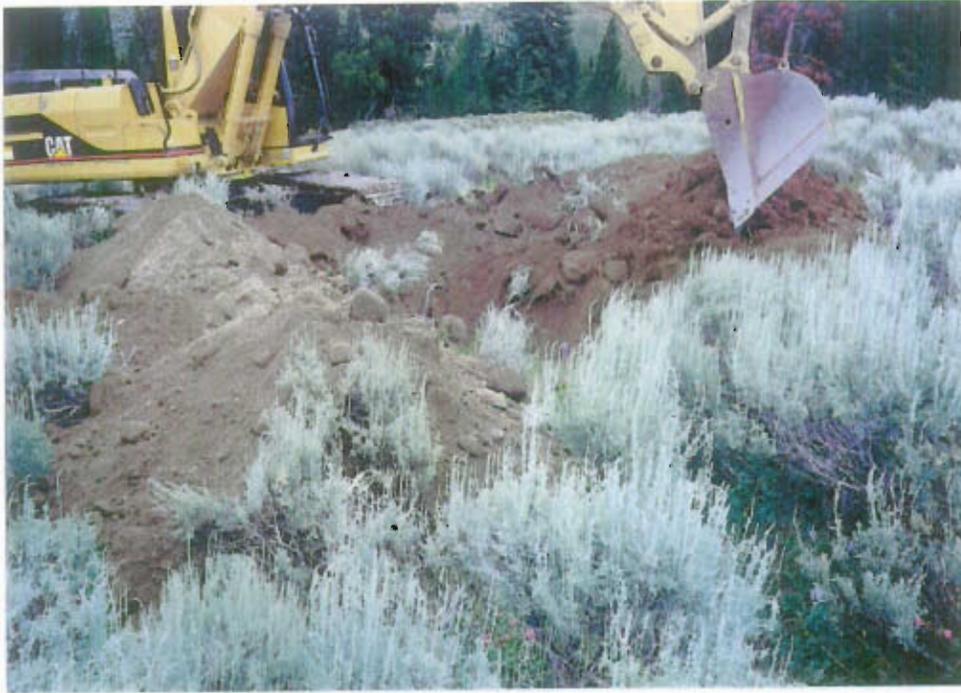
0.46 to 1.22	Light brown sand, cobbles, and boulders. Very bouldery. Boulders up to 762 mm (30 inches).
	1.22 to 4.88	Light brown sand, gravel, cobbles, and boulders. Sampled 152 mm (6 inches) minus. Estimated material 152 to 610 mm (6 to 24 inches) is 30 percent. Some boulders up to 914 mm (36 inches).
BK-12	0 to 0.61	Dark brown topsoil

PHOTO #9  
BK-11, CLOSE UP.

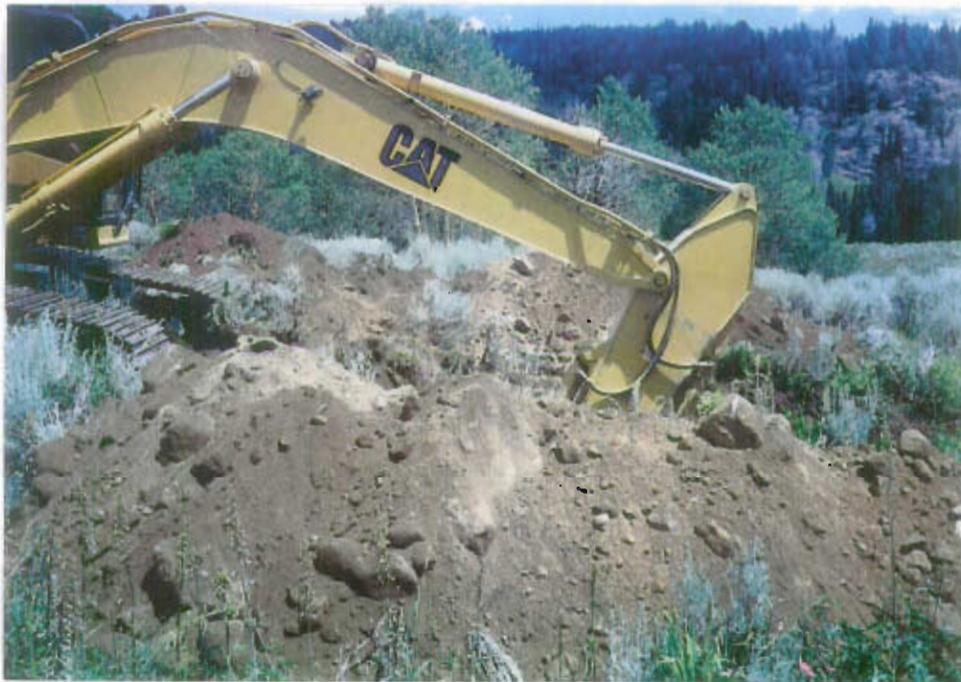
0.61 to 5.18	Light brown sand, gravel, cobbles, and boulders. Sampled 152 mm (6 inches) minus material. Estimated material 152 to 610 mm (6 to 24 inches) is 20 to 30 percent.

PHOTO #10  
BK-13, CLOSE UP.

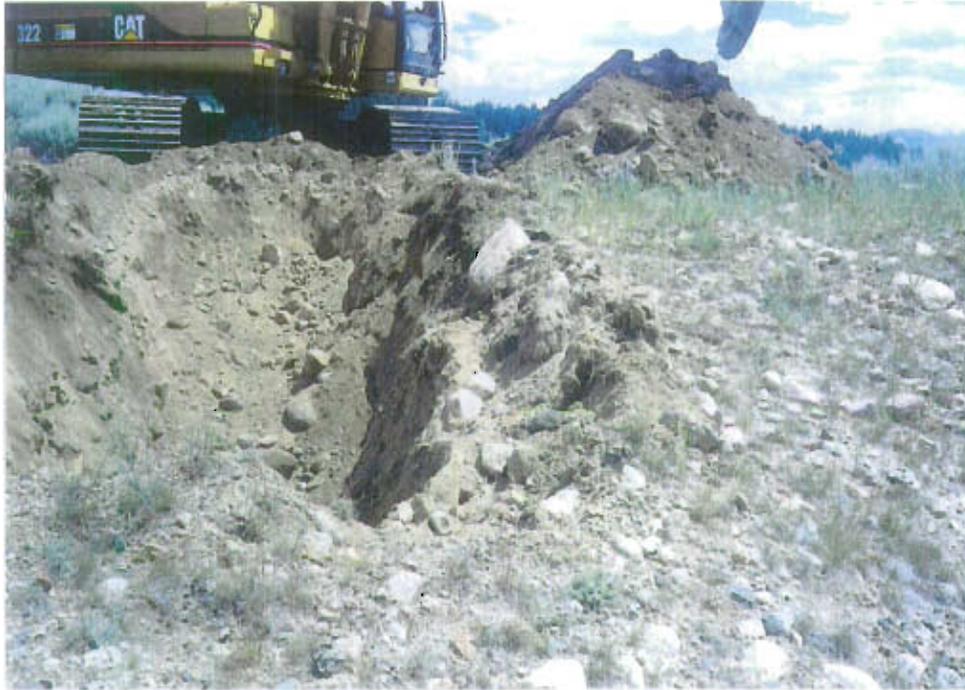
BORING NO.	DEPTH	DESCRIPTION
BK-14	0 to 5.49	No topsoil. Light brown sand, gravel, cobbles, and boulders. Sampled 152 mm (6-inches) minus material. Estimated material 152 to 762 mm (6 to 30 inches) is 20 to 30 percent.
BK-15	0 to 1.22	Very rocky cobbles and boulders.

PHOTO #11  
BK-14, CLOSE UP.

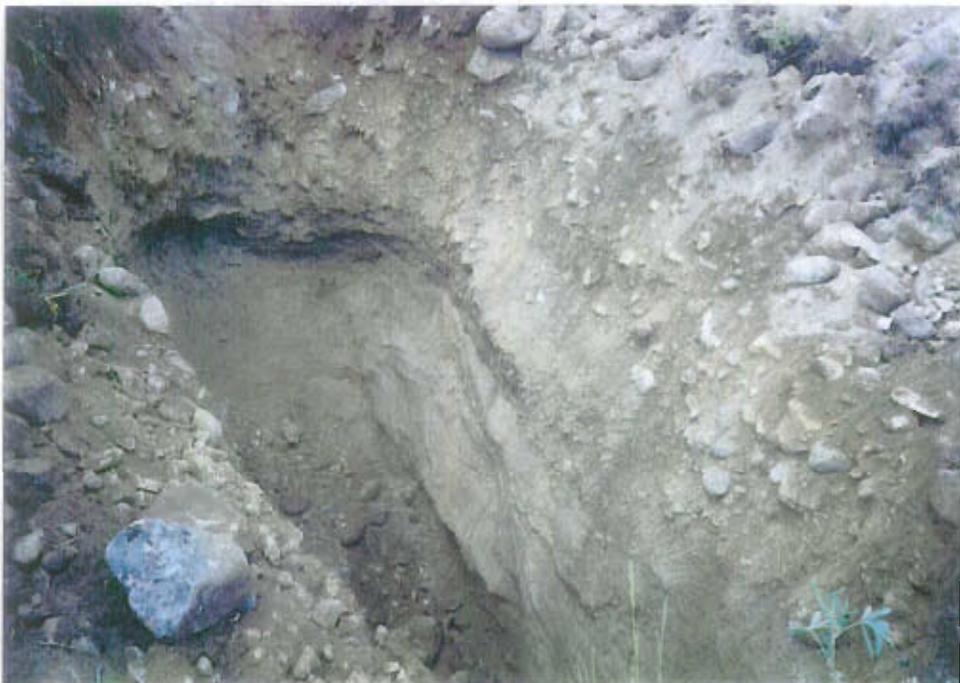
PHOTO #12  
BK-14, LOOKING IN EXCAVATION.

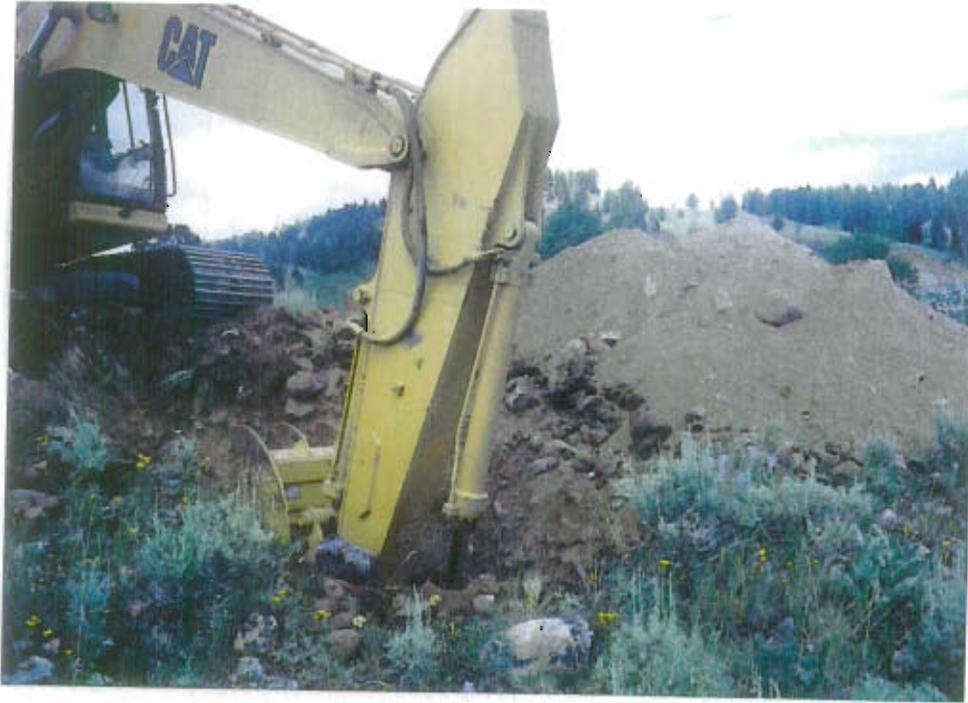
BK-15 was very rocky (cobbles and boulders) to 1.2 meters ( $\pm$  4 feet), then fine sand and gravel. BK-14, BK-18, BK-19, BK-21, BK-22 and BK-23 were taken along the existing previously excavated cut face. The excavations all consisted of sand and gravel. Excavations BK-16, BK-17, and BK-20 all showed coarse sand (crusher rejects). In BK-20, sand and gravel was present under the rejects after 1.8 meters. The crusher rejects would be ideal material for pipe backfill. The natural material in a large majority of the route will be rock, pipe backfill will be needed.

PHOTO #13  
BK-15, CLOSE UP.

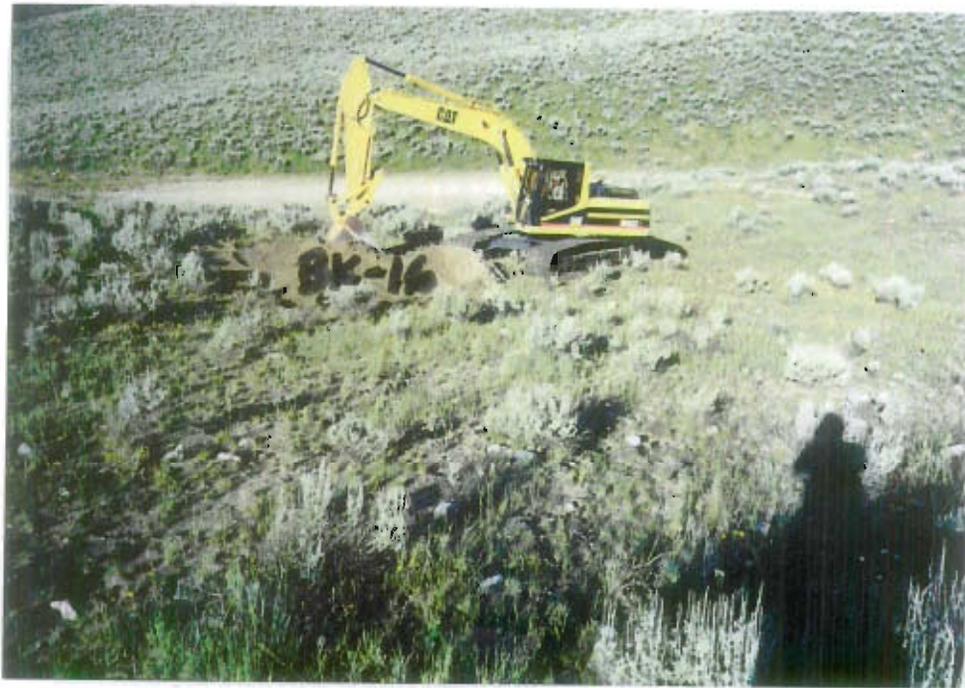
PHOTO #14  
BK-17, LOOKING DOWN AT BK-16.

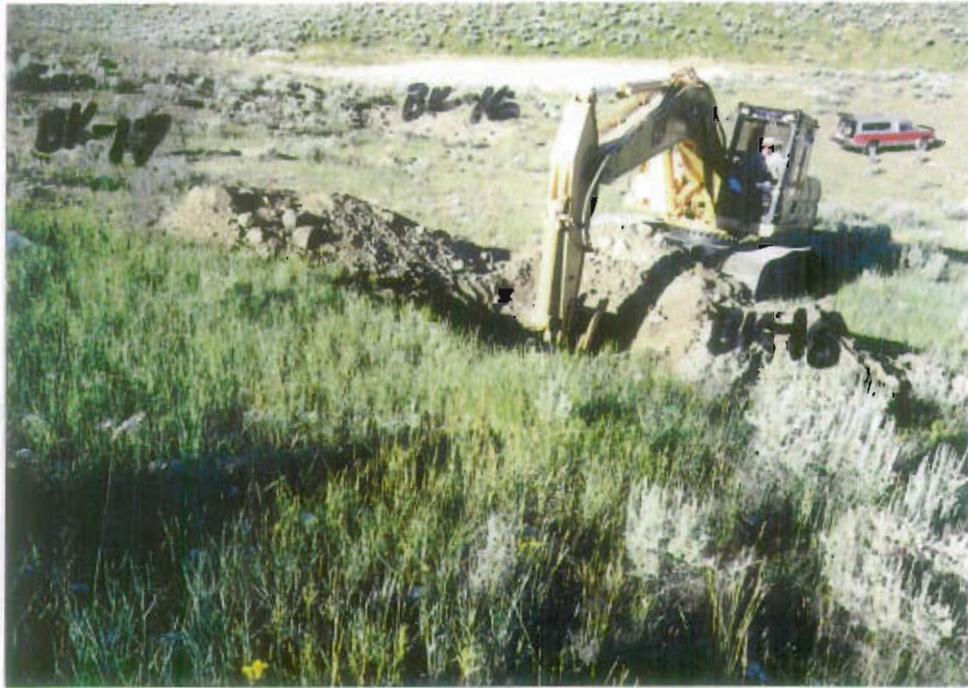
PHOTO #15  
ABOVE BK-18, LOOKING DOWN AT BK-18, BK-17, AND BK-16.

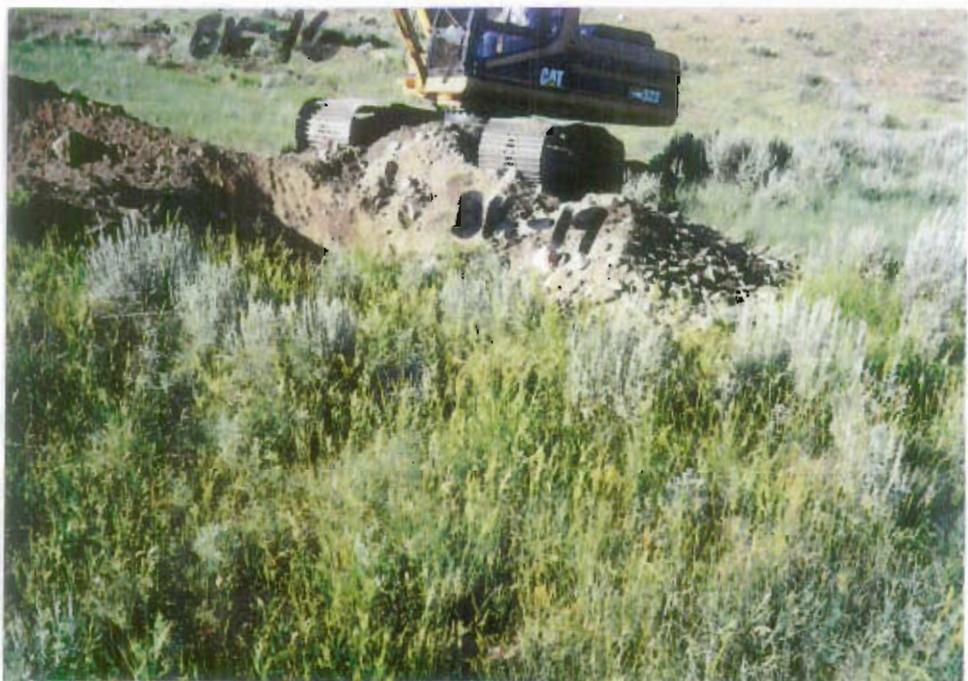
PHOTO #16  
BK-19 AND BK-16.

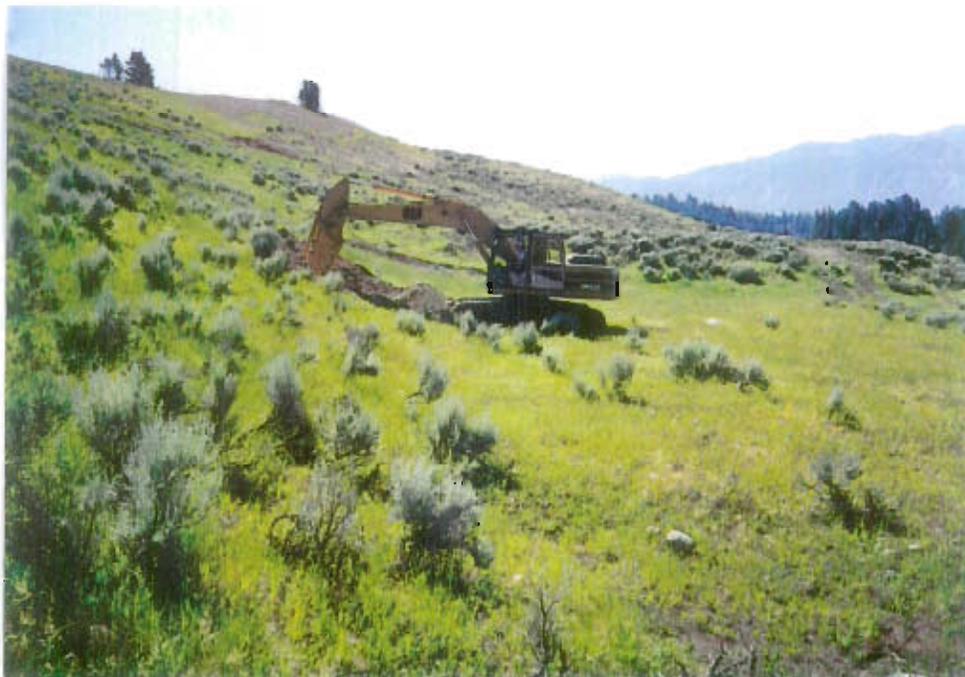
PHOTO #18  
T BK-23, LOOKING AT EXCAVATOR AT BK-22.
