**WYOMING  
BEARTOOTH HIGHWAY  
MATERIALS SOURCE INVESTIGATION**

**SEPTEMBER 1999  
REPORT 99-14**

**Technical Services Branch  
Central Federal Lands Highway Division  
Federal Highway Administration  
Denver, Colorado**

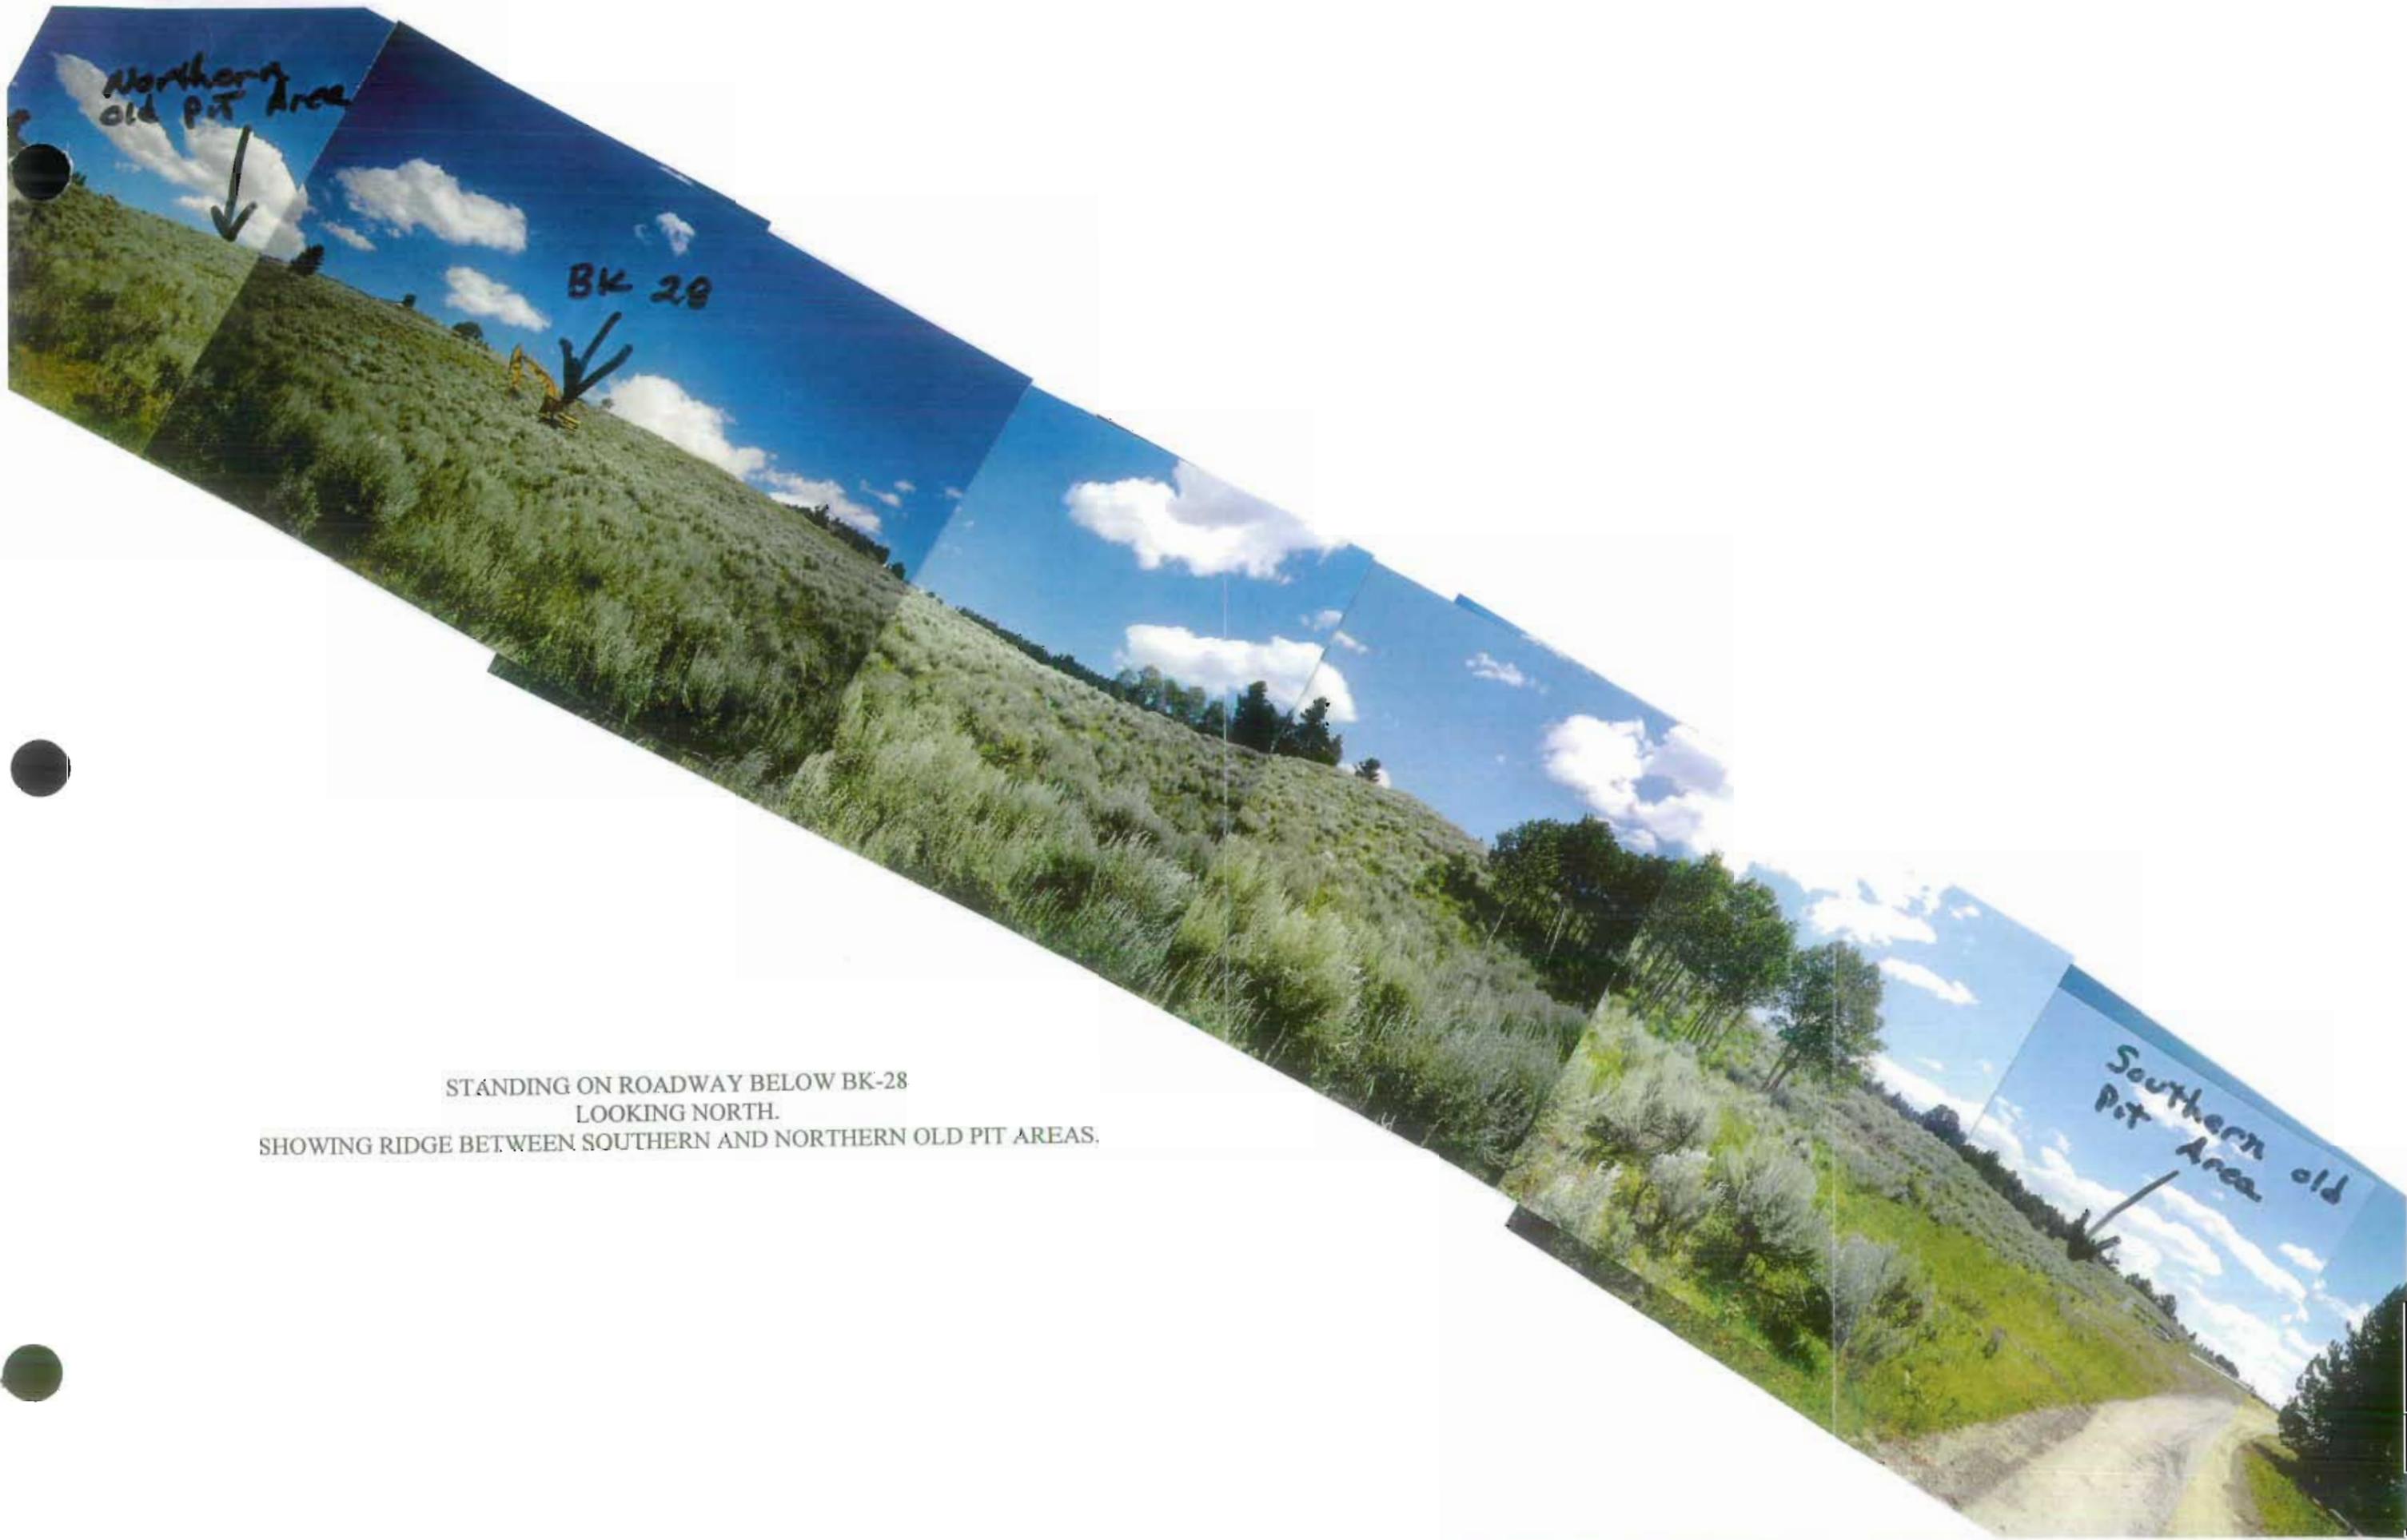
There are two areas along the ridge that have been worked in the past. We will call them the North Area and the South Area. There is an area between that has not been worked estimated to be a distance of approximately 300 meters ( $\pm$  1,000 feet). The South Area was outside of the present mapping. All excavations were marked with metal fence posts. Plans are to complete mapping of the area next year (2000). At this time, the excavation locations will be tied into the mapping.

STANDING ON ROADWAY BELOW BK-28  
LOOKING NORTH.  
SHOWING RIDGE BETWEEN SOUTHERN AND NORTHERN OLD PIT AREAS.

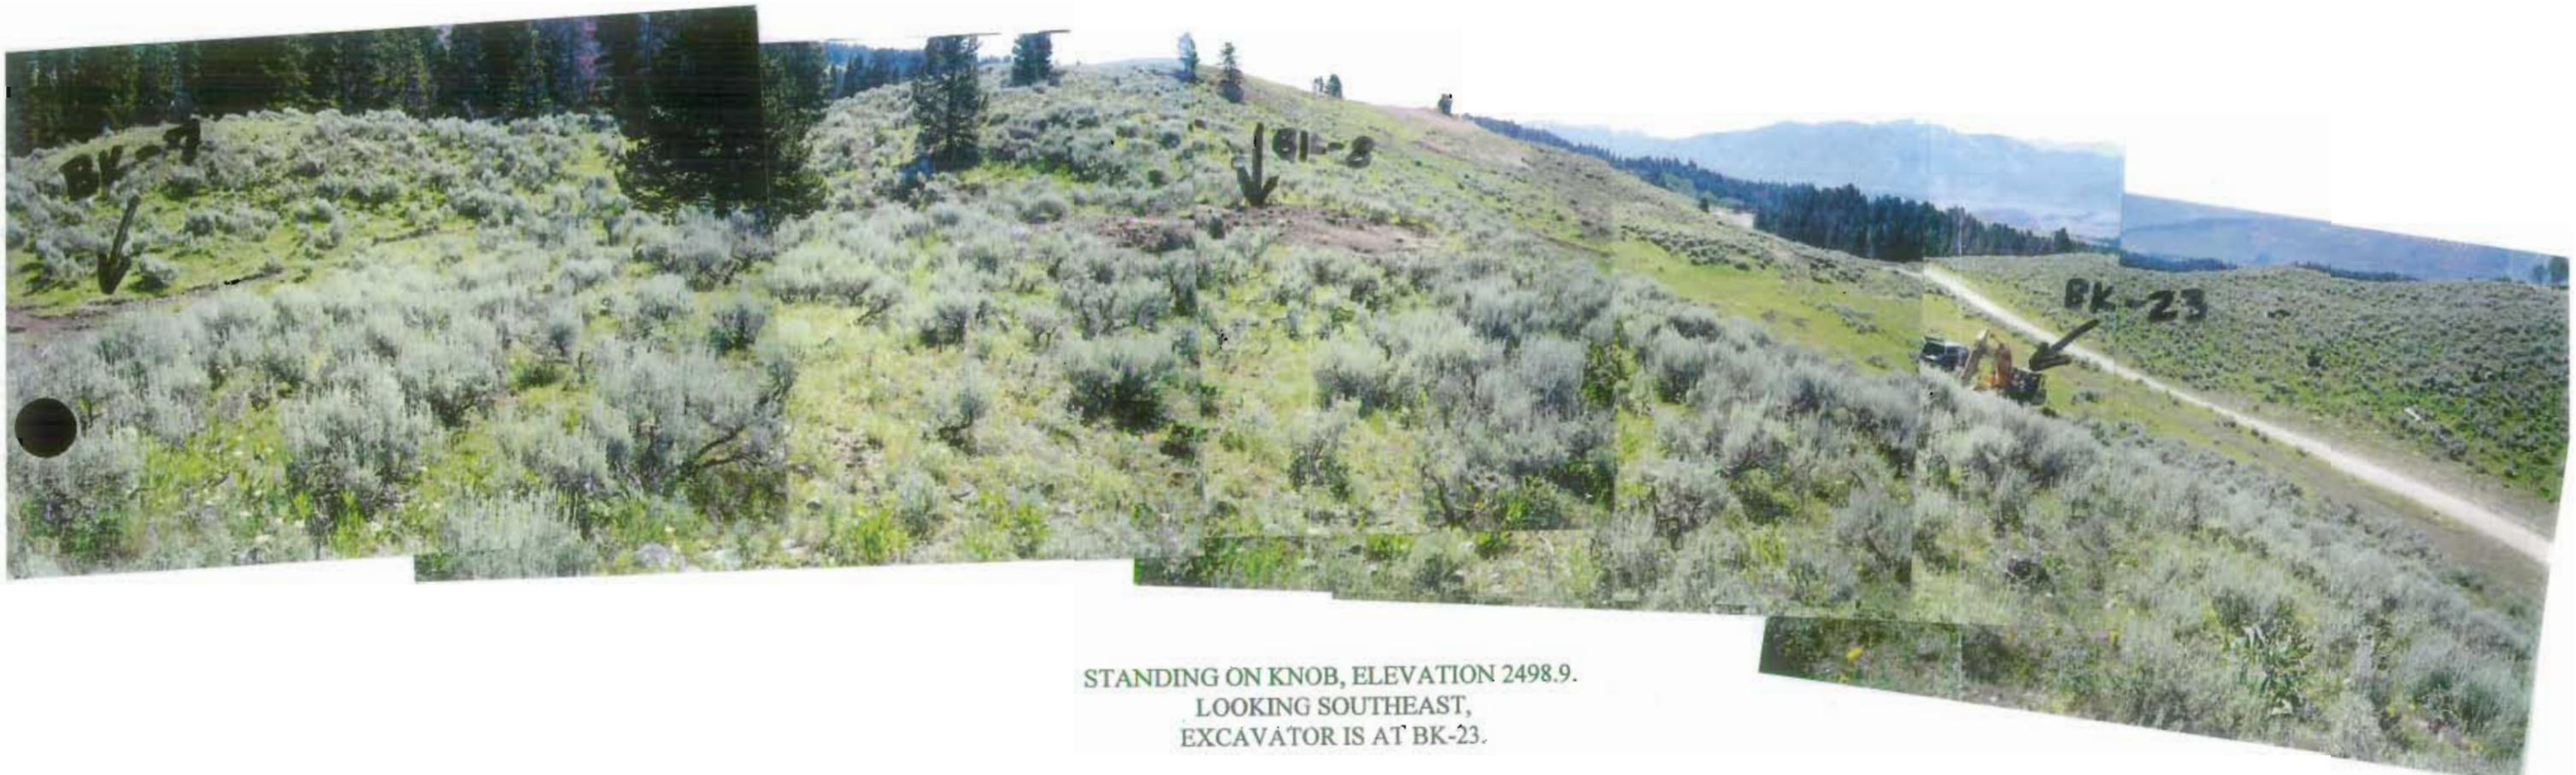
STANDING ON KNOB, ELEVATION 2498.9.  
LOOKING SOUTHEAST,  
EXCAVATOR IS AT BK-23.

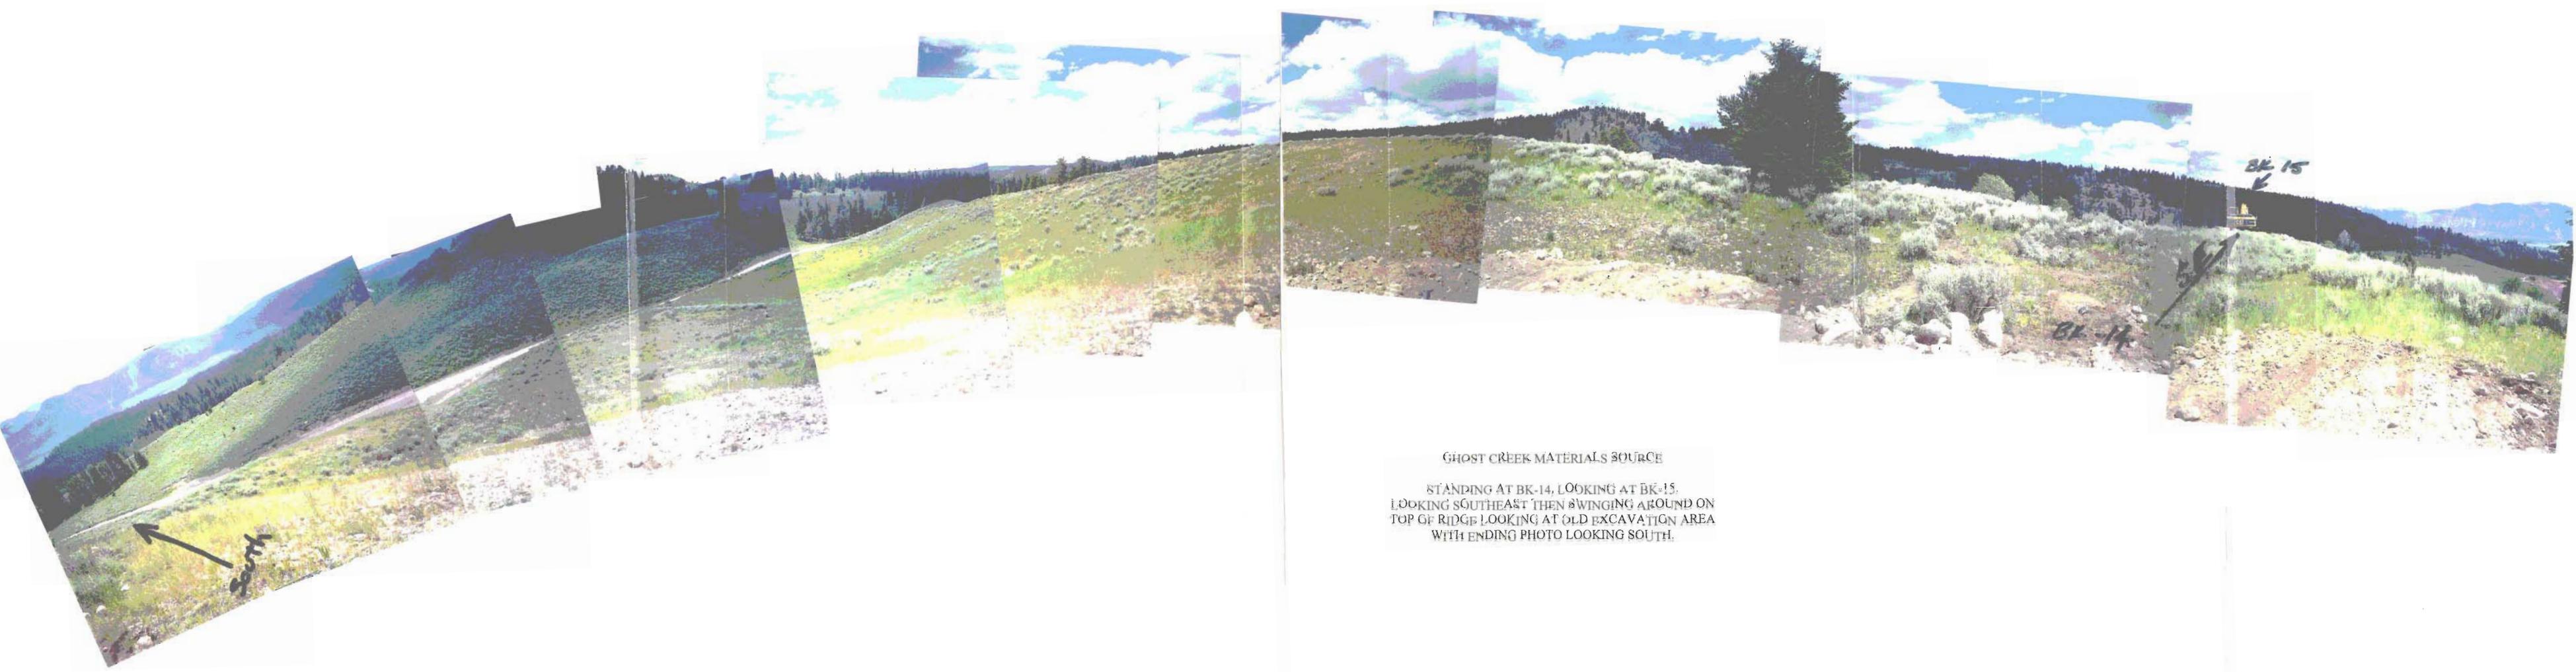
STANDING AT BK-14, LOOKING AT BK-15.  
LOOKING SOUTHEAST THEN SWINGING AROUND ON  
TOP OF RIDGE LOOKING AT OLD EXCAVATION AREA  
WITH ENDING PHOTO LOOKING SOUTH.
