Subject: TX RRP BRAZ 10(3) Brazoria
Pavement Recommendations

**BRAZORIA NATIONAL WILDLIFE
REFUGE
TX RRP BRAZ 10(2) BRAZORIA TOUR
LOOP ROAD**

**PAVEMENT RECOMMENDATION
SUMMARY
August 2006
REPORT 06-01**

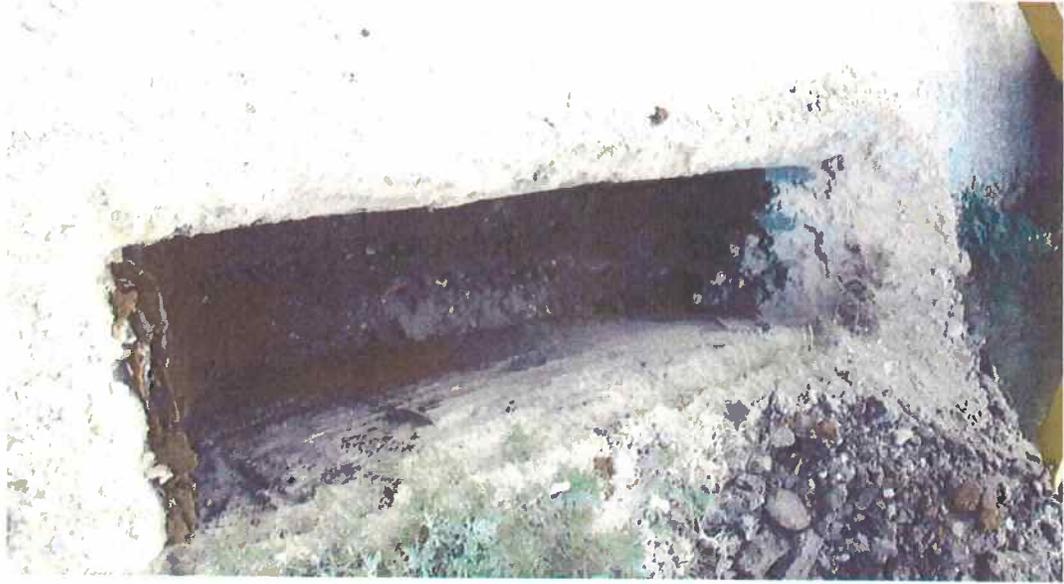
TESTPIT 1a

6" Gravel Base*		0.5

FAT CLAY (Cl), dark gray, lightens with depth		1.0

SAND (SF) with SILT to SILTY SAND (SM), reddish-brown		5.3	
				Total Depth of Boring = 5.3 Feet			
				Groundwater seepage was not encountered			
				*Geotextile fabric located below gravel road base

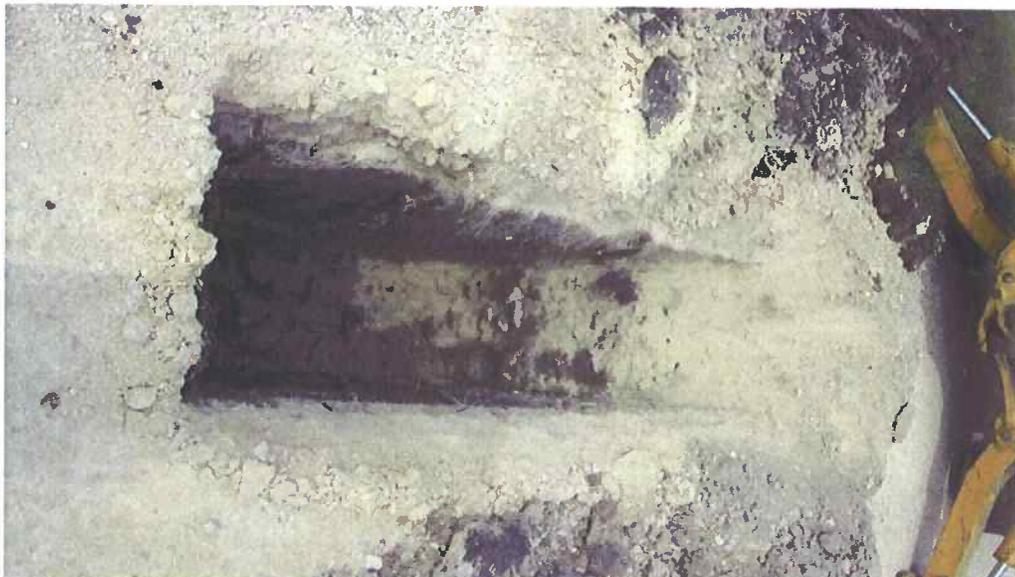
TESTPIT 2a

DEPTH FEET	SYMBOL	SAMPLE	TEST RESULTS	MATERIAL DESCRIPTION	ROCK CORE REC / ROD #	DEPTH	DEPTH
	~			16" Gravel Base*		00	
	/			FAT CLAY (CH), dark gray, lightens with depth		04	
5	/			FAT CLAY (CH), reddish-brown with gray seams		67	
10				Total Depth of Boring = 3.7 Feet Groundwater seepage was not encountered. *Geotextile fabric located below gravel road base

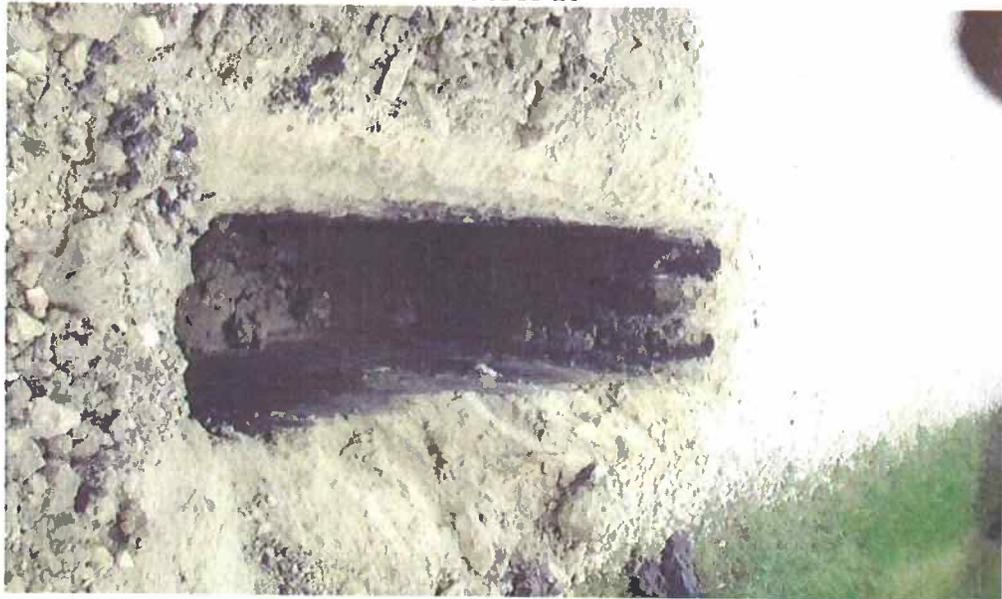
TESTPIT 3

9" Gravel Base*

FAT CLAY (CH), dark gray, lightens with depth		0.0

FAT CLAY (CH), gray with olive seams		4.7	
				Total Depth of Boring = 6.0 Feet Groundwater coverage was not encountered *Geotextile fabric located below gravel road base		6.0
