CHAPTER 3 – FIELD STUDY AND ANALYSIS PROGRAM

INSTALLATION, TESTING, AND ANALYSIS PROGRAM

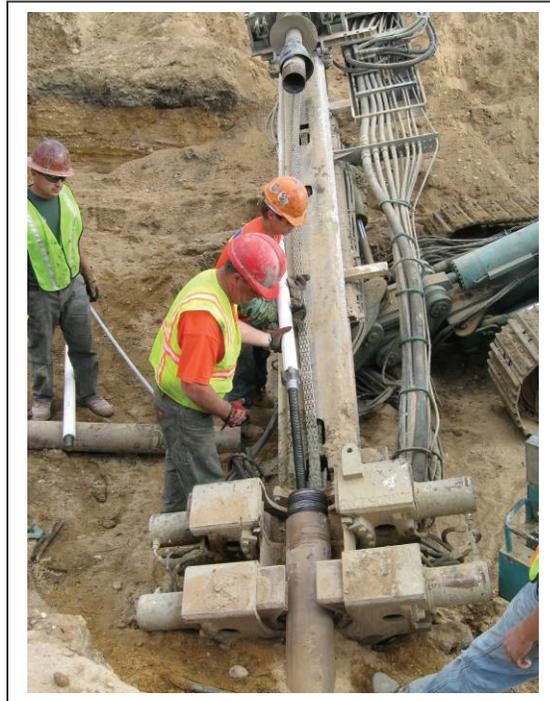
Figure 1. Photograph. Installation (Method A) of a solid bar at the Posillico Site.

This is the typical procedure for installation of test SBSNs, where the free length of the soil nail is achieved with the aid of a temporary casing as shown in Figure 1. For this project, the test SBSNs were drilled using casing and a drag bit or roller bit. The method of casing advancement and bit type are indicated on the installation logs, included in the site reports in Appendices 1-4.

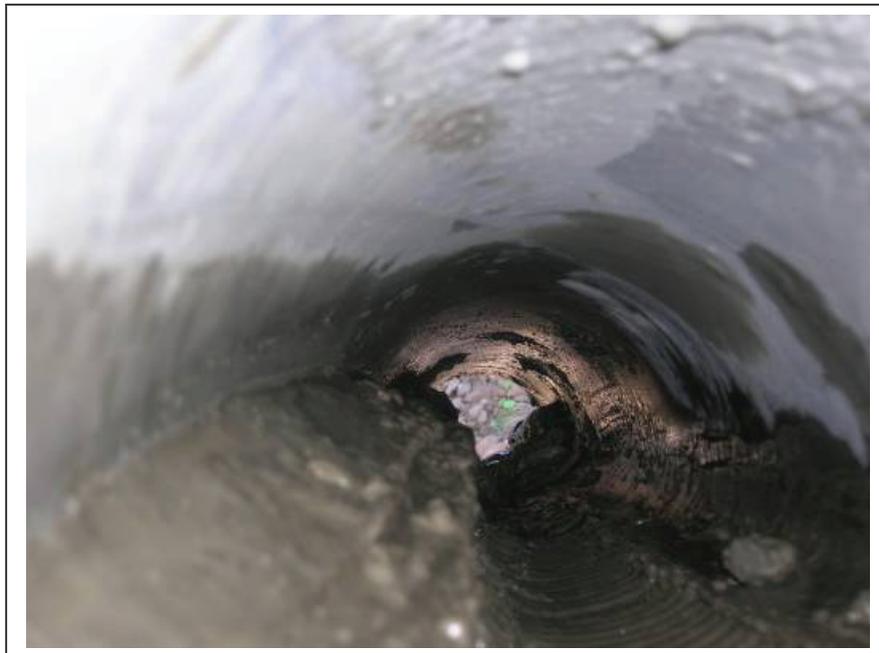
Figure 5. Photograph. Grout remaining in the casing after flushing at the Sunset Mesa Site.

note, significant grout remained in the casing at the Sunset Mesa site where the contractor elected to wait until the end of the day to pull all the casing for Method B nails as shown in Figure 5.

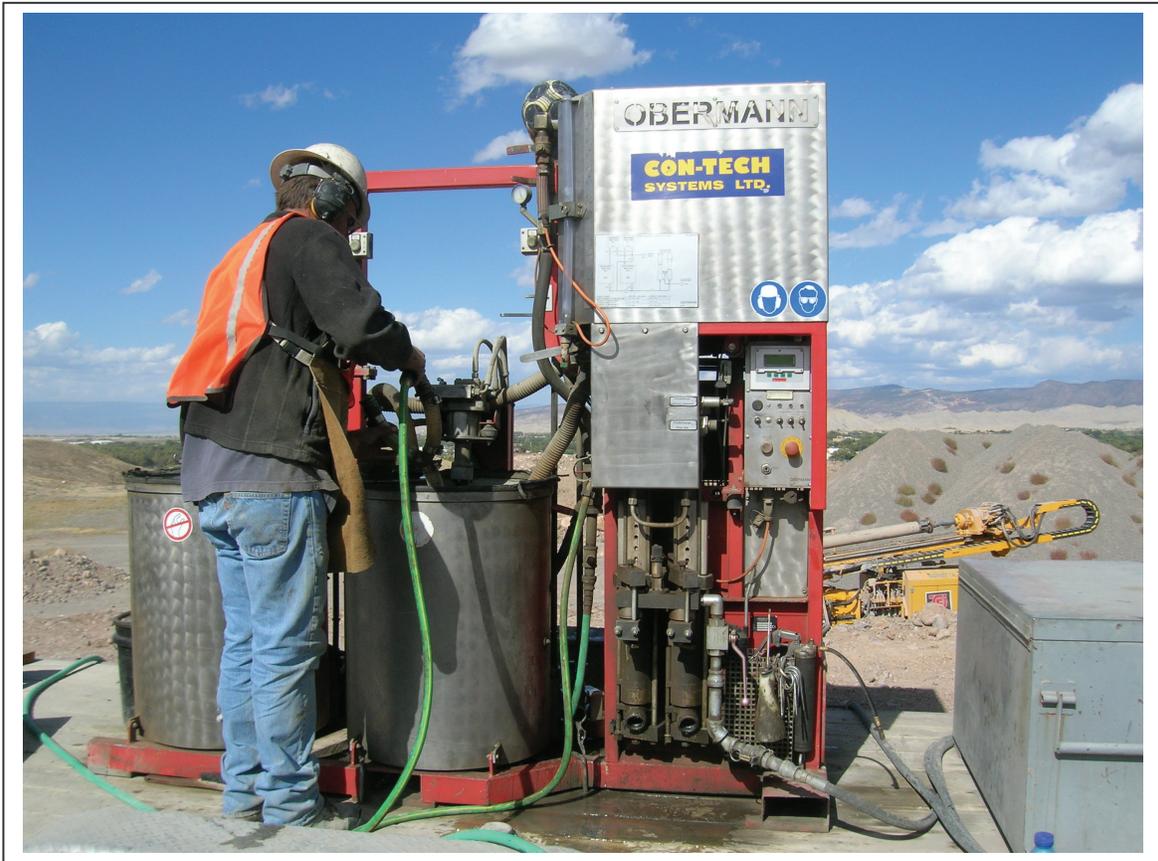
Figure 8. Photograph. Obermann high shear mixer grout pump.

The grout mix used for this research study was comprised of Type I, Type II, or Type V cement with a target water-cement ratio of about 0.44 (1 bag of cement per 5 gallons of water). The grout was mixed using a high shear mixer group pump (typical pump shown in Figure 8). The specific gravity of the grout was measured before injection into the hole at the end of the tremie tube, or connection of the hose and swivel. Occasionally the specific gravity of the grout return was also measured. For nails where a pre-measured volume of grout was placed, no return was expected or observed. As noted on the drill logs, the specific gravity of the sampled grout was at least 1.8, as measured using a mud balance.

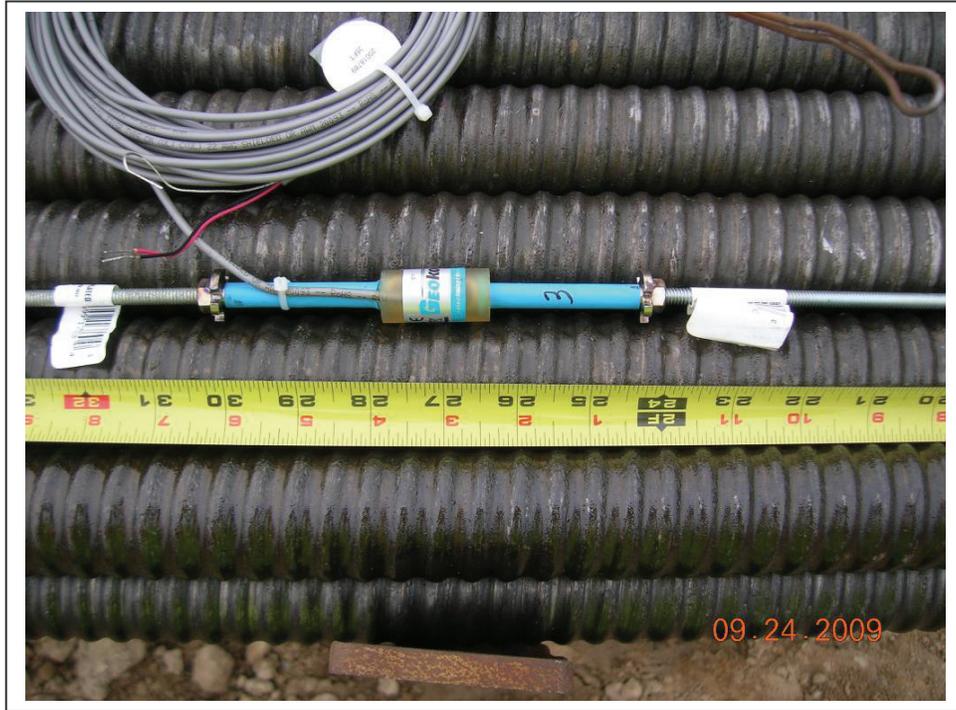
Figure 9. Photograph. Geokon Model 4200-AX strain gauge with threadbar attachment and notched dumbbells.

The strain gauges used were Geokon Model 4200-AX as shown in Figure 9, which have a relatively small diameter (maximum 19 mm). To reduce the cable diameter, the thermistors were not activated. The wings of the dumbbell style strain gauge were notched to allow the cables to pass without having to increase the overall diameter of the strain gauge footprint. On either end of the dumbbell, Geokon welded a nut, which provided a positive connection for a ¼-inch diameter all-thread bar. The ¼-inch diameter all-thread bar was used to space and to plunge the gauges into the grout column within the hollow core bar.

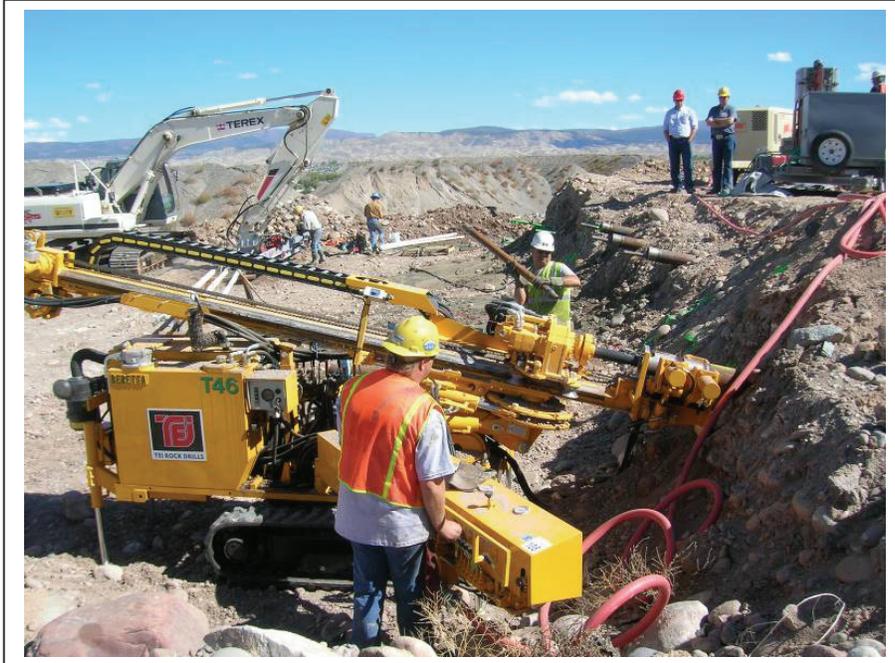
Figure 10. Photograph. Casing installation at the Sunset Mesa Site.

The equipment for each site depended on subsurface conditions and equipment availability to the contractor. The Sunset Mesa, Block 76, and Posillico sites required two different rigs: one to install the casing as shown in Figure 10, and one to perform the rotary hollow bar drilling. In general, the equipment used at each site was sufficient to successfully complete the installation. The equipment used at each site is listed on the respective drill logs. For the installation of the HBSNs, a pressure gauge was installed at the swivel, as shown in Figure 11. The grout pressure during installation of the HBSNs is noted on the drill logs.

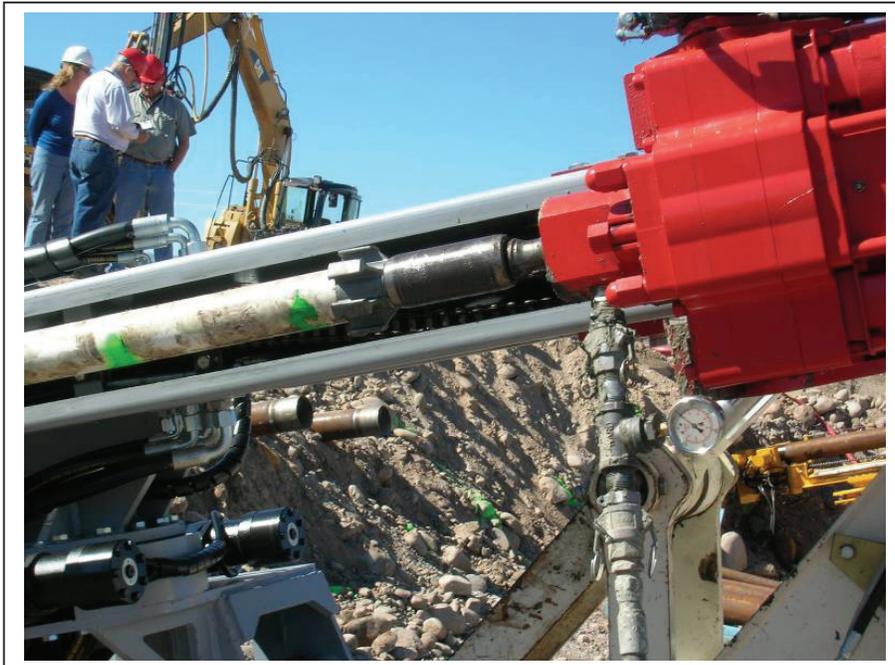
Figure 11. Photograph. Top hammer setup used for installation Methods B and C. Note the grout pressure gauge at the swivel and centralizer used to hold PVC in place.
