# ROAD STABILIZER PRODUCT PERFORMANCE

## Buenos Aires National Wildlife Refuge

Publication No. FHWA-CFL/TD-05-011

October 2005

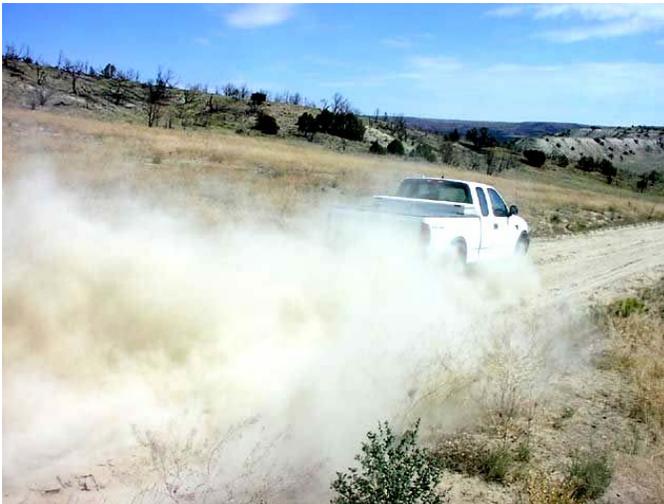
**Figure 1. Photo<sup>(1)</sup>. Dust typical of untreated roadway.**

Today on unsurfaced roads or on road construction projects or travel ways adjacent to fields with loose material, blowing dust, as shown in Figure 1, is an irritant and obstacle that slows travel times and decreases driver safety due to loss of visibility. Several western State Department of Transportations (DOTs) now post signs on their roadways warning travelers to beware of dust.

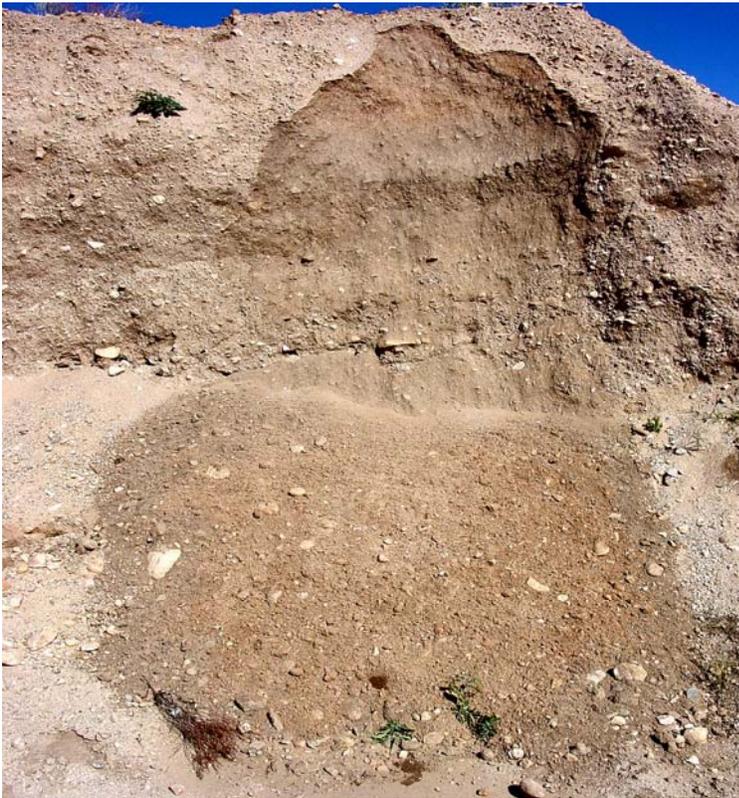
**Figure 8. Photo. Stockpile of granular material used for topping.**

Material from a wash of a local dry streambed was used as the borrow source for the select topping. This borrow material was generally of good quality and met the Special Contract Requirement Section 704.08<sup>(11)</sup>. The specific borrow characteristics prior to and after treatment are discussed in Chapter 4.

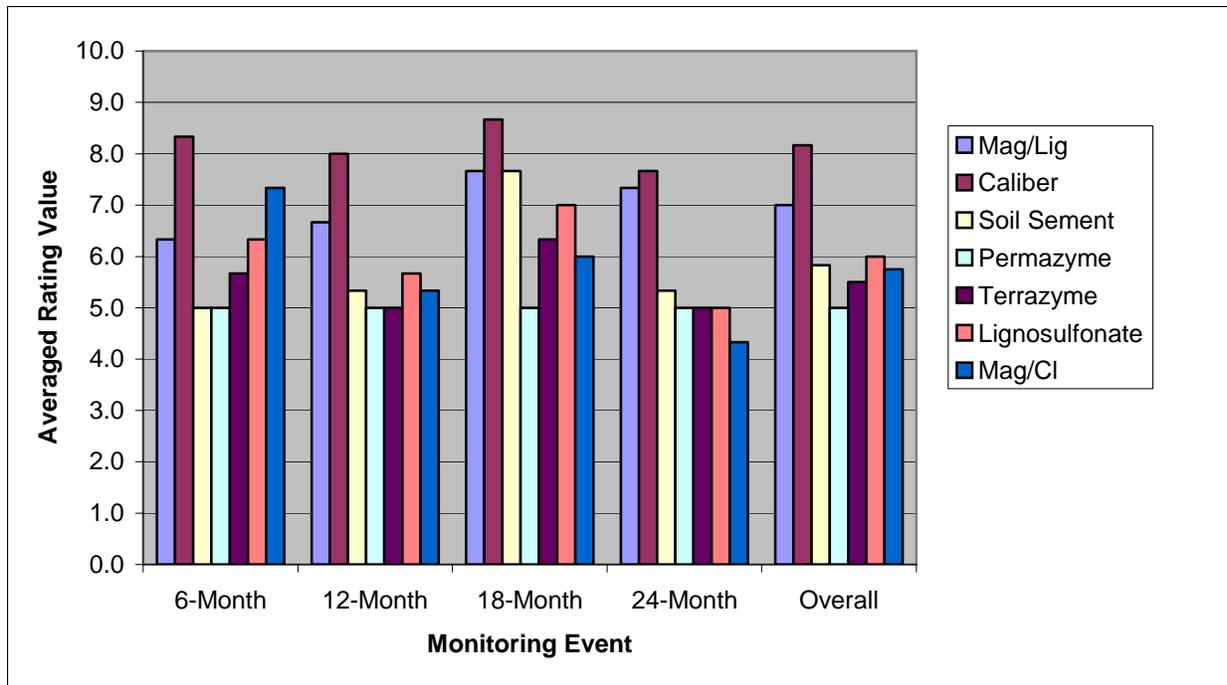
**Figure 9. Plot. Dust values over time.**

As indicated by the data in Table 6 and plotted in Figure 9, over time each product’s relative standing in the group stayed pretty much the same. There were variations, for instance the improved relative values for Soil Sement at the 18-month event, but the relative standings remained substantially the same. The average over the four monitoring events best shows the overall relative performance of the products in dust abatement.

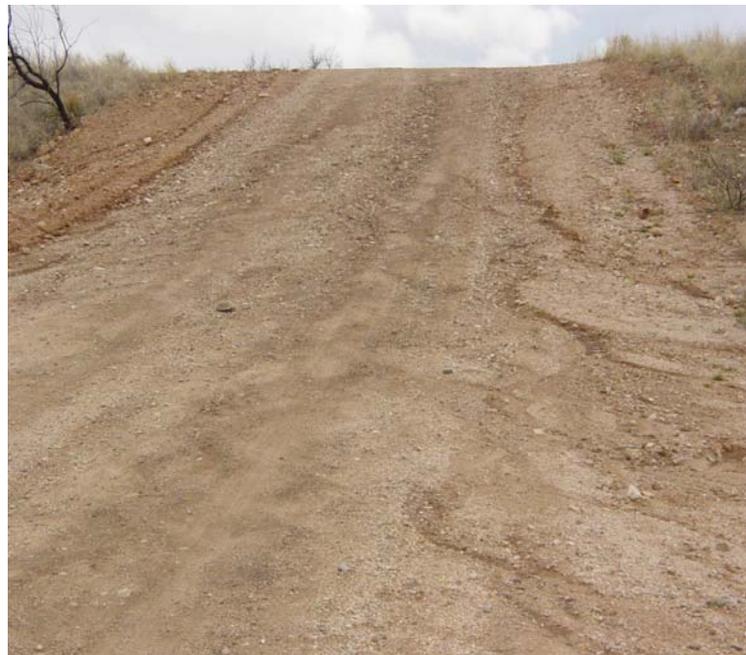
**Figure 12. Photo. Water erosion rivulets.**

An ideal study location would be one where all sections had identical geometry, grade, and composition. Unfortunately, the terrain varied throughout the project from relatively level or slightly rolling hills to some steeper sections as shown in Figure 12. The Mag/Lig, Terrazyme and Lignosulfonate roadway sections all had areas of rougher terrain, steeper grades, and curvilinear alignment. The evaluation team recognized that the effects of vehicles traveling on these steeper grades and curvilinear alignments would be greater than on the relatively flat and straight portions of each of these sections. Thus, difficult terrain areas were excluded from the rating process. Similarly,

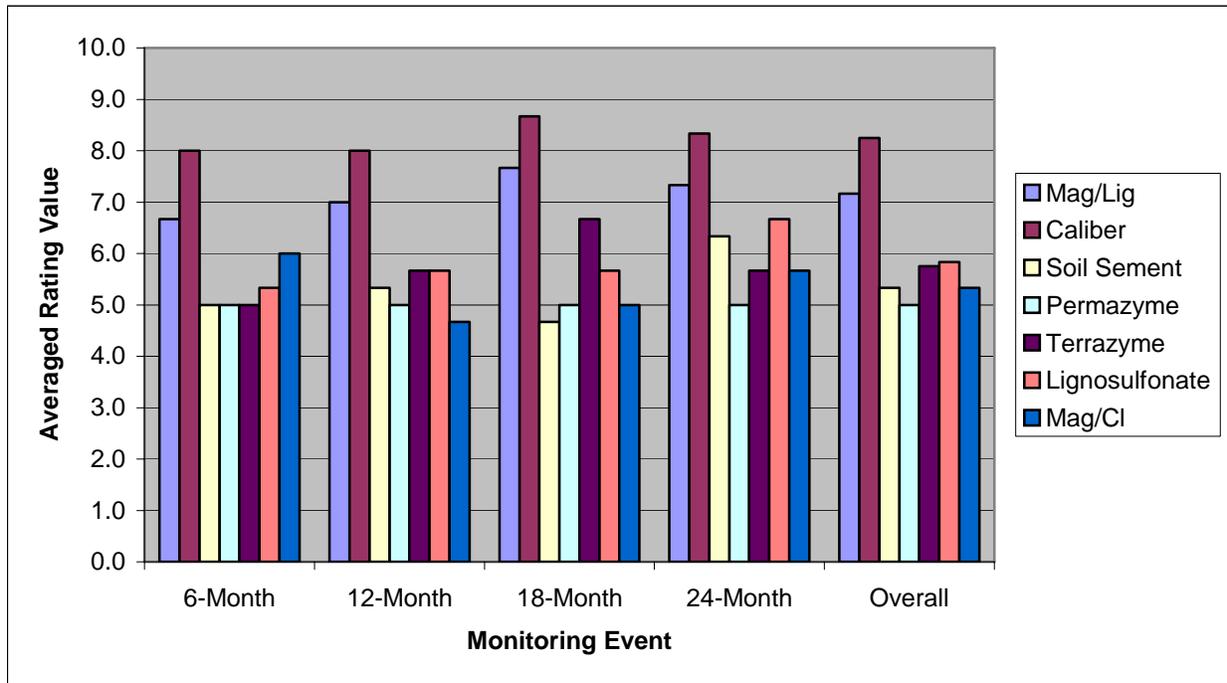
**Figure 13. Plot. Raveling values over time.**

Table 8 shows the raveling rating values for each of the monitoring periods and the overall averages. These values for each product are plotted in Figure 13.

As indicated by the data in Table 8 and plotted in Figure 13, over time each product’s relative standing in the group did not significantly change.

The products shown in Table 8 can be separated into three raveling groups. In the first group was the Caliber section that appeared to have less loose particles at the roadway surface than other sections. It had a “tighter” surface appearance and little or no raveling. There was progressively more raveling in the Mag/Lig section in the second group. In the third group were all of the other products whose sections had higher but similar levels of raveling. Figure 11 shows the raveling on the Mag/Cl Section, typical of the sections in this third group.

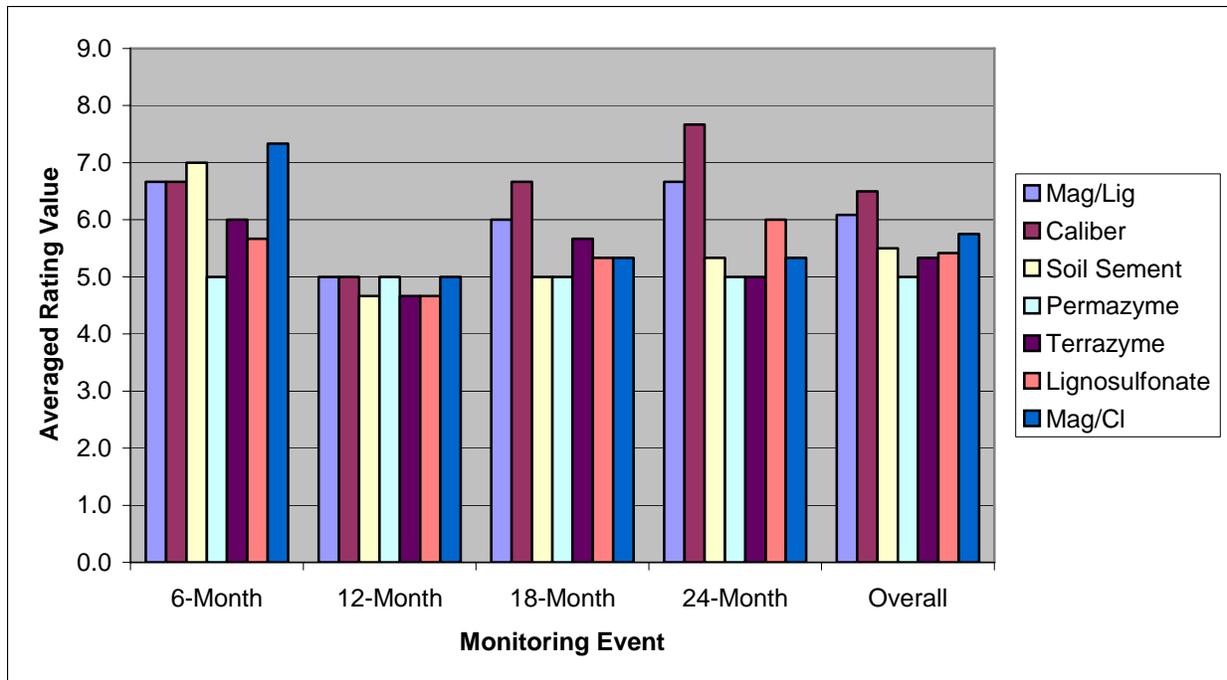
**Figure 14. Plot. Rutting values over time.**

As indicated by the data in Table 9 and plotted in Figure 14, over time each product’s relative standing in the group remained pretty much the same. Although there were specific variations,

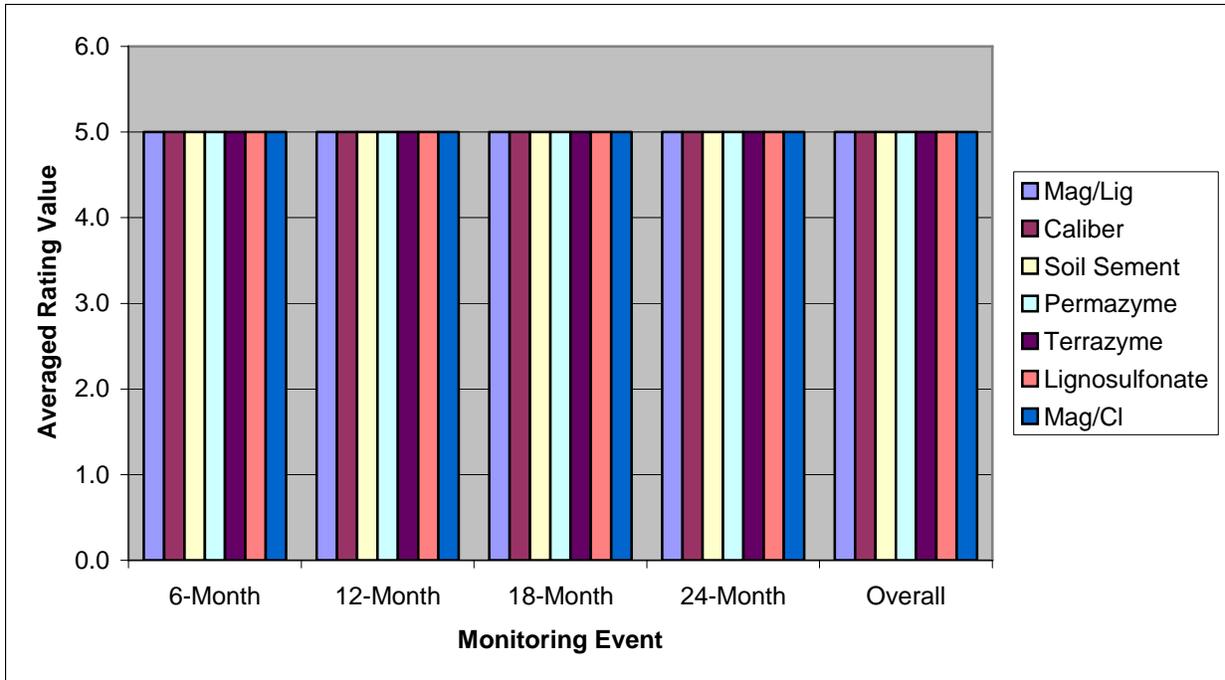
**Figure 15. Plot. Potholing values over time.**

As indicated by the data in Table 10 and plotted in Figure 15, no true potholing was observed. Therefore all products had similar relative performance over the entire 24-month monitoring period.

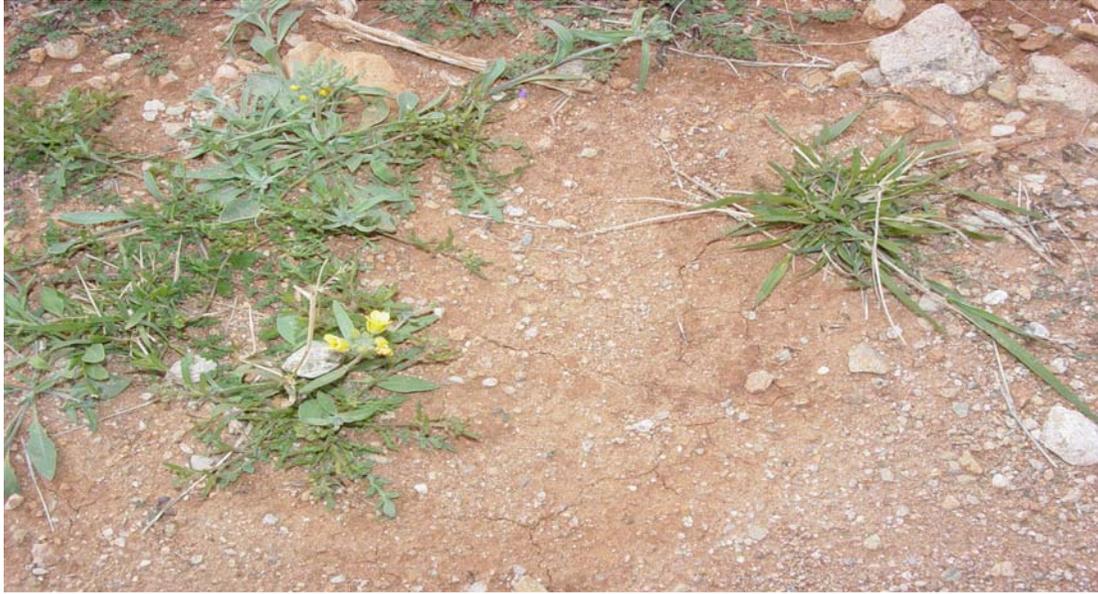
**Figure 16. Photo. Minor surface crusting as a result of leaching.**

In the 6-month monitoring event, minor leaching of soluble stabilizing material was evident in the Caliber Section II as shown in Figure 16. Most of what appeared to be leaching occurred as crusting in some low-lying areas. Rather than leaching, this appeared to be the result of the product over-application during installation. In subsequent monitoring events, there was no

visual evidence of leaching of soluble stabilizing material into the surrounding soils, nor did the earlier noted product appear to damage roadside vegetation.

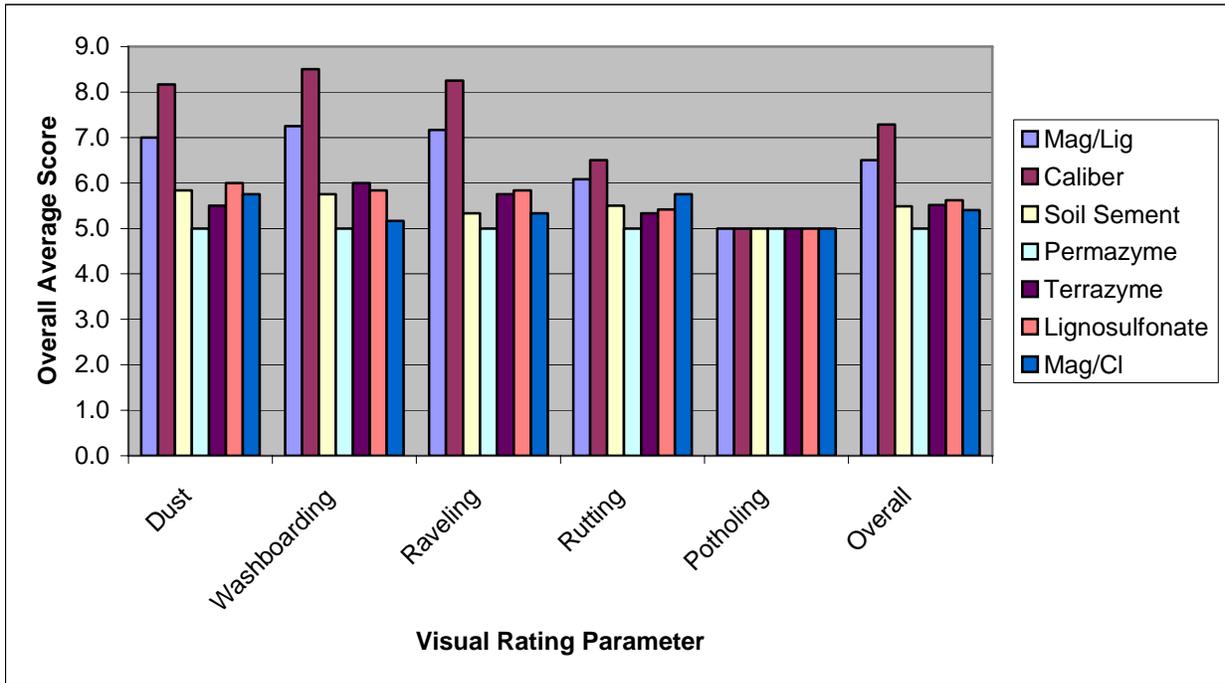
**Figure 17. Plot. Overall average scores for each parameter.**

From these average scores covering all parameters, three groups of product performance are evident. In the first group, one product, Caliber, performed the best overall. Second to this was the Mag/Lig product. The other products showed a fairly comparable relative performance and comprised the third group.

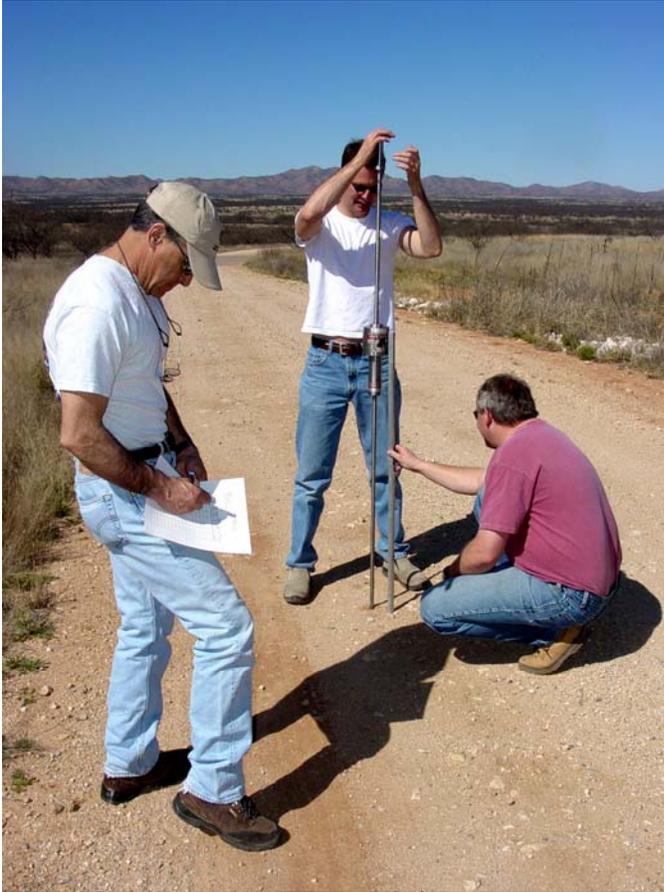
**Figure 18. Photo. Dynamic cone penetrometer testing.**

A Dynamic Cone Penetrometer (DCP) as shown in Figure 18 was used to evaluate the in situ strength of the treated soils. The evaluation team added this test procedure after the 6-month monitoring event. The DCP strength values were then used to estimate the California Bearing Ratio (CBR) or shear strength of the treated roadway material throughout its depth.

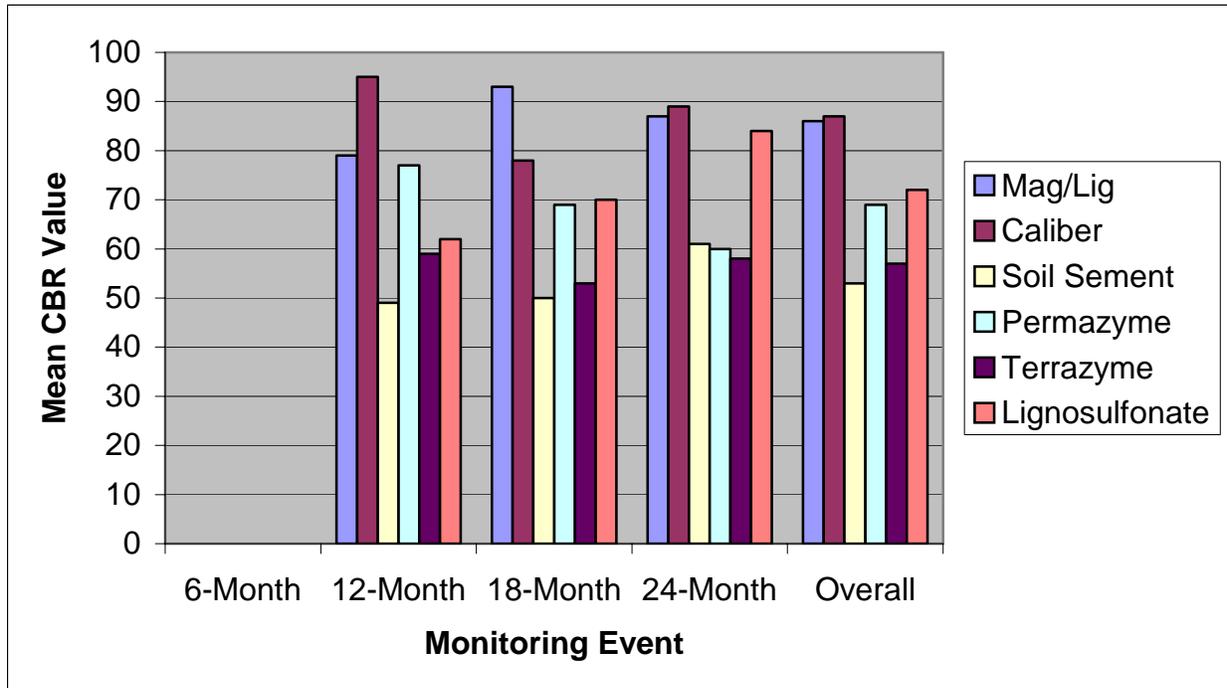
**Figure 19. Plot. Dynamic cone penetrometer testing.**

values from each event are summarized as one averaged CBR number in Table 16, and are plotted in Figure 19. No DCP measurements were taken in the Mag/Cl Section VII.

The evaluation team had hoped to see clear trends in the DCP data that showed how each product either maintained its stability over time, or more likely indicated a lessening of effectiveness. Unfortunately, the lack of a consistent trend in the overall data makes it difficult to draw conclusions about each specific product's performance over time. However, one observation that can be made is that the Caliber and Mag/Lig products consistently produced higher CBR values, while the Soil Sement and Terrazyme had the lowest. Even so, all CBR values were within a good to excellent range.

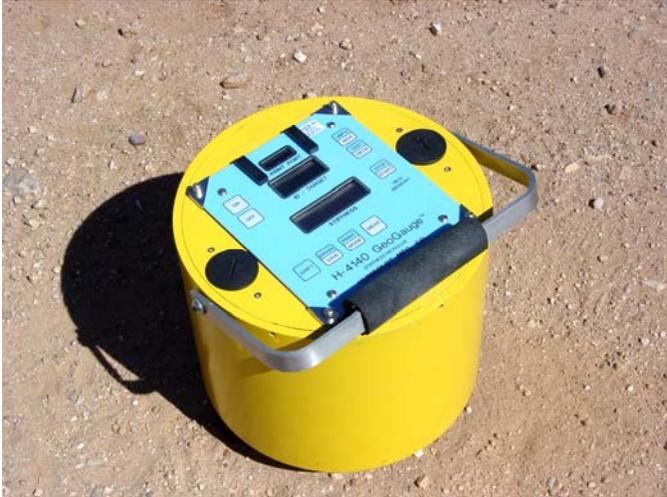
**Figure 20. Photo. Soil modulus testing device.**

The GeoGage as shown in Figure 20 is a non-nuclear non-destructive acoustic device that measures stiffness and modulus throughout the depth of a section rather than at discrete depths. The gauge generates a series of varying frequency impedance, or mechanical vibrations, which produce small changes in force that induce small deflections of the surface. The response measurements are then recorded as stiffness and modulus. Both stiffness and modulus values are produced for each single test and are related to each other mathematically. The GeoGage's stiffness and soil modulus can be related to soil density, thus providing a quality control method for construction. Because the GeoGage data can be related to density, it is tempting to compare

the relative standings of the products using GeoGage and Nuclear Gage results. Though little correlation exists, it must be acknowledged that far too little data from this project is available to study any correlation of these instruments.

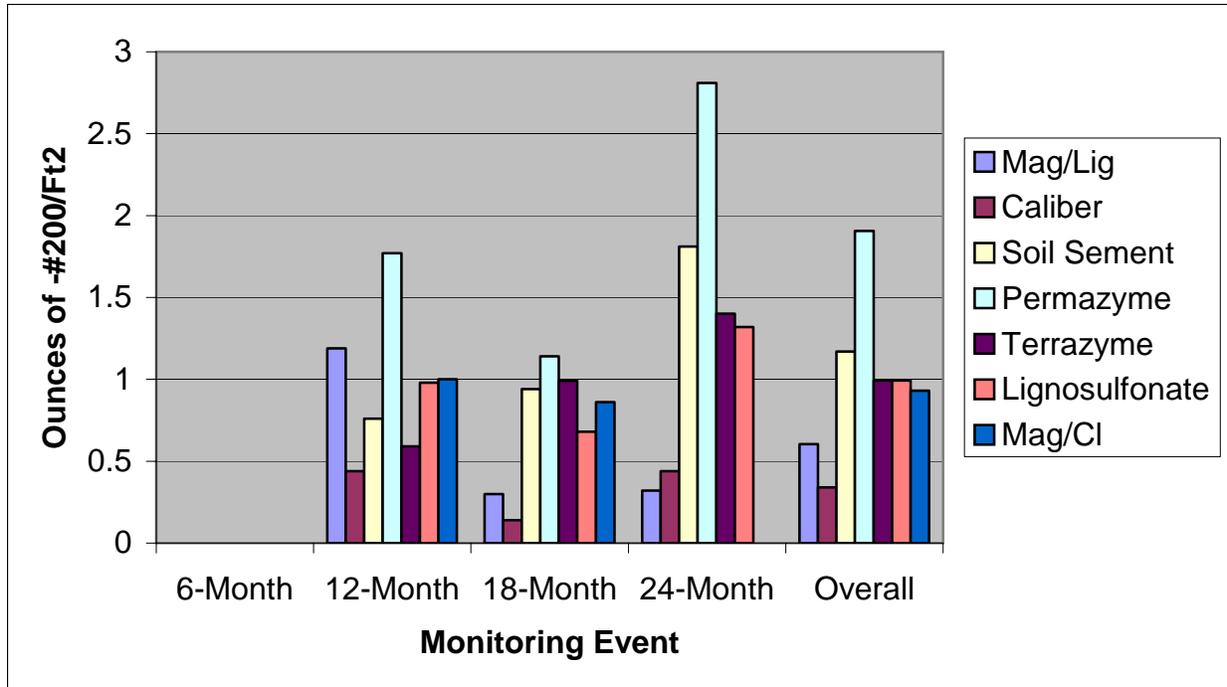
**Figure 22. Plot. Silt Loading tests.**

Once again three groups are evident based on the mean of the means. In the first group the products with the lowest silt loading value and therefore the least amount of material available for dust generation were the Caliber and the Mag/Lig. In the second group with somewhat higher silt loading values were the Soil Sement, Terrazyme, Lignosulfonate, and Mag/Cl. Only one product, Permazyme, was in the third group with the highest silt loading value. Unfortunately as indicated in Table 18, all of the products' mean of the means silt load values exceeded the maximum limit of  $0.1 \text{ kg/m}^2$  ( $0.33 \text{ oz/ft}^2$ ) set for stabilized material according to the 40 CFR method.
