**Initial Site Assessment
Bautista Canyon Road Project
Anza, California**

**Prepared for
County of Riverside
Transportation Department
4080 Lemon Street, 8th Floor
Riverside, CA 92501**

April 2002

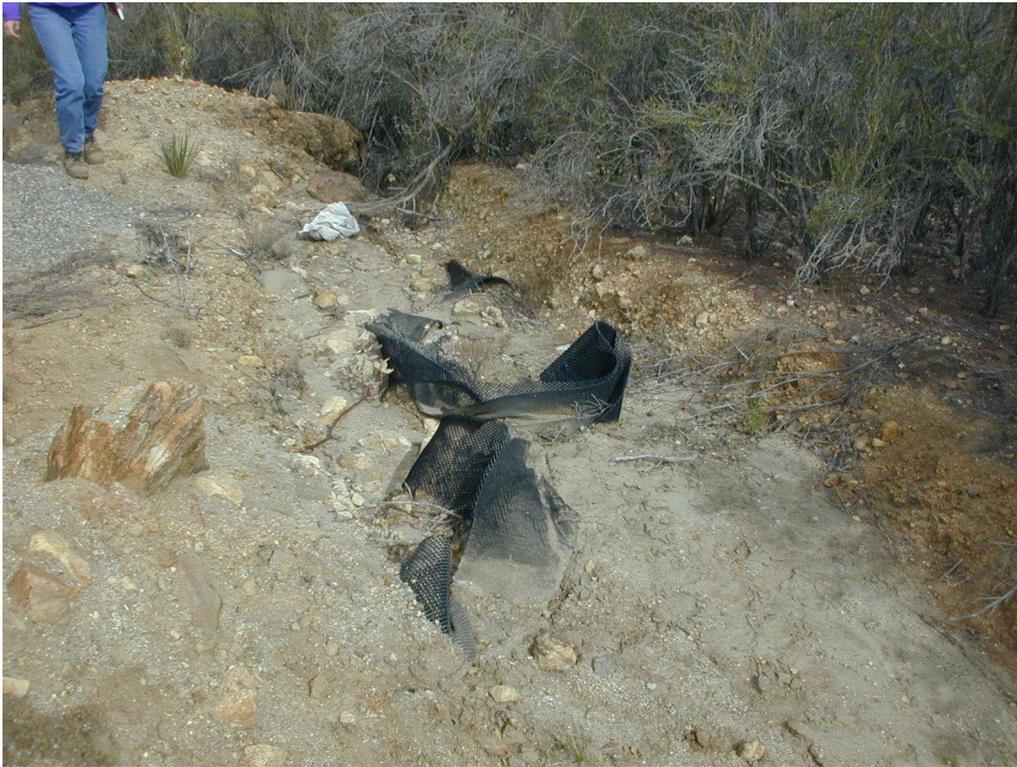
Photograph 1. View of east side of roadway looking at road washout. Evidence of erosion control (grapple fencing and a gravel pile) are in the background.

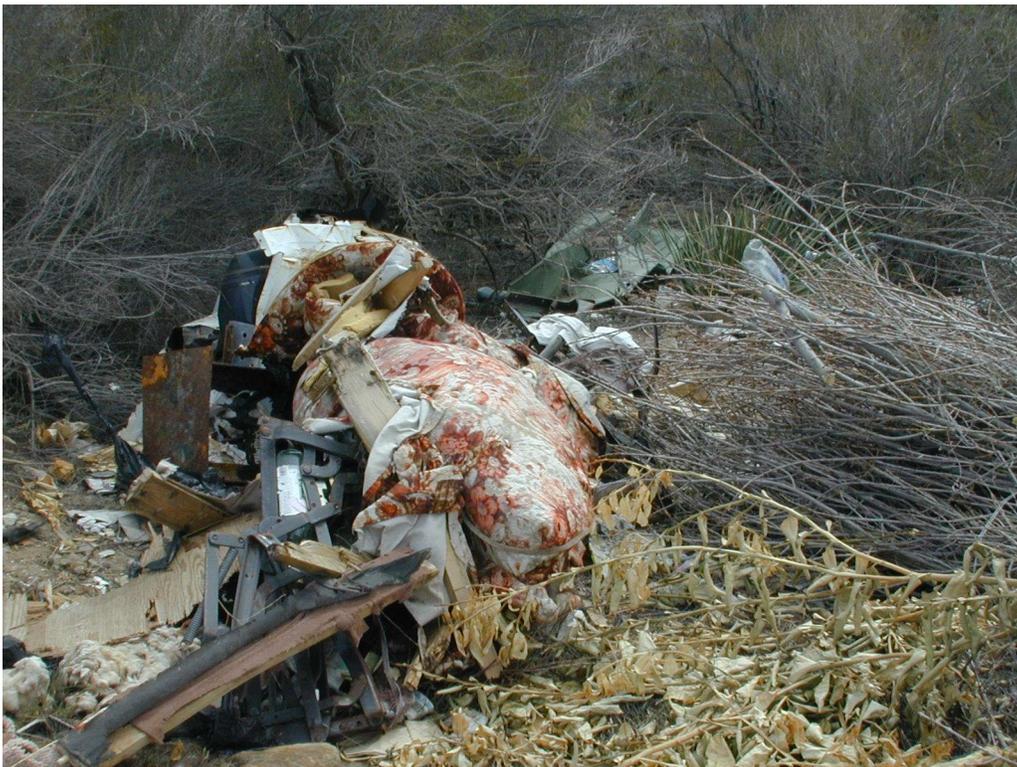
Photograph 2. View of west side of roadway looking at open dumping of furniture, scrap metal, and other trash. The dumping extends approximately 30 - 50 feet downhill westward and approximately 50 feet north along road.

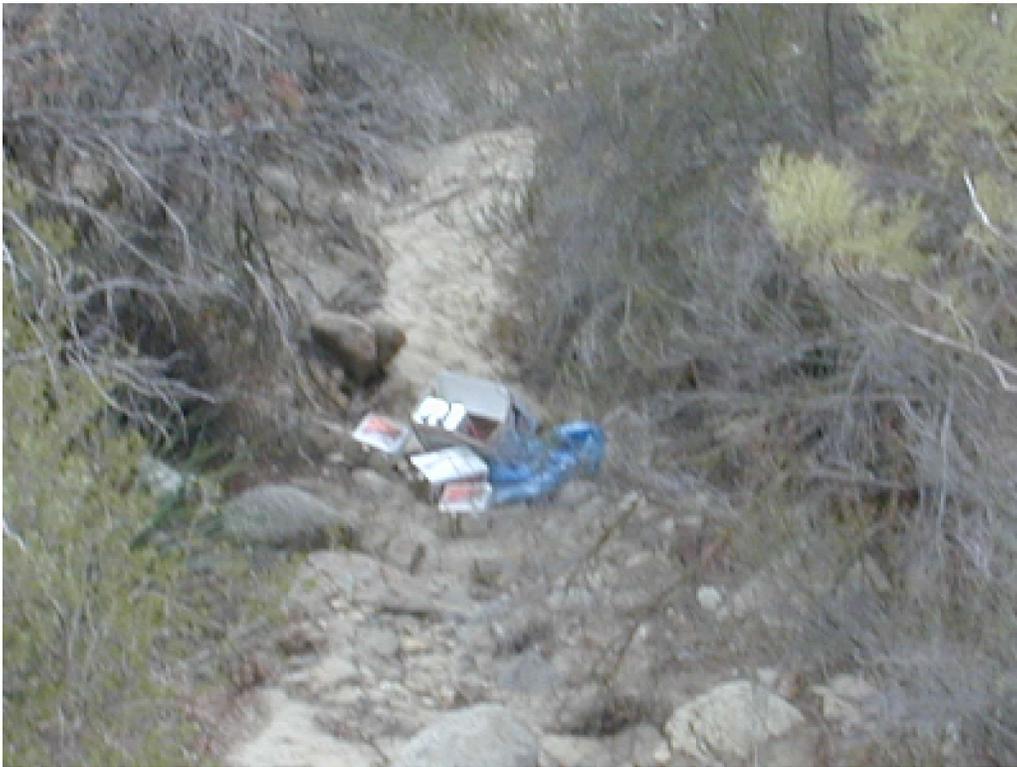
11.6	4 one-gallon metal de-natured alcohol containers dumped in culvert south of "main dump".	Photo 3
11.6	A white, powdery substance was observed to have leaked down the hillside towards the culvert.	Photo 4

Based on observations made during the site reconnaissance, evidence of potential hazardous substance and petroleum product release, and/or disposition was observed at several of the open dumping areas along the subject site including staining and burning. (See photographs 3, 7, 8, and 9, Appendix B)

Photograph 3. View of west side of roadway looking at 4 one-gallon metal denatured alcohol containers dumped in culvert south of "main dump" site.

Based on the site reconnaissance conducted during this ISA, AMEC recommends soil sampling and analysis be performed for the subject site in the areas where staining and burning was observed to further characterize the nature of the staining. Although there was no documentation of unauthorized releases or of existing hazardous substance or petroleum product contamination at the subject site, the evidence observed indicates the potential for contamination.

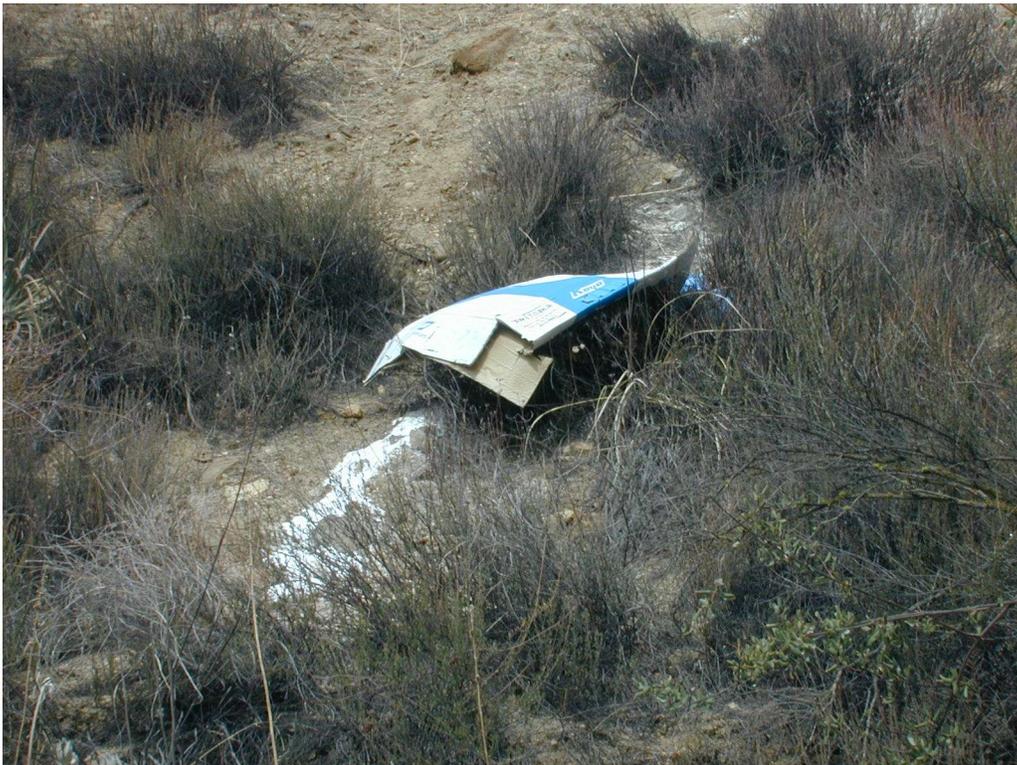
Photograph 4. View of west side of roadway looking northward. Evidence of a white, powdery substance that leaked down the hillside towards the culvert is seen in the foreground.

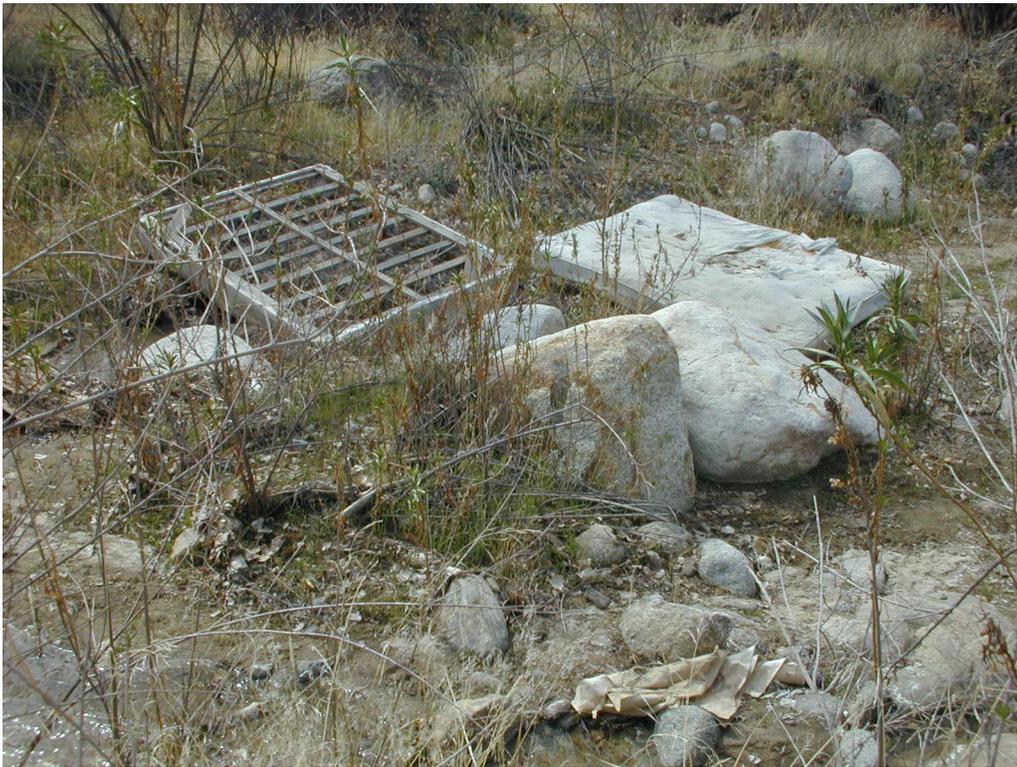
Photograph 5. View of west side of roadway looking at open dumping of a mattress and boxspring next to Bautista Creek.

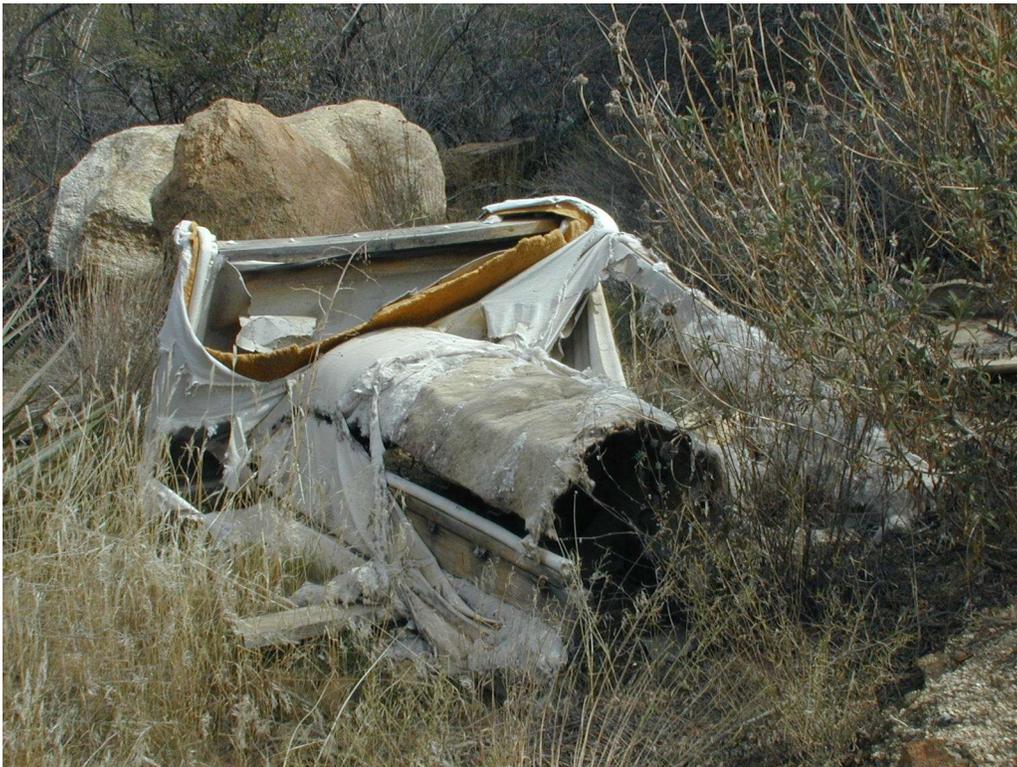
Photograph 6. View of east side of roadway. Evidence of open dumping (decomposing furniture) is seen in the foreground.

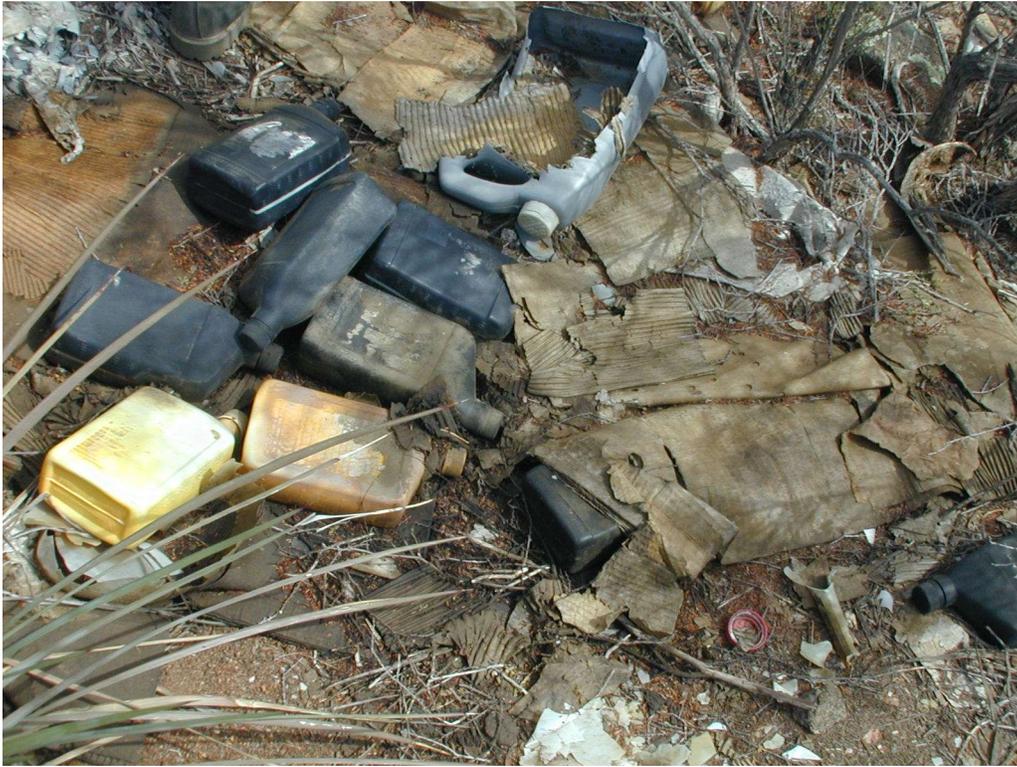
Milepost*	Observations	Photograph No.
12.5	Evidence of open dumping – approximately 15 quart-size motor oil containers, 5 1-gallon antifreeze containers – on east side of roadway. Also evidence of open burning within the same area.	Photo 7 through Photo 9

Photograph 7. View of area approximately 40 feet in from the east side of roadway. Evidence of open dumping of motor oil and antifreeze containers is seen in the background. Evidence of open burning is also seen within the same area.

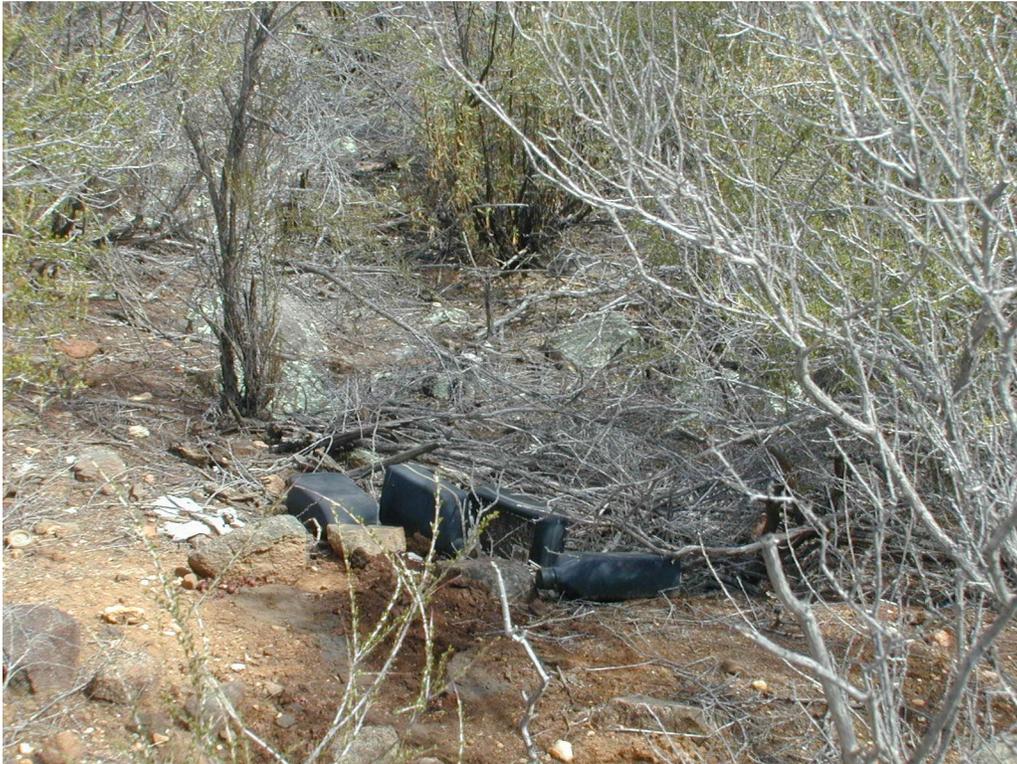
Photograph 8. View of same site as above showing open dumping of empty motor oil containers.

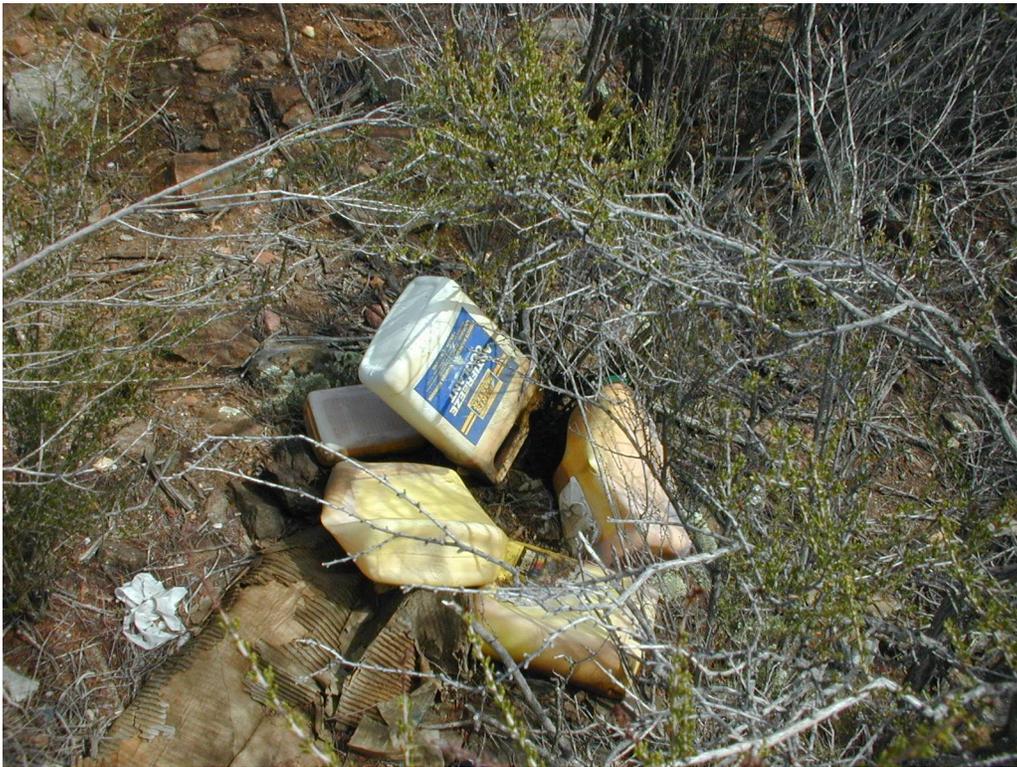
Photograph 9. View of same site as photographs 7 and 8, looking closer at containers and area of open burning.

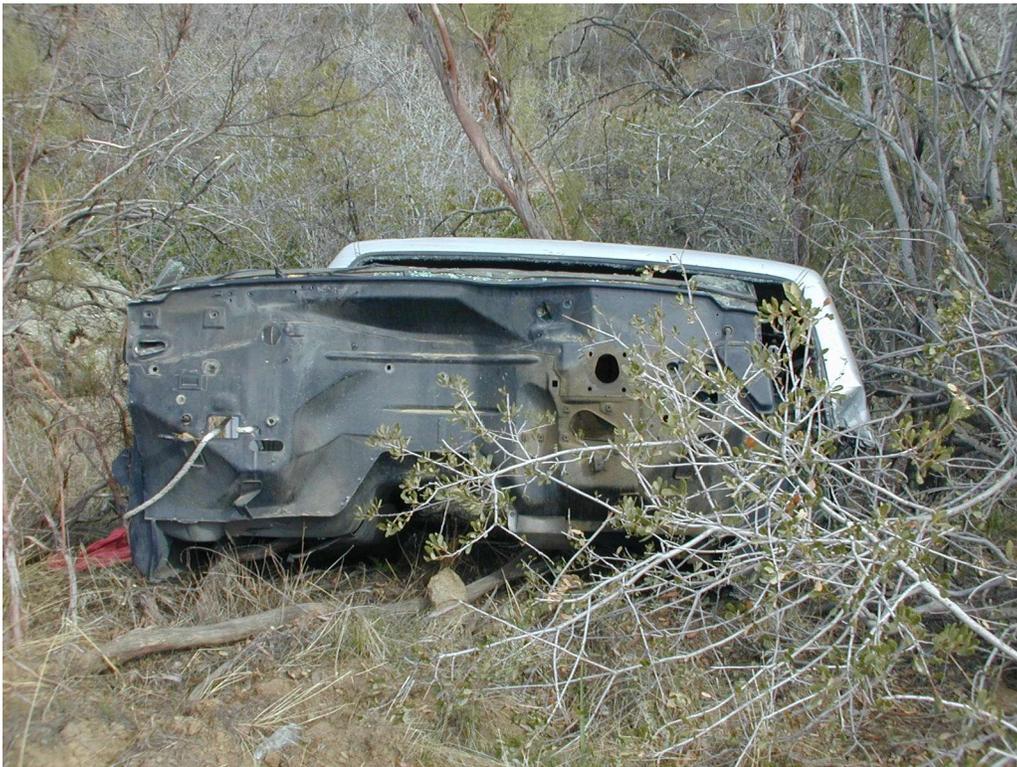
Photograph 10. View of east side of roadway looking at open dumping of trash and the front end of an automobile.

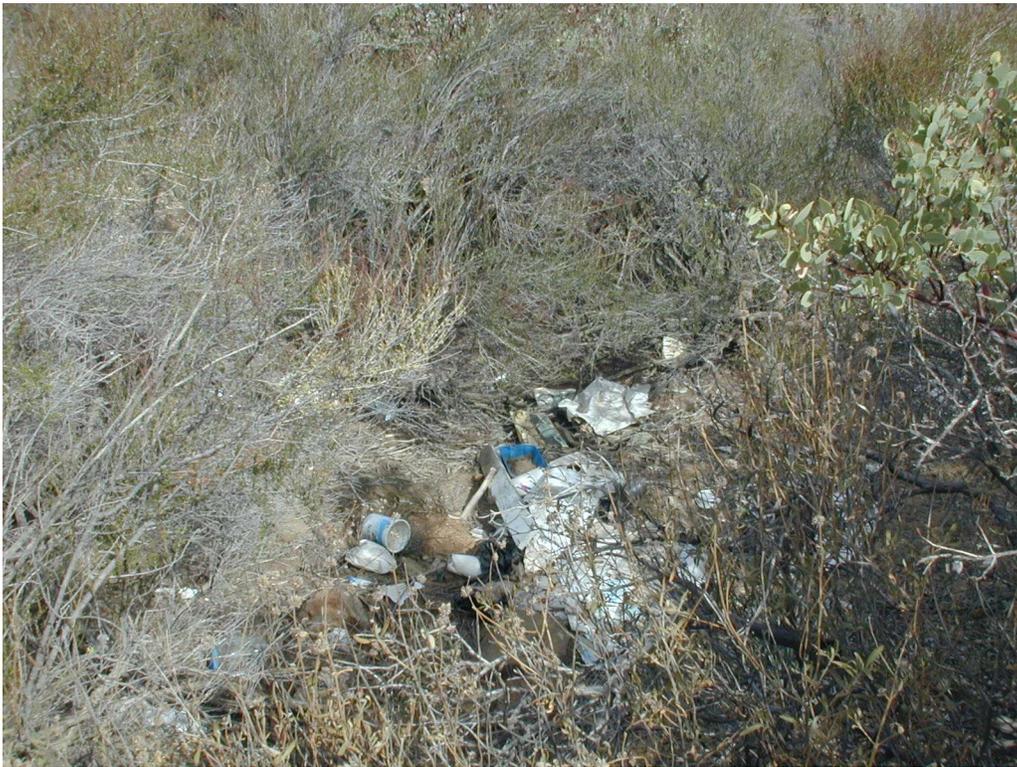
Photograph 11. View of east side of roadway looking at evidence of open dumping of trash such as empty containers and cardboard.

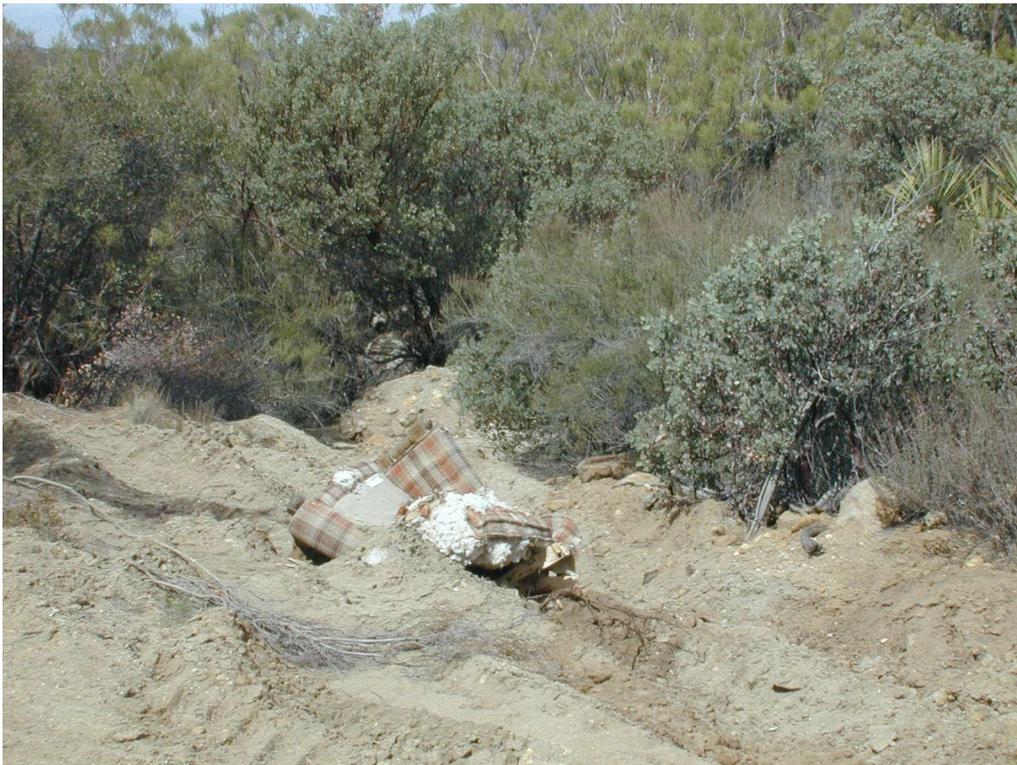
Photograph 12. View of a dumped chair along east side of roadway.

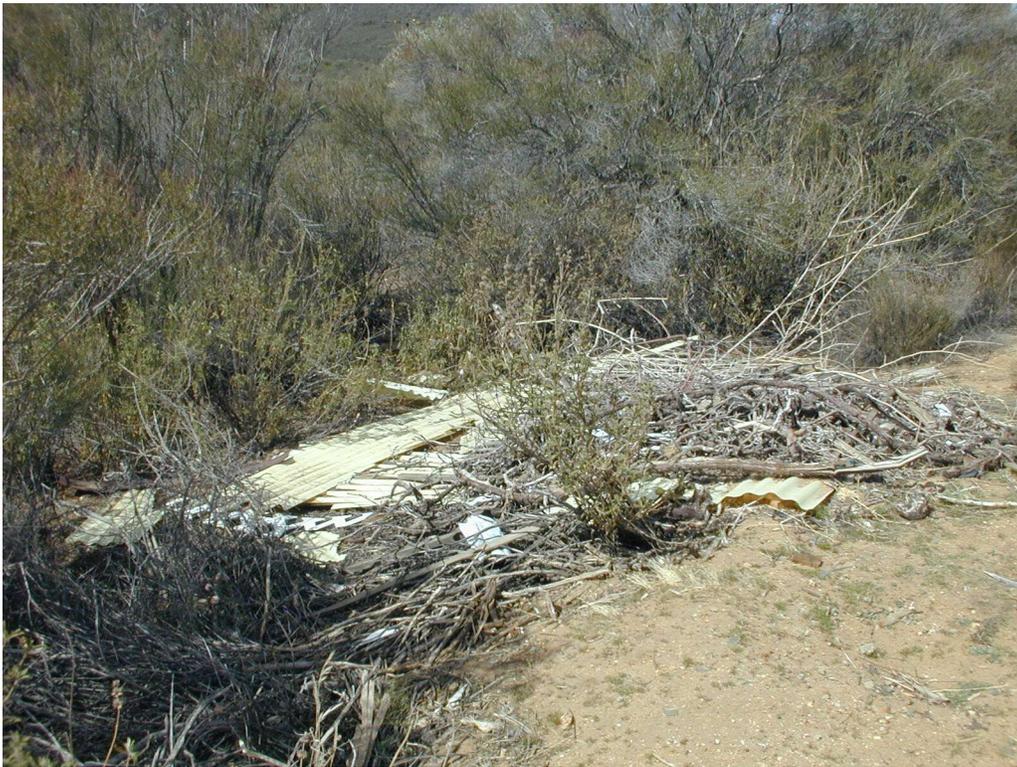
Photograph 13. View of east side of roadway. Evidence of open dumping (futon couch, household wastes, paint cans, motor oil containers, and miscellaneous debris) is seen in background.

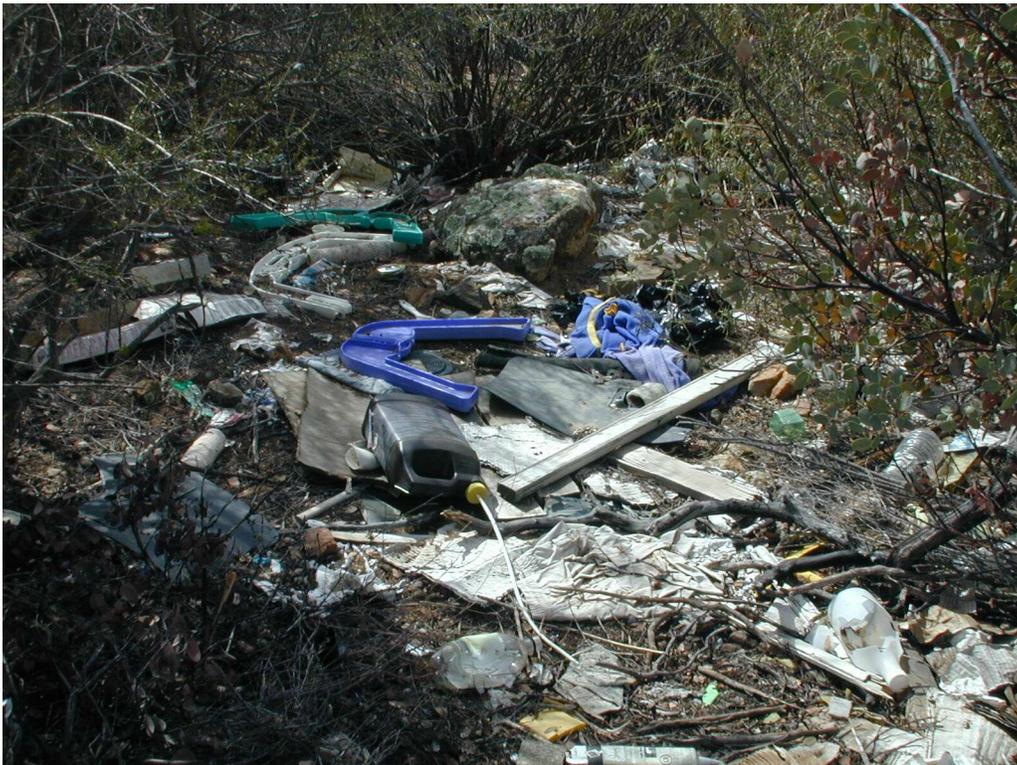
Photograph 14. View of same site as above looking closer at the evidence of open dumping of empty containers, furniture, and household waste.

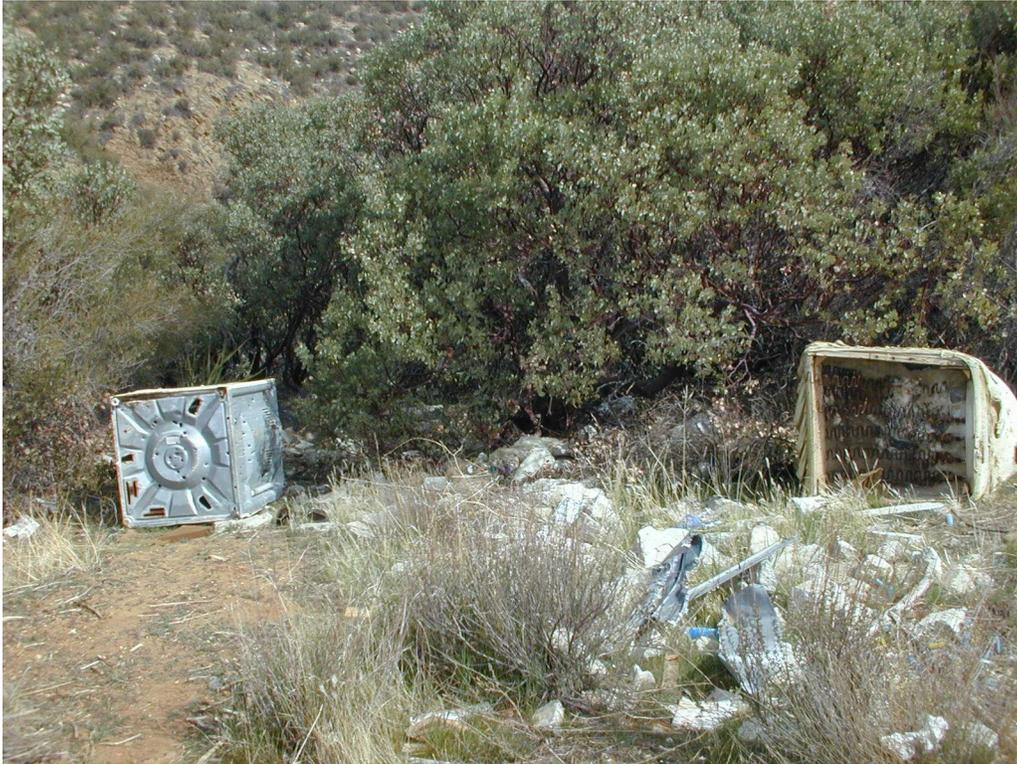
Photograph 15. View of portion of the site seen in photographs 13 and 14. Evidence of open dumping of a washer and dryer is seen in the background.

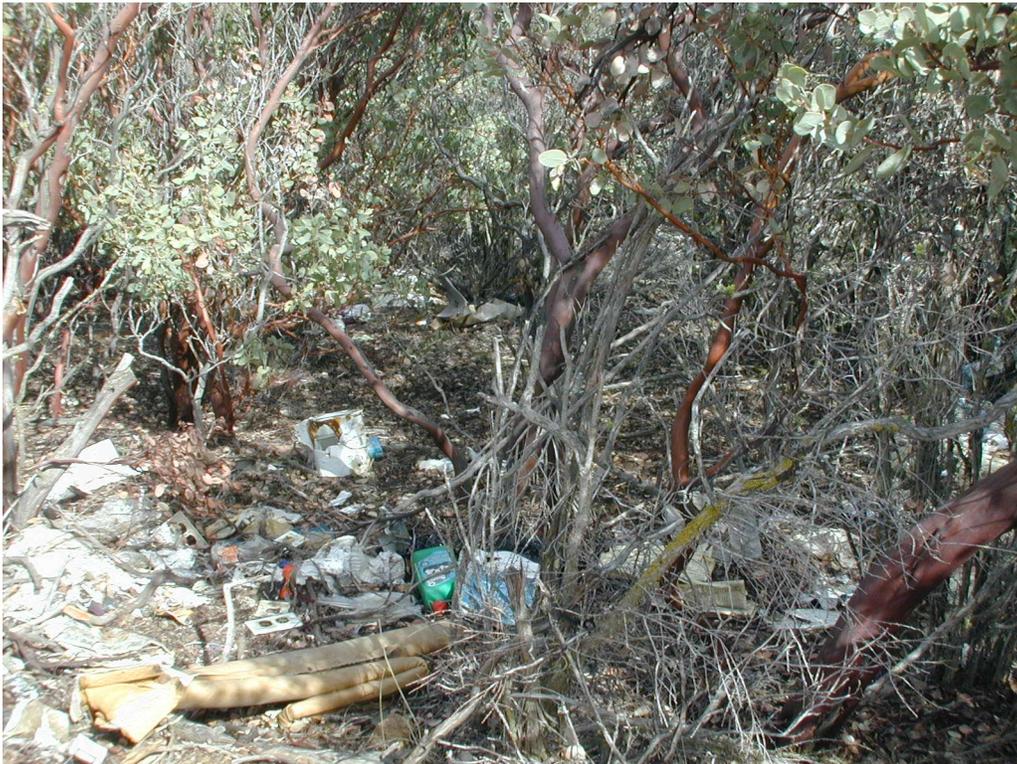
Photograph 16. View of site seen in photographs 13 through 15 looking at the evidence of open dumping of furniture, paint cans, motor oil cans, household waste, and miscellaneous debris is seen in the foreground.

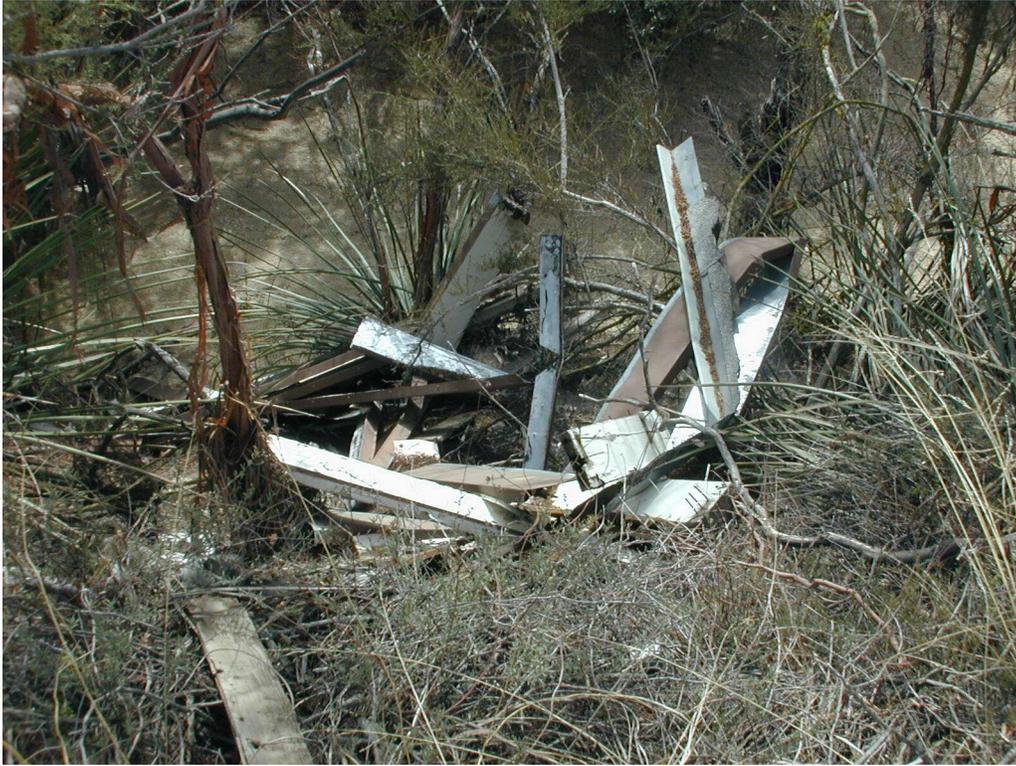
Photograph 17. View of west side of roadway. Evidence of open dumping of house gutters, box with used filters, and miscellaneous debris is seen in the background.
