The Road Inventory of Chamizal National Memorial CHAM - 7210

Road Inventory Program

Prepared By:
Federal Highway Administration
Eastern Federal Lands Highway Division
Cycle 3

Chamizal National Memorial
in
Texas

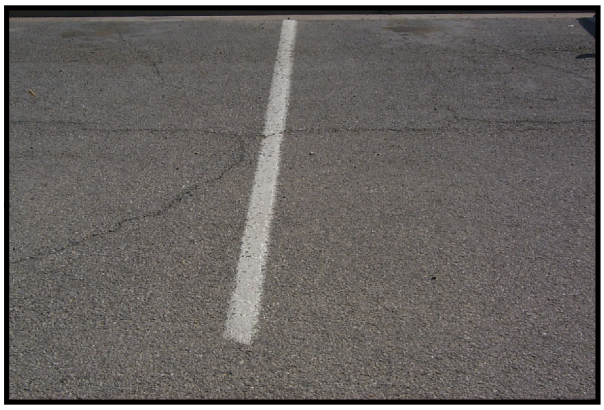
Route	Public / NonPublic	Date Visited	Area (sq ft)	Lane Miles *	Surface Type	Condition / PCR
0900	Public	3/4/2003	83166	1.43	AS	FAIR / 73
