The Road Inventory of Fort Davis National Historic Site FODA – 7220

Road Inventory Program

Prepared By:
Federal Highway Administration
Eastern Federal Lands Highway Division
Cycle 3

Fort Davis National Historic Site
in
Texas

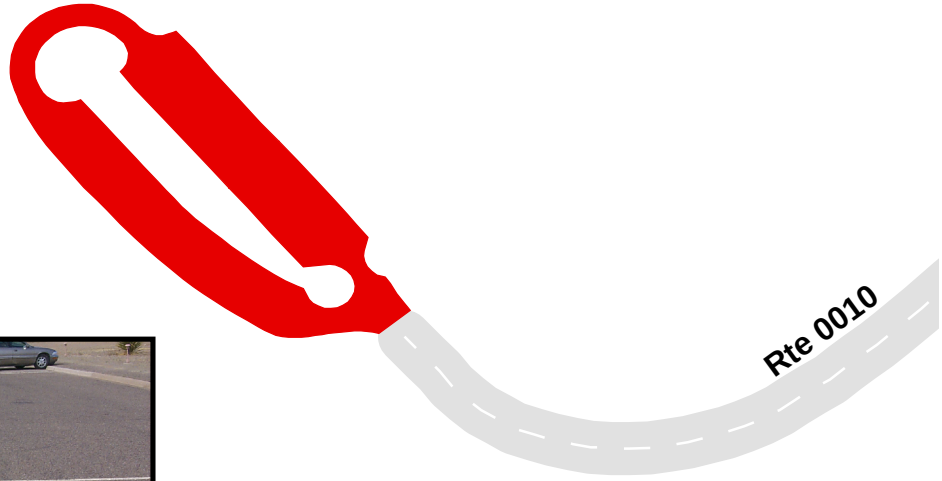
Route	Public / NonPublic	Date Visited	Area (sq ft)	Lane Miles *	Surface Type	Condition / PCR
0900	Public	3/1/2003	35893	0.62	AS	GOOD / 90

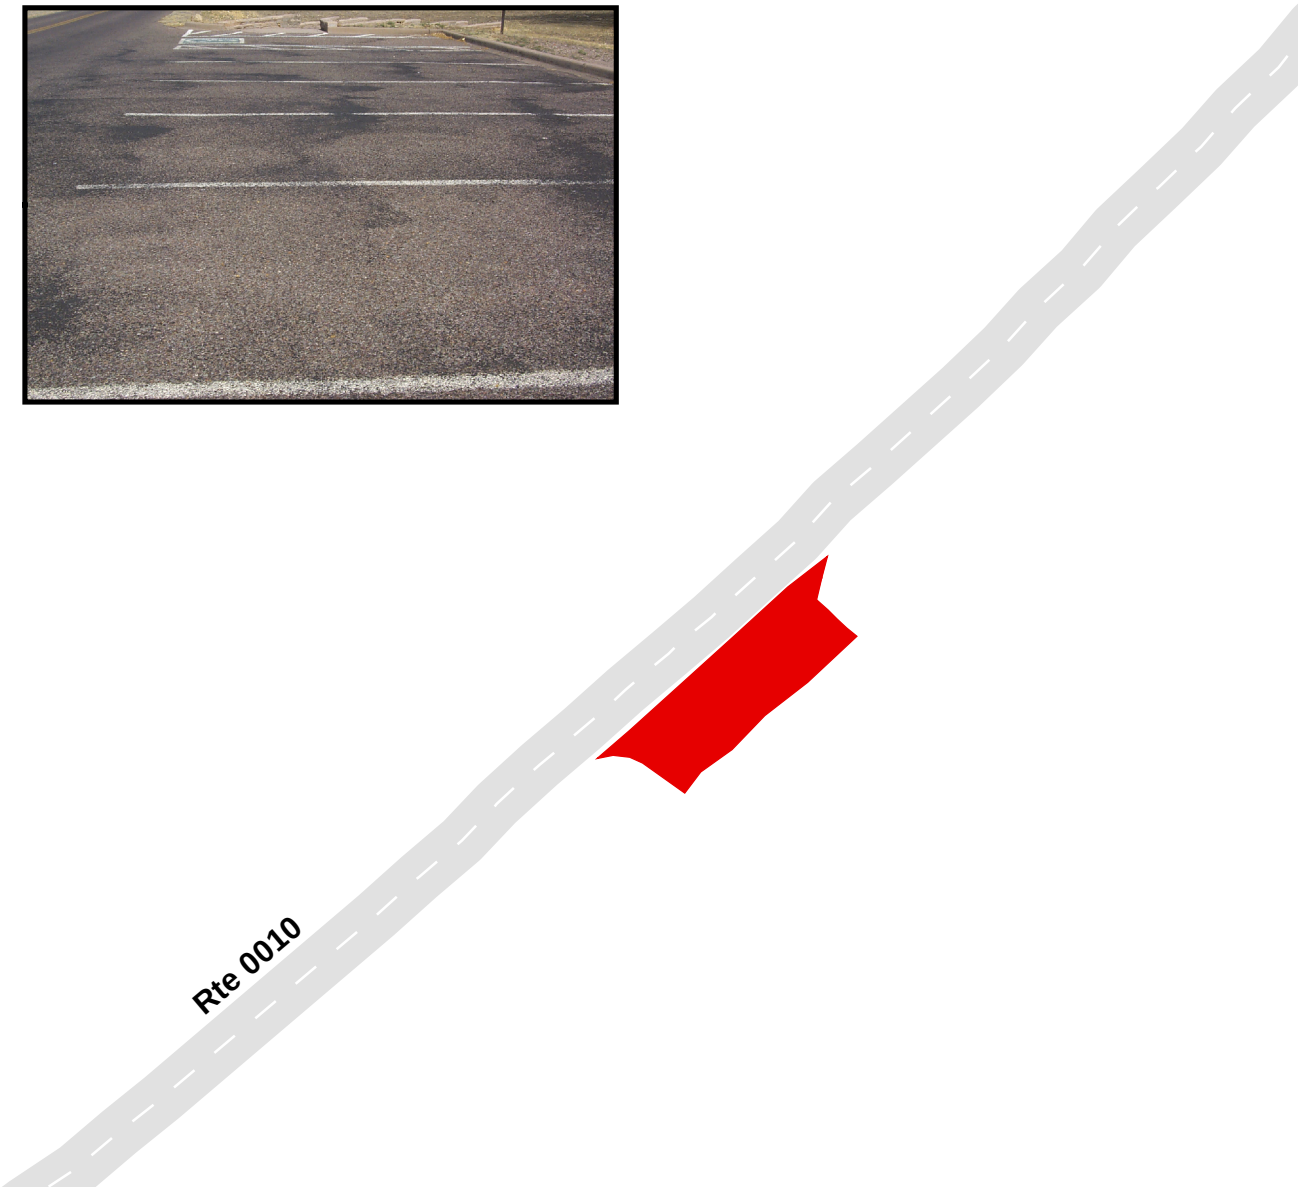
Route	Public / NonPublic	Date Visited	Area (sq ft)	Lane Miles *	Surface Type	Condition / PCR
0904	Public	3/1/2003	1835	0.03	AS	GOOD / 90
