The Road Inventory of Guadalupe Mountains National Park GUMO - 7180

Road Inventory Program

Prepared By:
Federal Highway Administration
Eastern Federal Lands Highway Division
Cycle 3

Guadalupe Mountains National Park
in
Texas

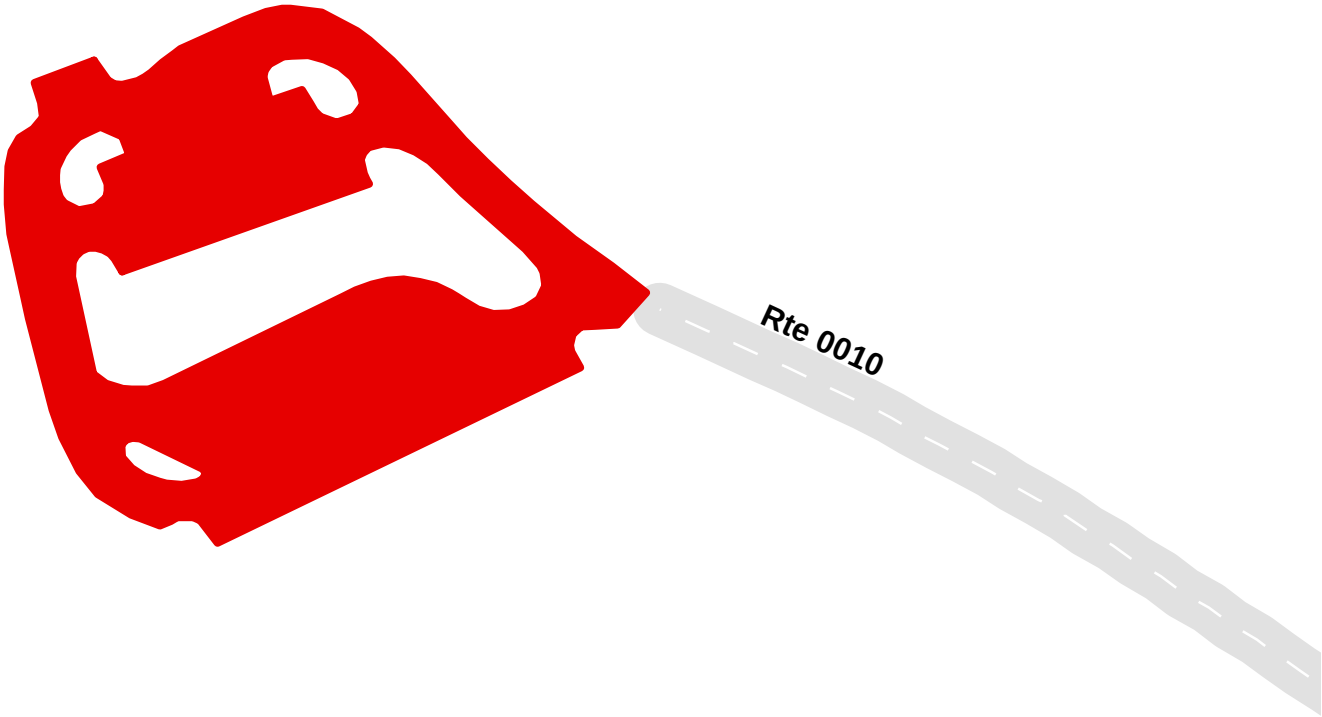
Route	Public / NonPublic	Date Visited	Area (sq ft)	Lane Miles *	Surface Type	Condition / PCR
0900	Public	3/3/2003	53082	0.91	OC	GOOD / 90

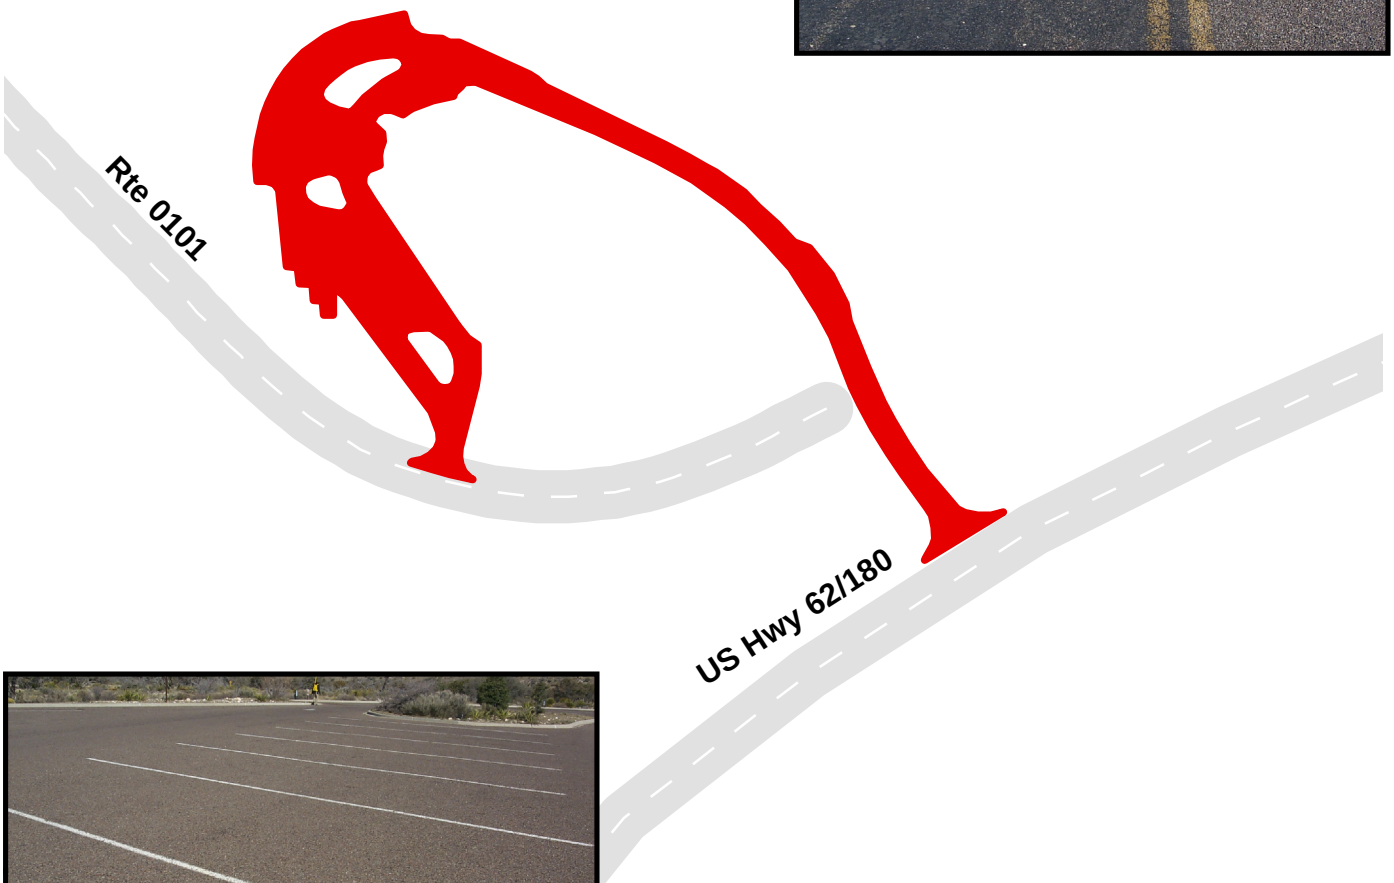
Route	Public / NonPublic	Date Visited	Area (sq ft)	Lane Miles *	Surface Type	Condition / PCR
0903	Public	3/3/2003	68028	1.17	OC	GOOD / 90

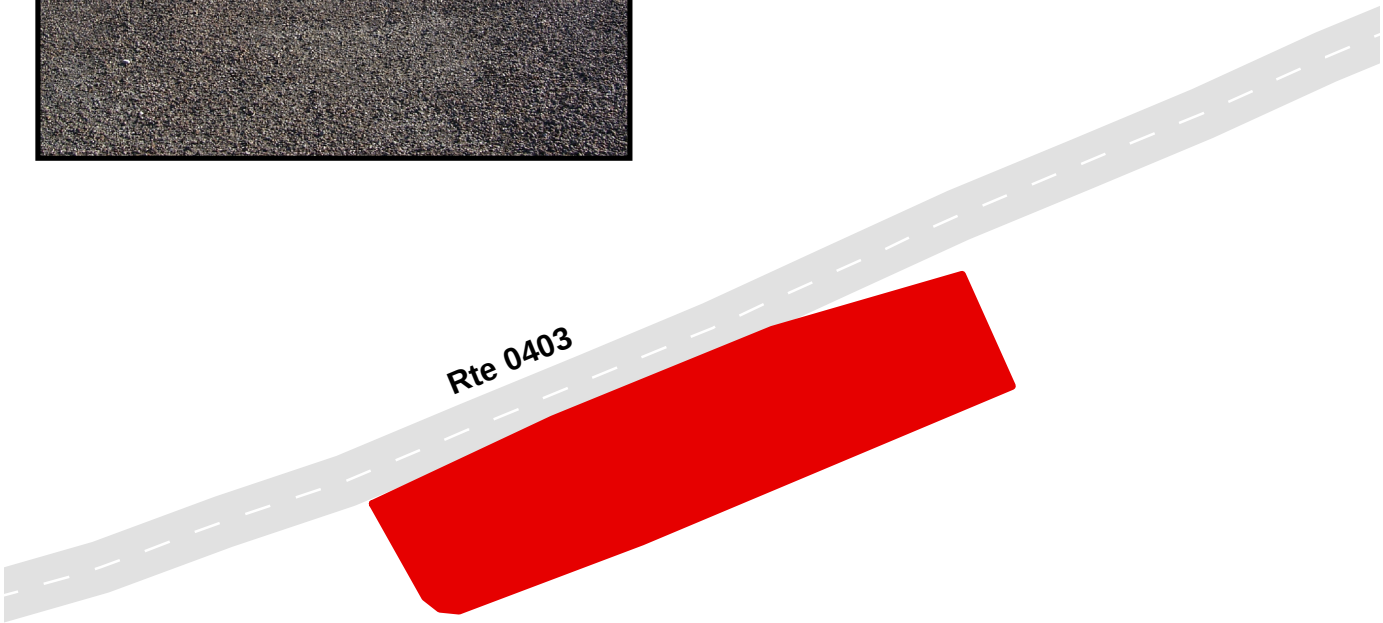
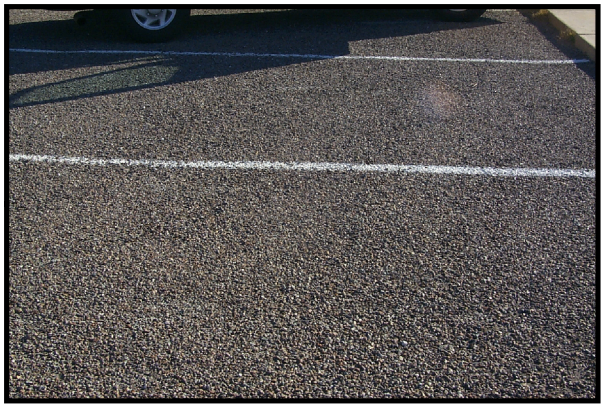
Guadalupe Mountains National Park
Route 0913
RESIDENCE ROAD PARKING
From Route 0403

Route	Public / NonPublic	Date Visited	Area (sq ft)	Lane Miles *	Surface Type	Condition / PCR
0913	NonPublic	3/3/2003	1377	0.02	OC	GOOD / 90
