The Road Inventory
of
Lyndon B. Johnson
National Historical Park
LYJO - 7350

Road Inventory Program

Prepared By:
Federal Highway Administration
Eastern Federal Lands Highway Division
Cycle 3

Lyndon B. Johnson National Historical Park
in
Texas

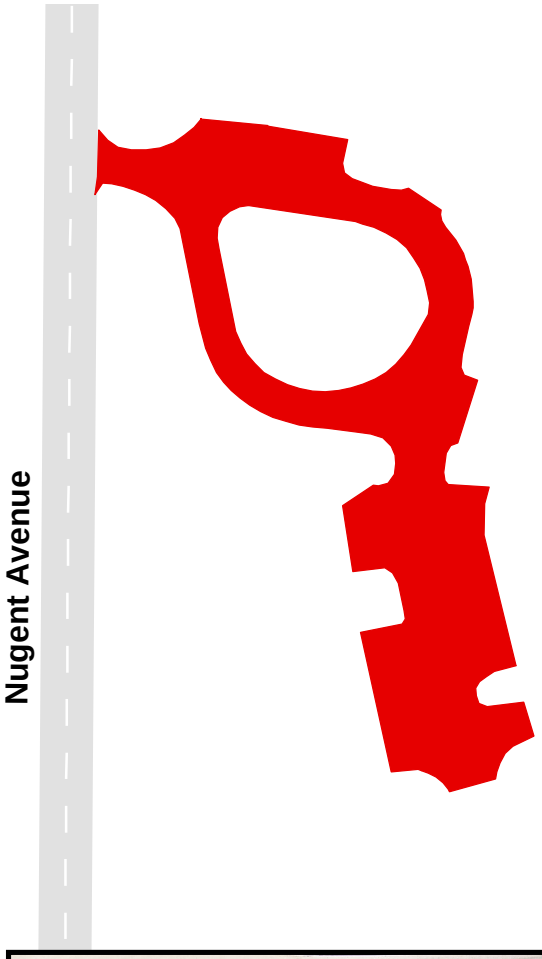
Route	Public / NonPublic	Date Visited	Area (sq ft)	Lane Miles *	Surface Type	Condition / PCR
0901	NonPublic	12/17/2001	13678	0.24	AS	GOOD / 90

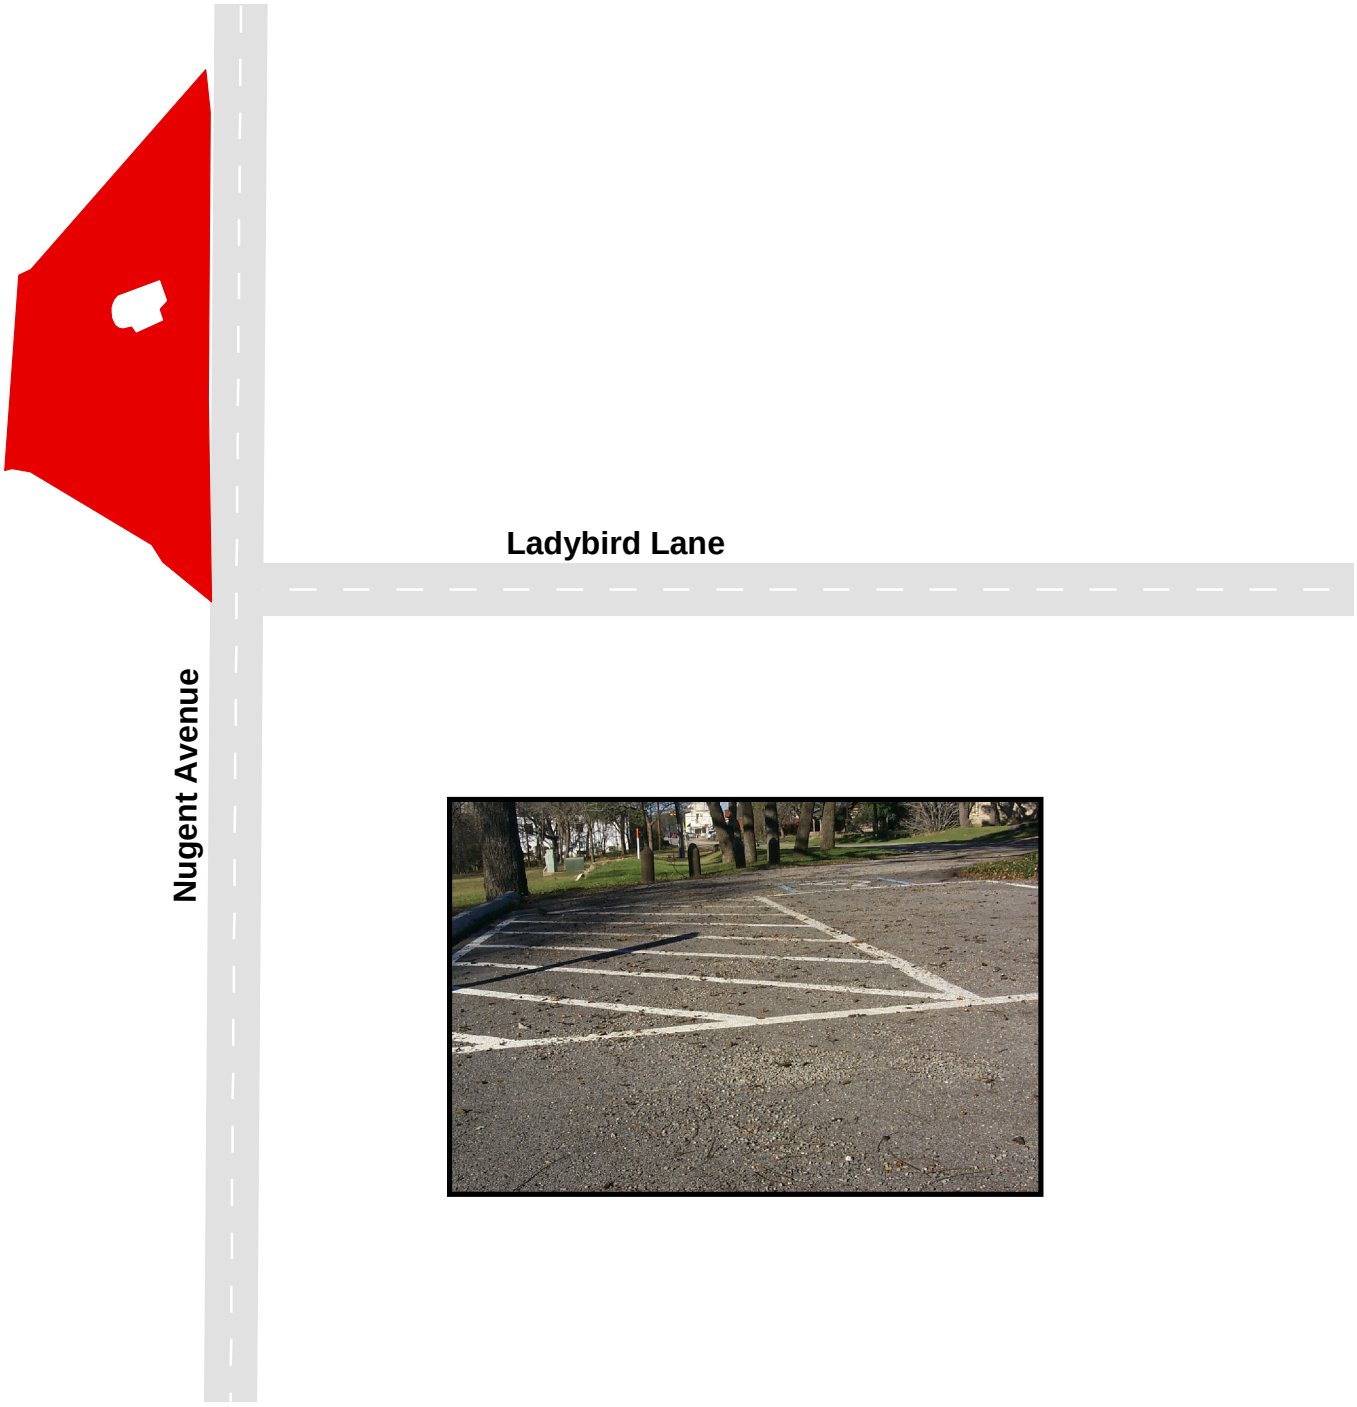
Lyndon B. Johnson National Historical Park
Route 0904
VISITOR CENTER BUS PARKING
From Ladybird Lane

Route	Public / NonPublic	Date Visited	Area (sq ft)	Lane Miles *	Surface Type	Condition / PCR
0904	NonPublic	12/17/2001	1730	0.03	CO	EXCELLENT / 97

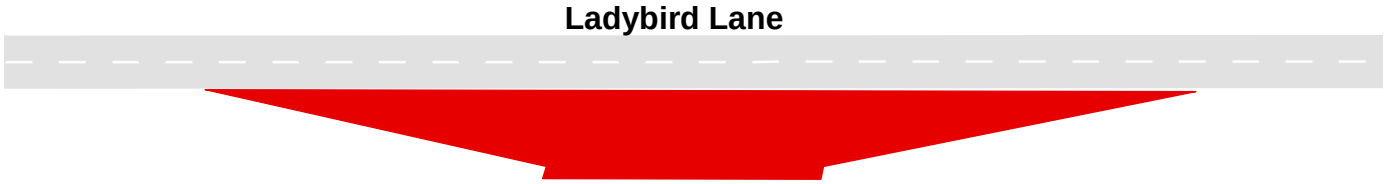
Lyndon B. Johnson National Historical Park
Route 0905
CEMETERY PARKING
From Route 0400

Route	Public / NonPublic	Date Visited	Area (sq ft)	Lane Miles *	Surface Type	Condition / PCR
0905	Public	12/18/2001	9773	0.17	AS	GOOD / 90

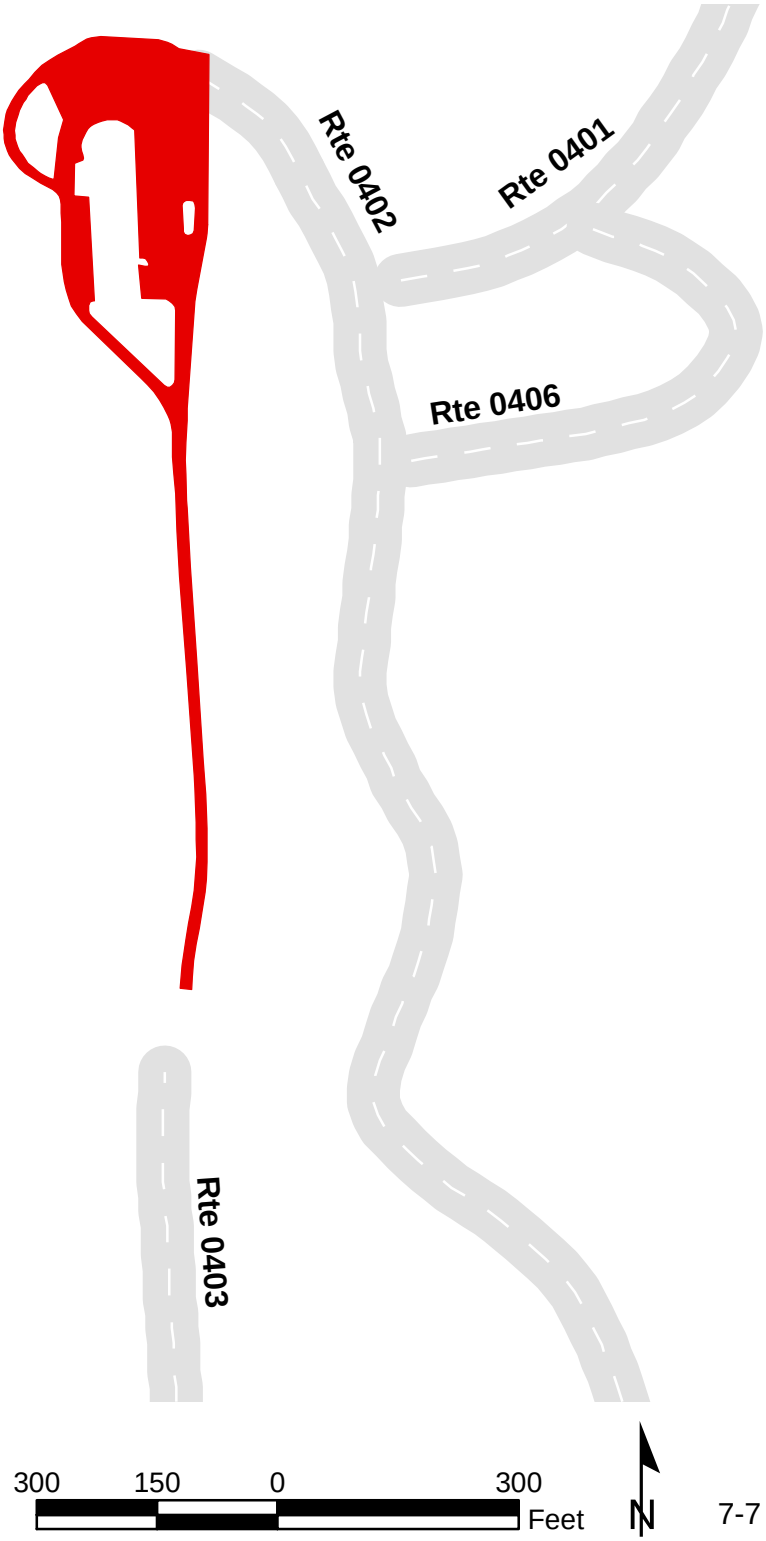
Route	Public / NonPublic	Date Visited	Area (sq ft)	Lane Miles *	Surface Type	Condition / PCR
0907	NonPublic	12/18/2001	53309	0.92	AS	FAIR / 73
