The Road Inventory
of
Padre Island National Seashore
PAIS - 7490

Road Inventory Program

Prepared By:
Federal Highway Administration
Eastern Federal Lands Highway Division
Cycle 3

Padre Island National Seashore
in
Texas

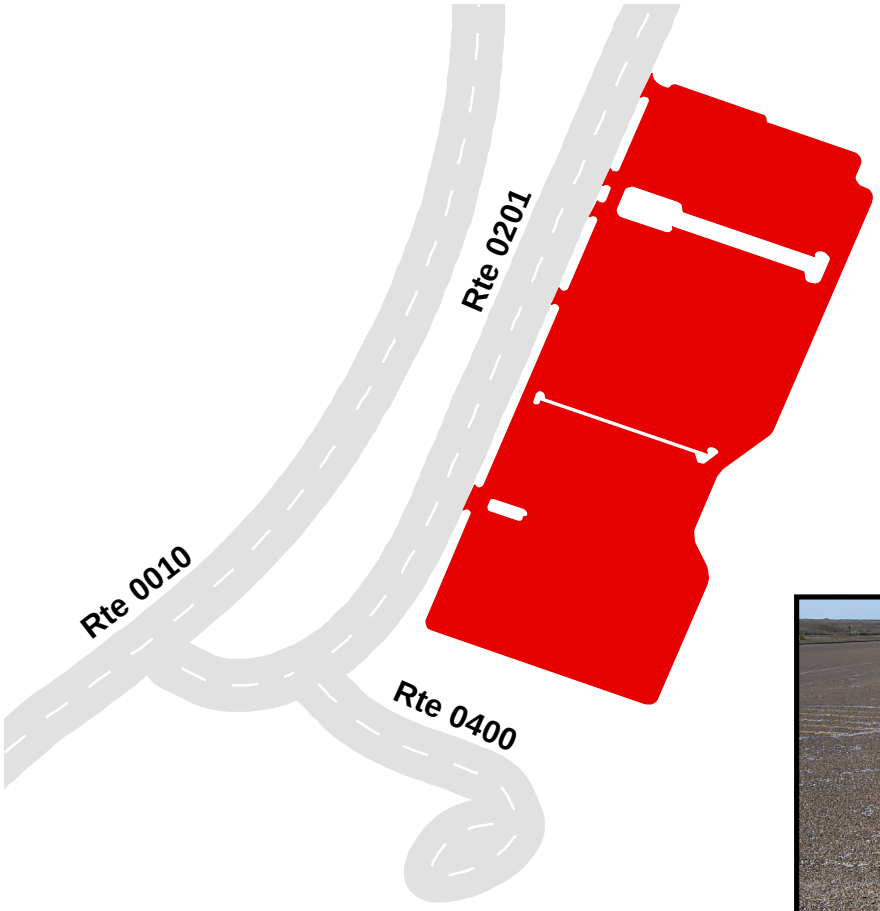
Route	Public / NonPublic	Date Visited	Area (sq ft)	Lane Miles *	Surface Type	Condition / PCR
0900	Public	1/8/2002	538213	9.27	NC	GOOD / 90

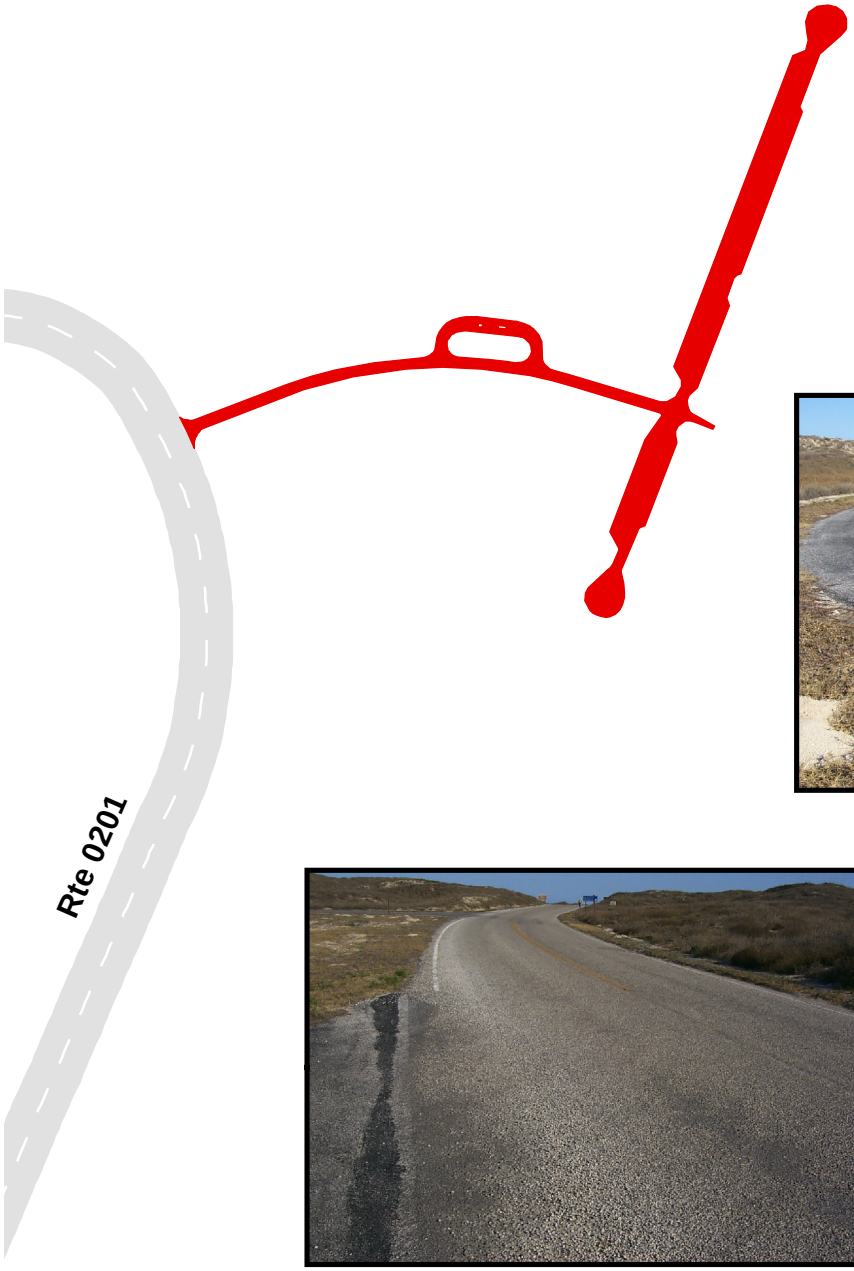
Route	Public / NonPublic	Date Visited	Area (sq ft)	Lane Miles *	Surface Type	Condition / PCR
0901	Public	1/8/2002	134590	2.32	NC	GOOD / 90

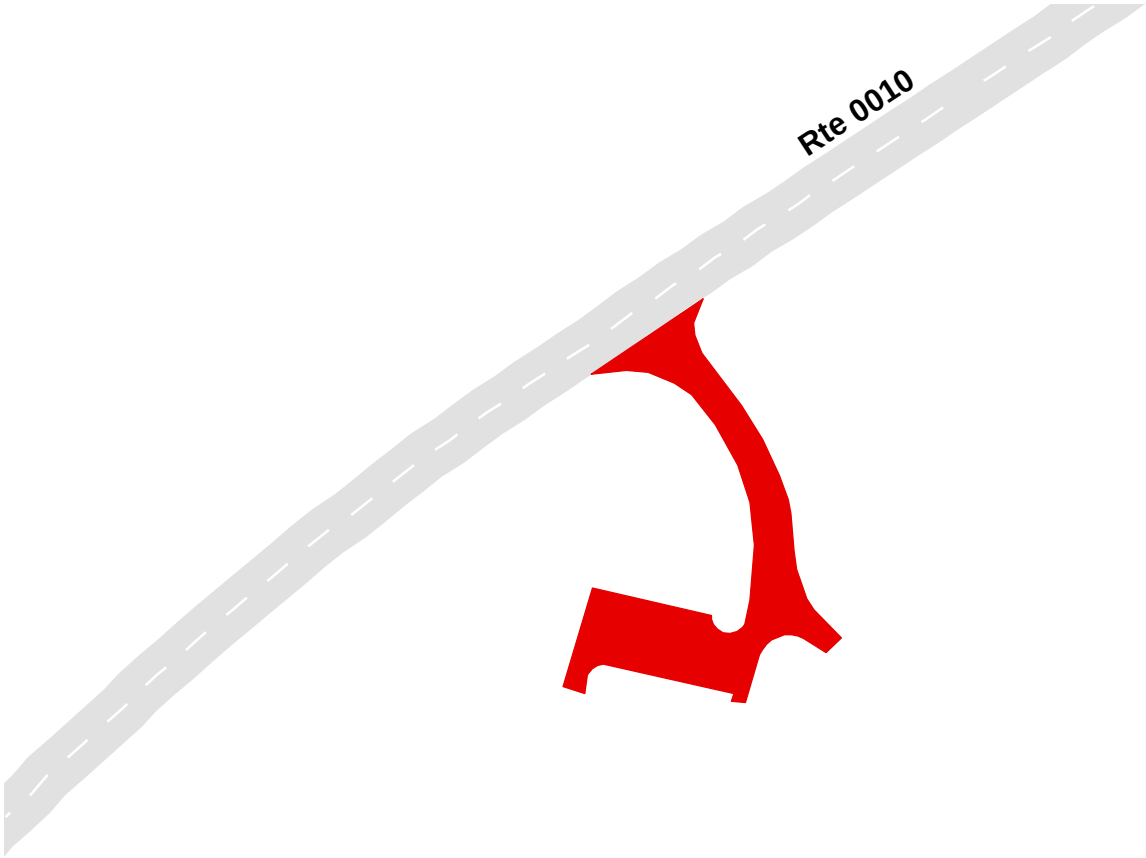
Route	Public / NonPublic	Date Visited	Area (sq ft)	Lane Miles *	Surface Type	Condition / PCR
0902	NonPublic	1/8/2002	14090	0.24	NC	GOOD / 90

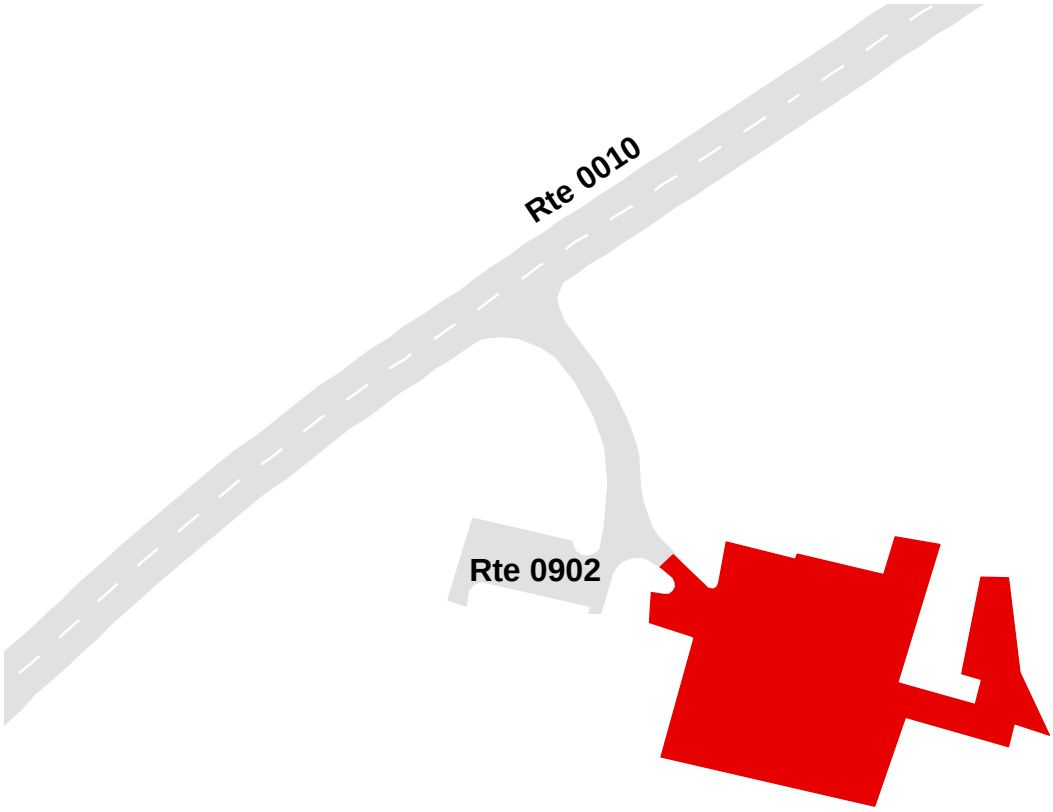
Route	Public / NonPublic	Date Visited	Area (sq ft)	Lane Miles *	Surface Type	Condition / PCR
0903	NonPublic	1/8/2002	43153	0.74	CO	EXCELLENT / 97

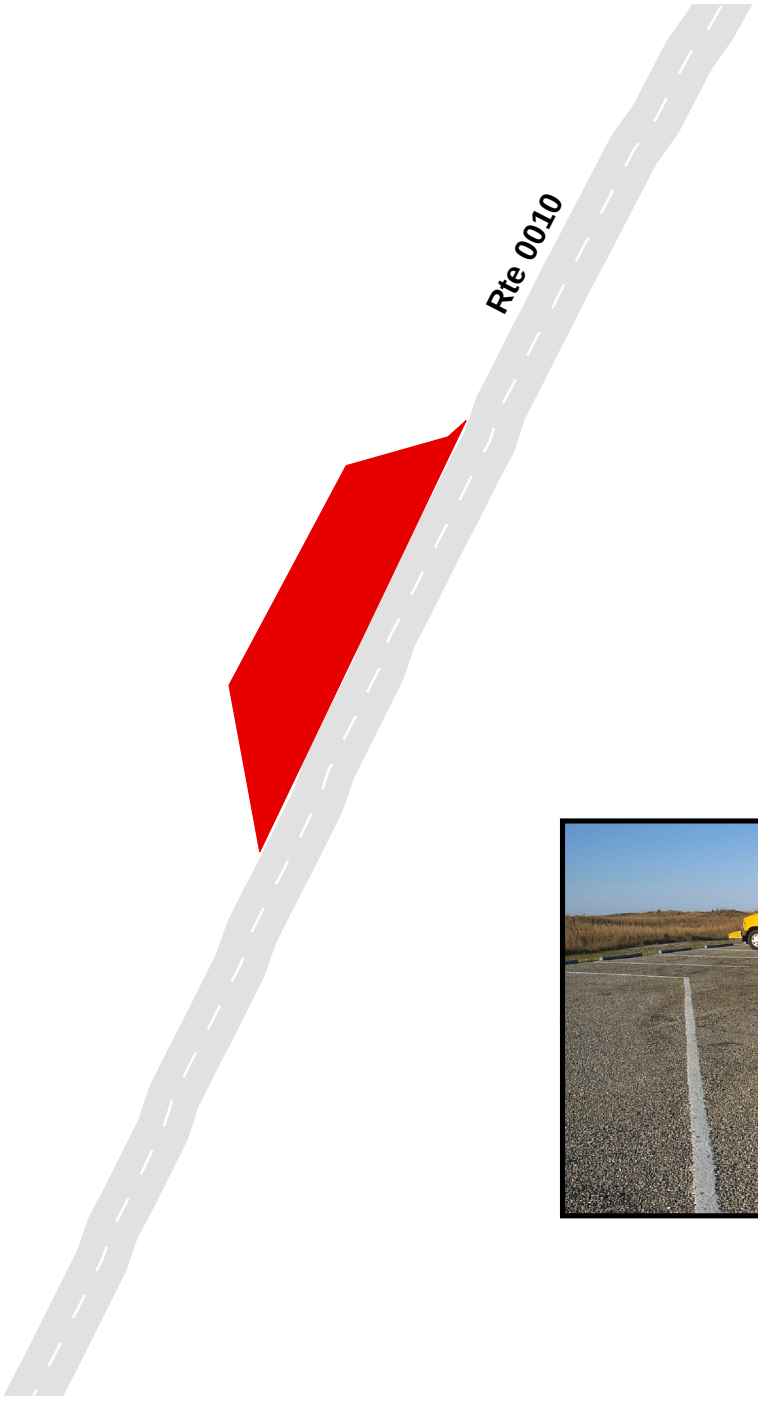
Route	Public / NonPublic	Date Visited	Area (sq ft)	Lane Miles *	Surface Type	Condition / PCR
0904	Public	1/8/2002	7527	0.13	NC	GOOD / 90
