The Road Inventory
of
San Antonio Missions National Historical Park
SAAN - 7600

Road Inventory Program

Prepared By:
Federal Highway Administration
Eastern Federal Lands Highway Division
Cycle 3

San Antonio Missions National Historical Park
in
Texas

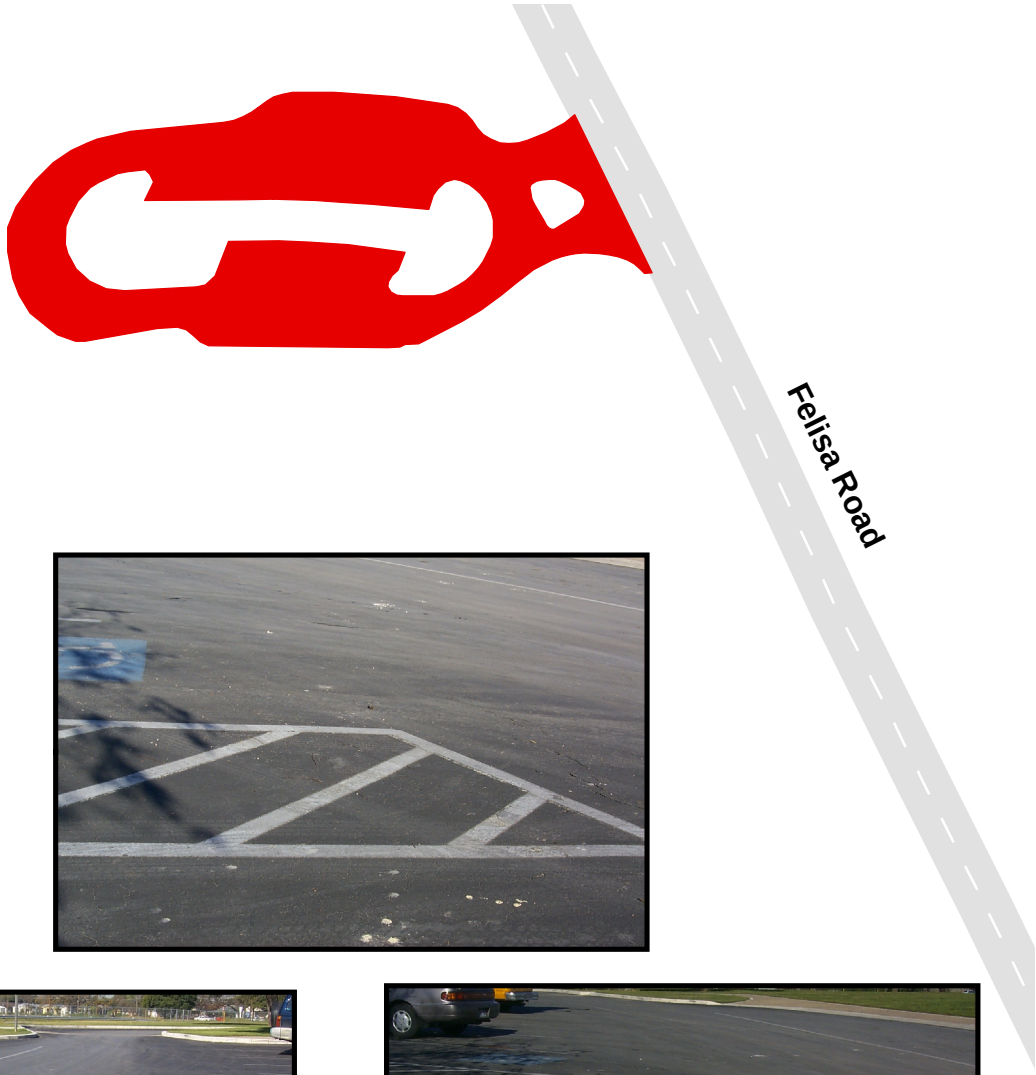
Route	Public / NonPublic	Date Visited	Area (sq ft)	Lane Miles *	Surface Type	Condition / PCR
0900	Public	12/20/2001	19988	0.34	AS	FAIR / 73

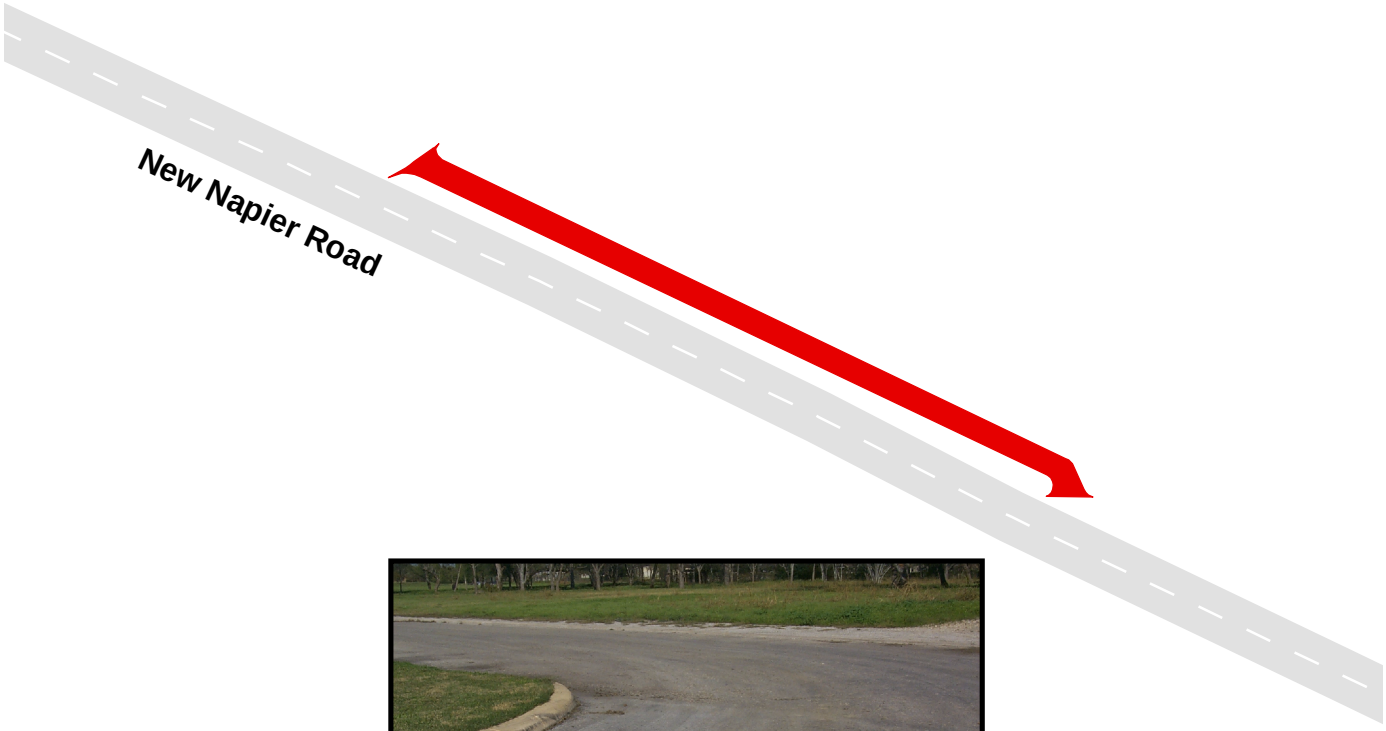
Route	Public / NonPublic	Date Visited	Area (sq ft)	Lane Miles *	Surface Type	Condition / PCR
0902	Public	12/20/2001	22082	0.38	AS	POOR / 45

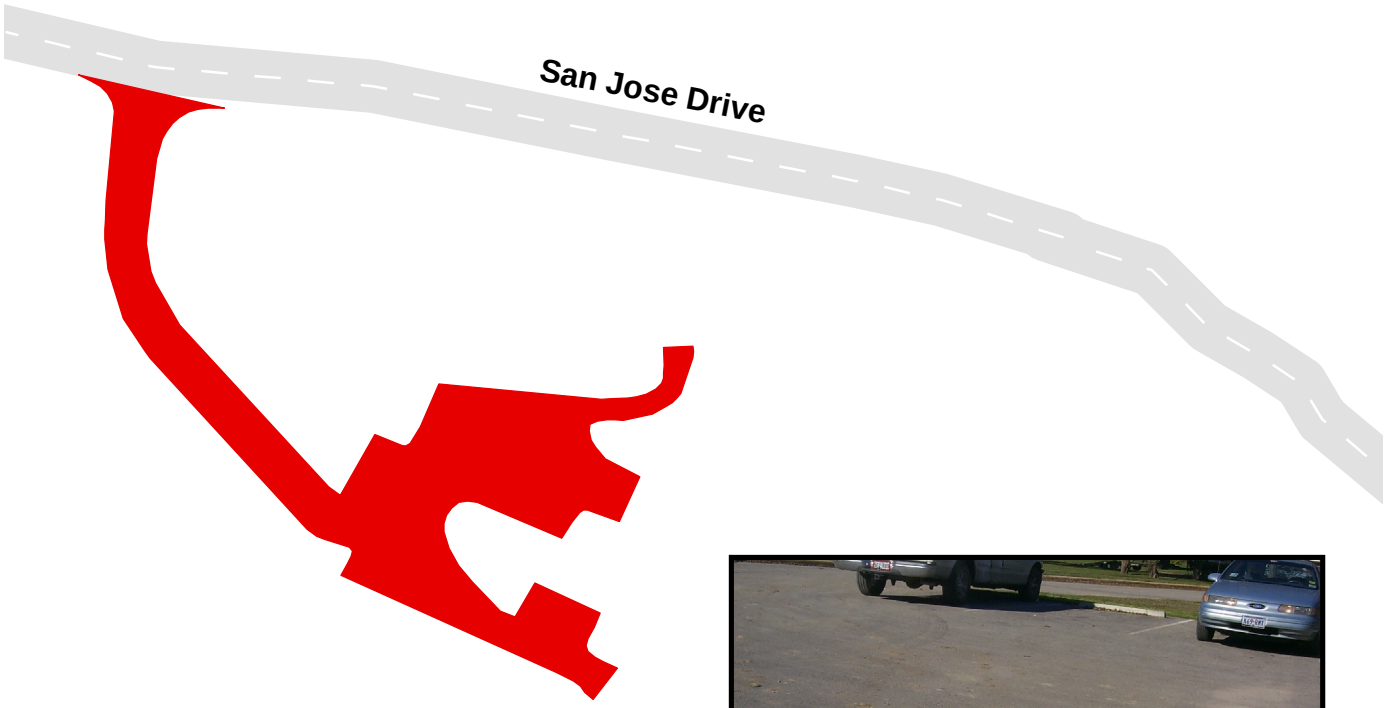
Route	Public / NonPublic	Date Visited	Area (sq ft)	Lane Miles *	Surface Type	Condition / PCR
0903	NonPublic	12/20/2001	17226	0.30	AS	FAIR / 73

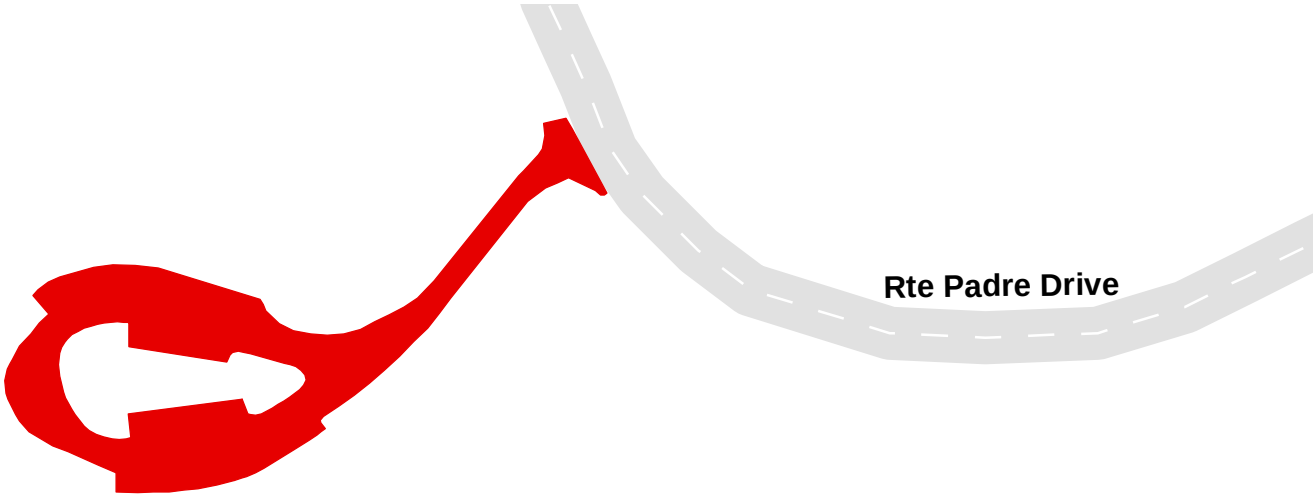
Route	Public / NonPublic	Date Visited	Area (sq ft)	Lane Miles *	Surface Type	Condition / PCR
0904	Public	12/20/2001	23510	0.40	AS	POOR / 45

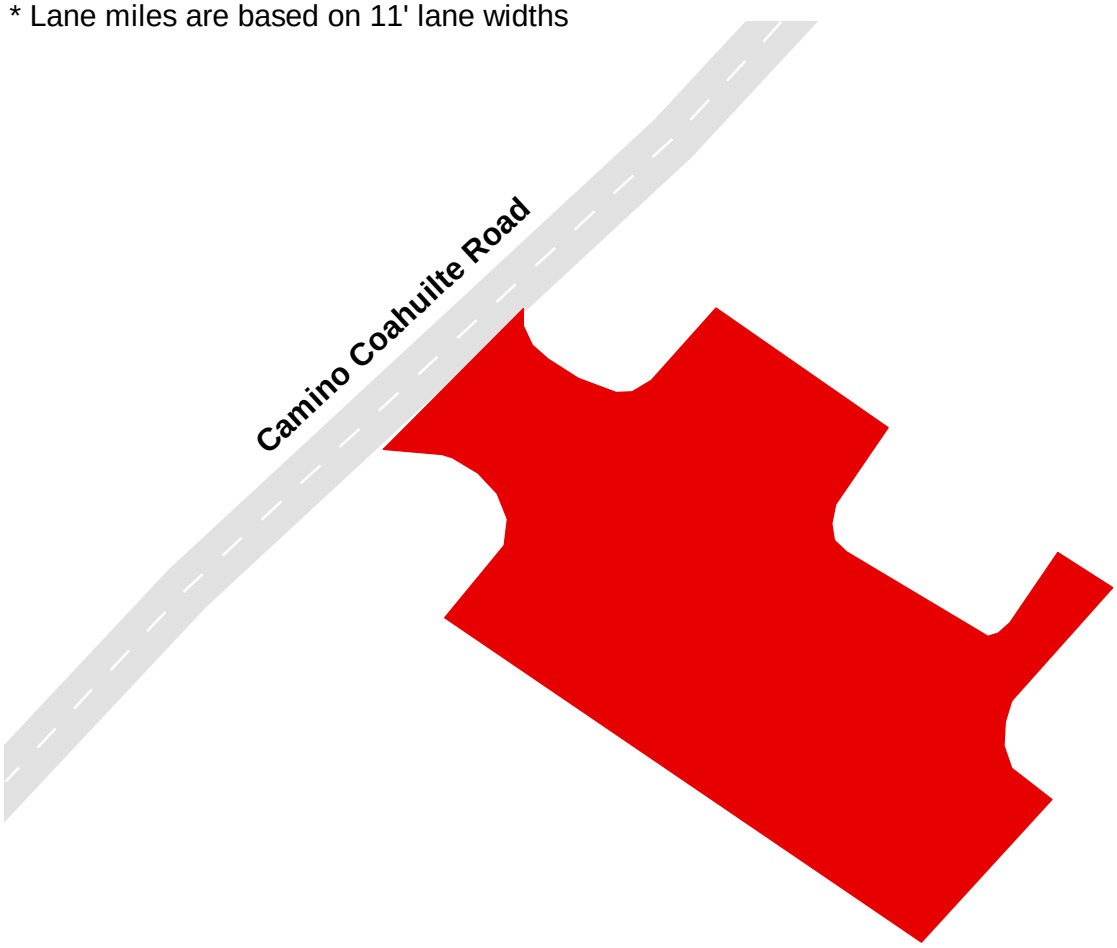
Route	Public / NonPublic	Date Visited	Area (sq ft)	Lane Miles *	Surface Type	Condition / PCR
0905	Public	12/20/2001	4292	0.07	AS	GOOD / 90

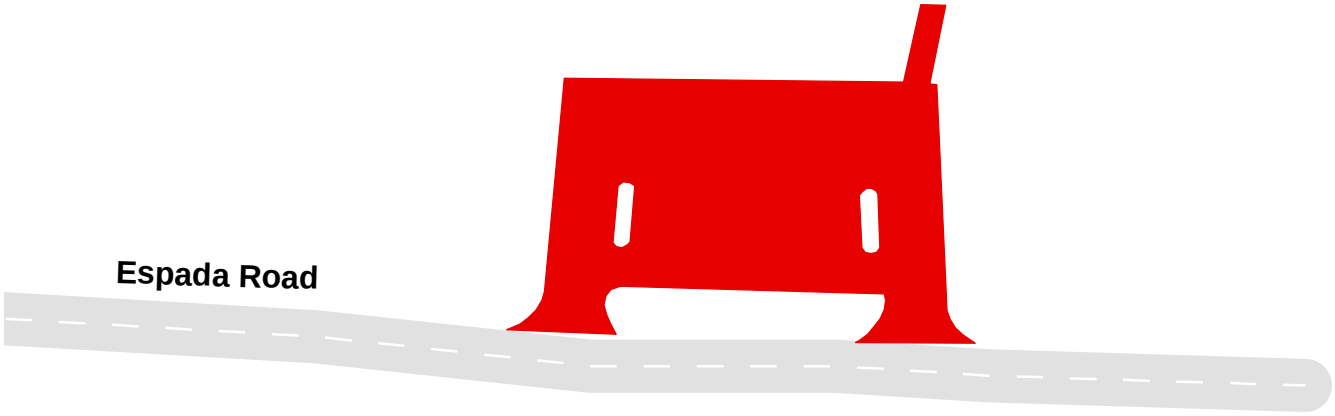
Route	Public / NonPublic	Date Visited	Area (sq ft)	Lane Miles *	Surface Type	Condition / PCR
0906	Public	12/20/2001	16101	0.28	AS	GOOD / 90
