Appendix A
CSL Data from Site #1

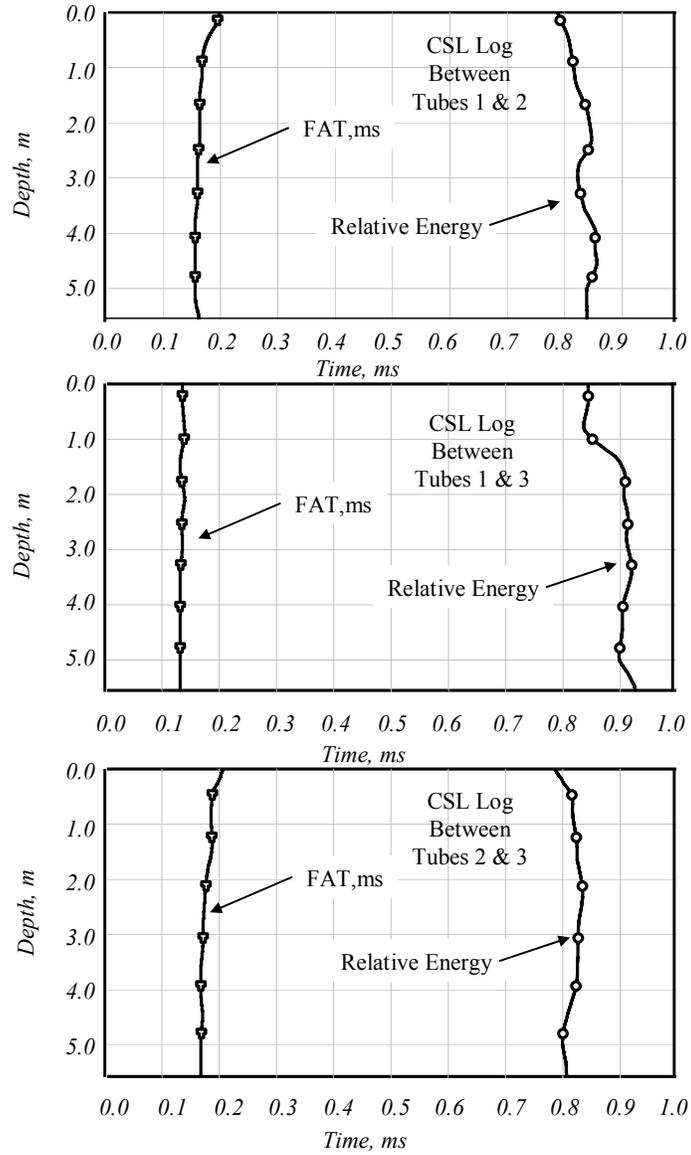
Figure A1 CSL Data from Site#1 Abutment 1 Shaft 1

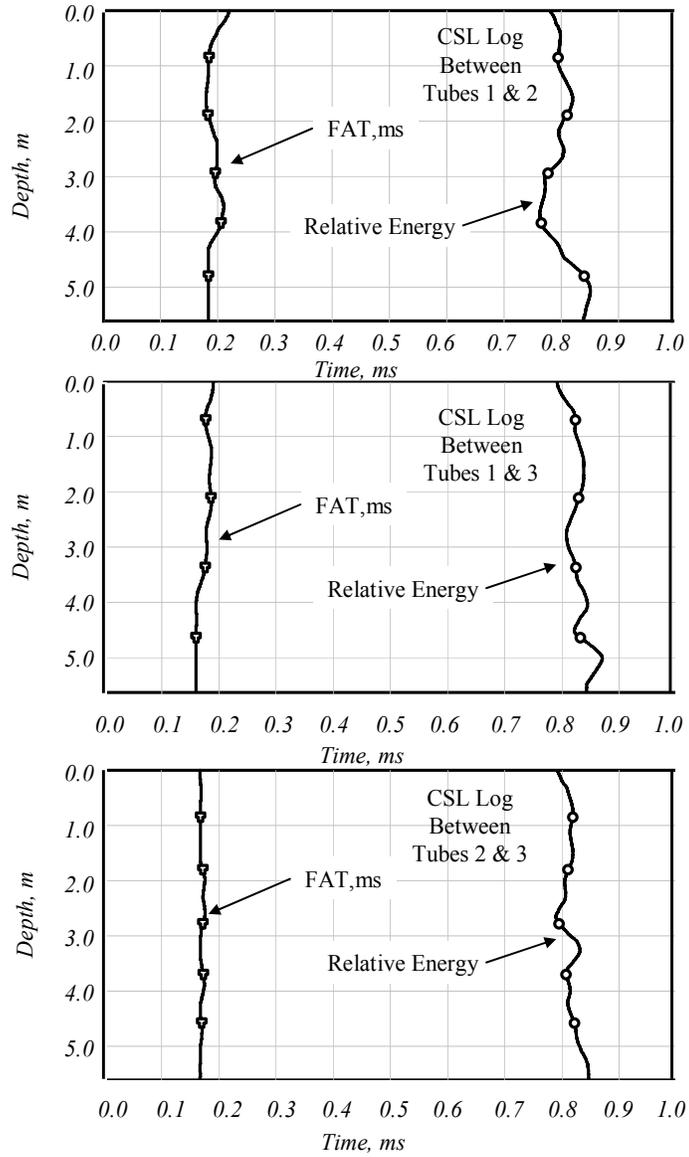
Figure A2 CSL Data from Site#1 Abutment 1 Shaft 2

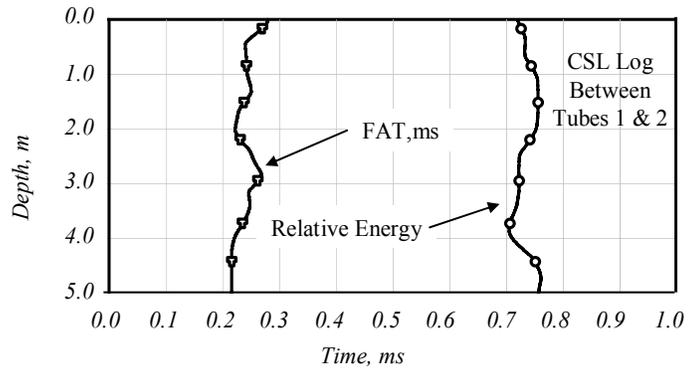
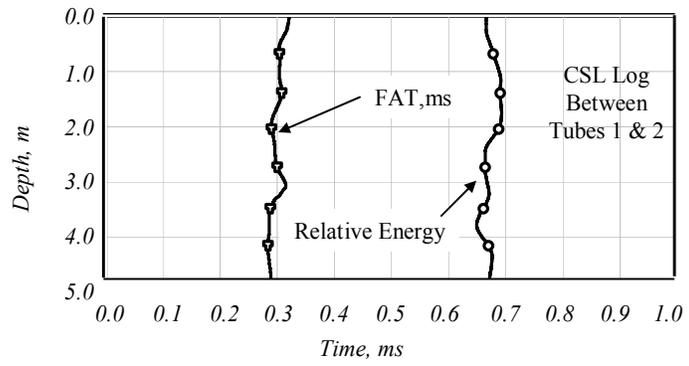
Retest with 500 mm offset

Retest with 1000 mm offset

Figure A3 Retest Data from Site#1 Abutment 1 Shaft 2

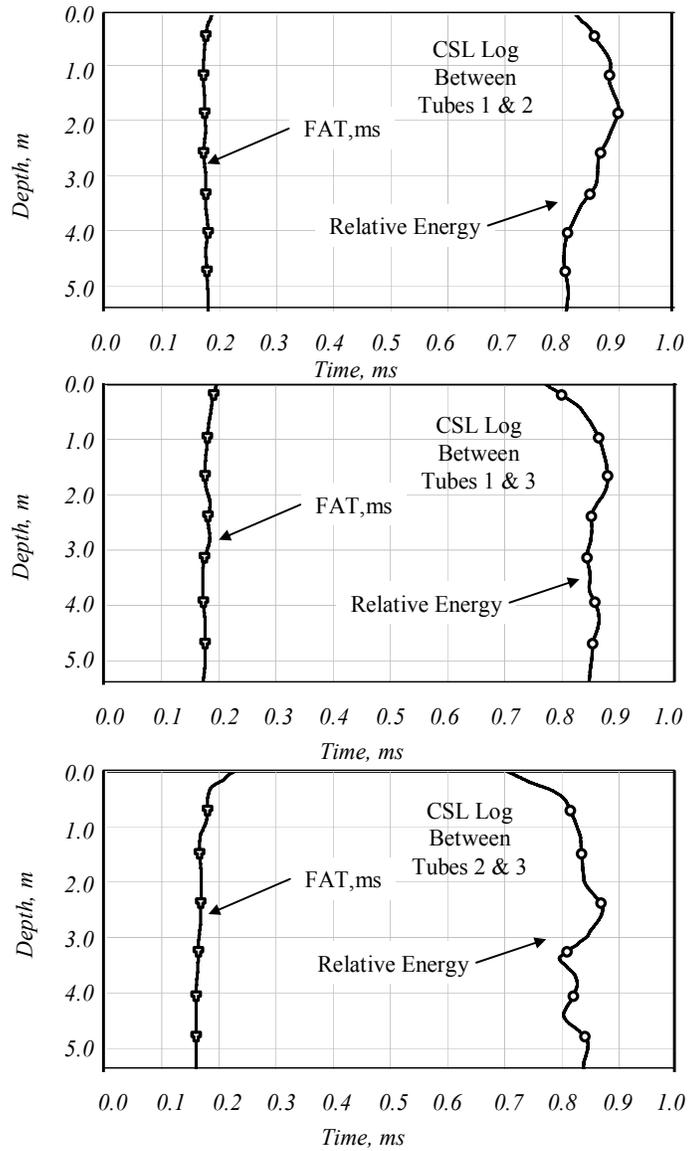
Figure A4 CSL Data from Site#1 Abutment 1 Shaft 3

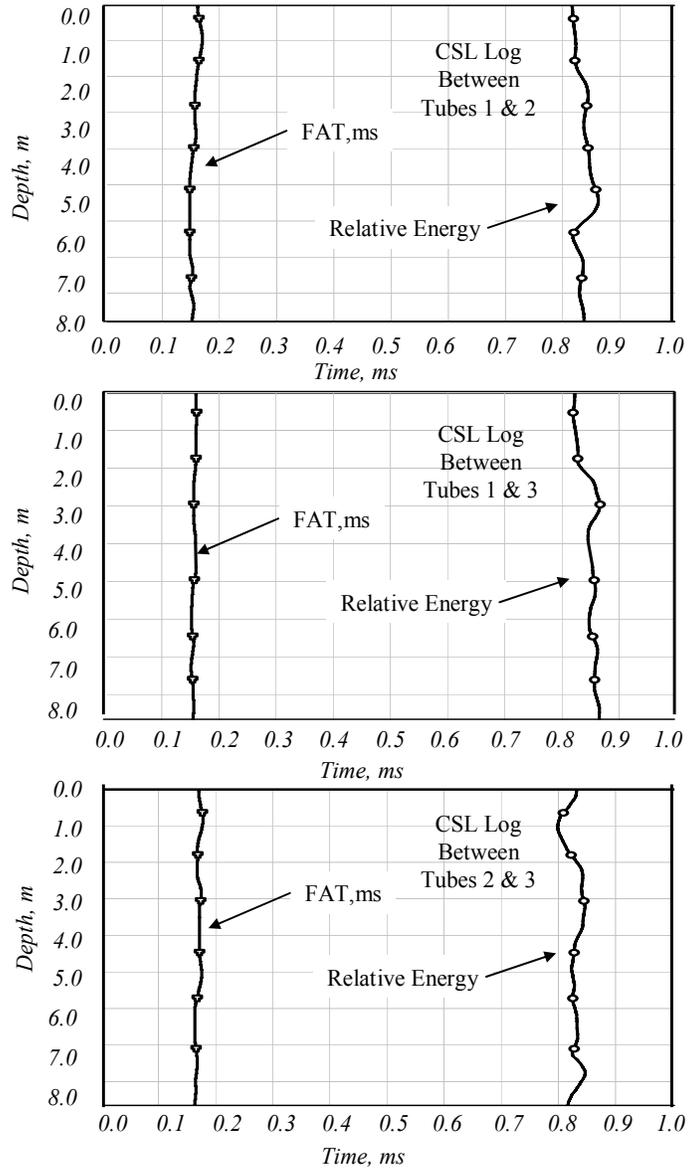
Figure A5 CSL Data from Site#1 Abutment 1 Shaft 4

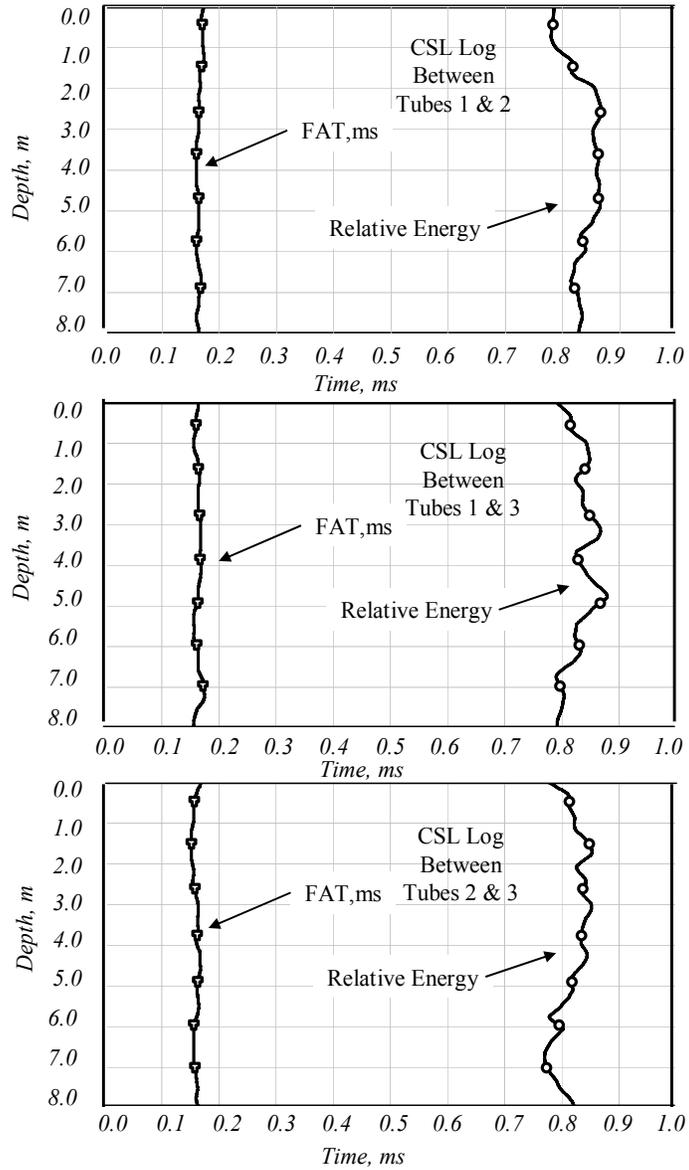
Figure A6 CSL Data from Site#1 Abutment 2 Shaft 1

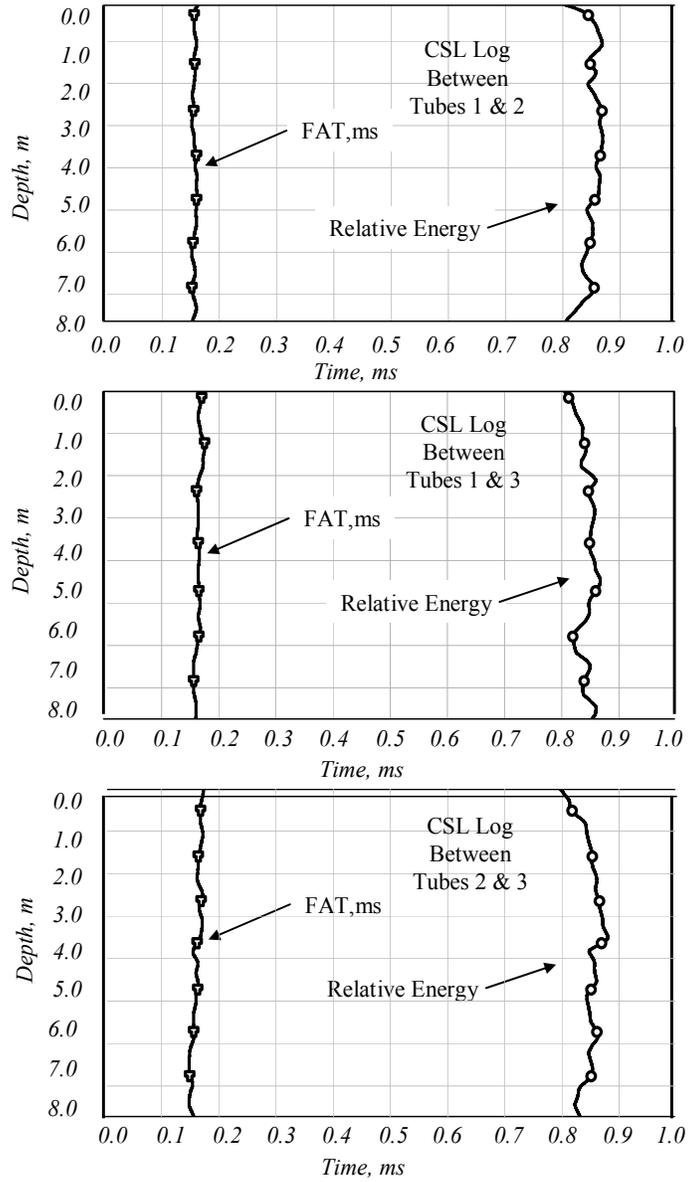
Figure A7 CSL Data from Site#1 Abutment 2 Shaft 2

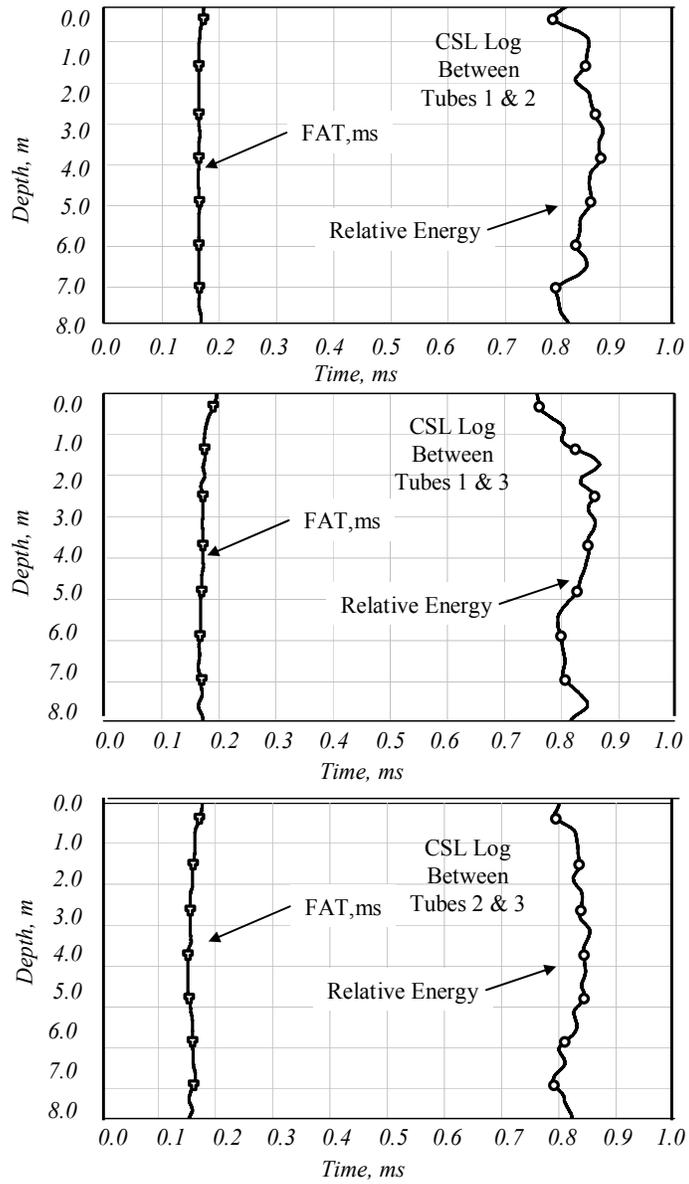
Figure A8 CSL Data from Site#1 Abutment 2 Shaft 3

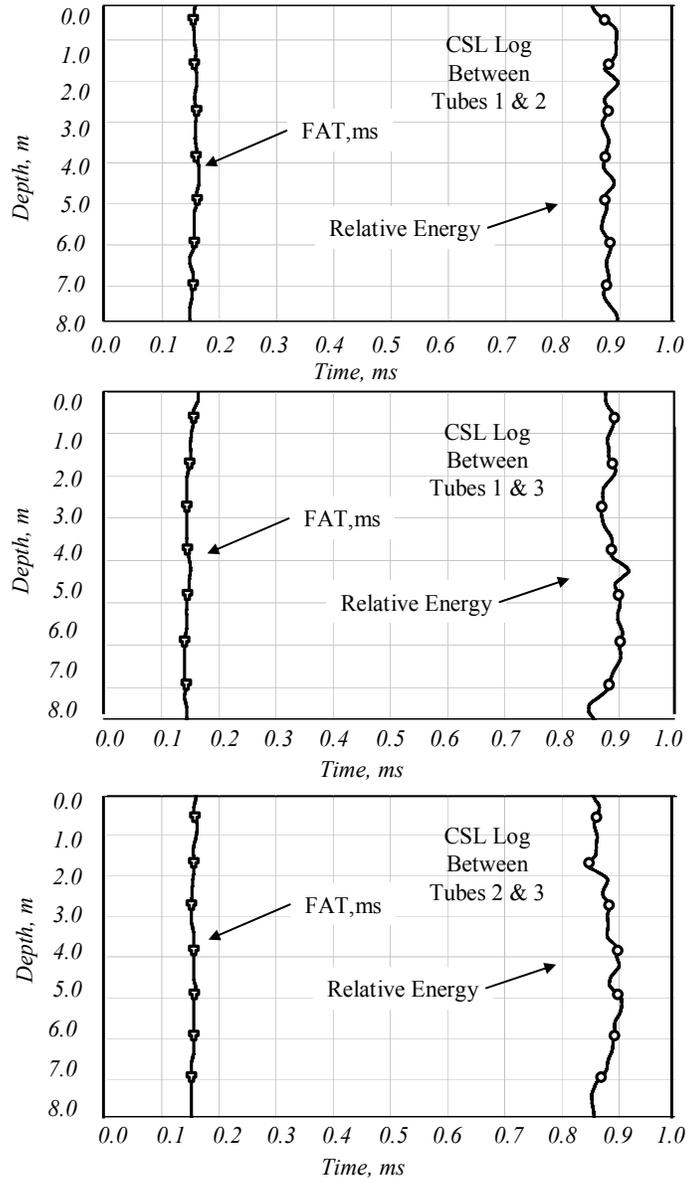
Figure A9 CSL Data from Site#1 Abutment 2 Shaft 4
